Dedicated Home Services LLC

This is an actual inspection report

Aaron Pfaff, Dedicated Home Services LLC

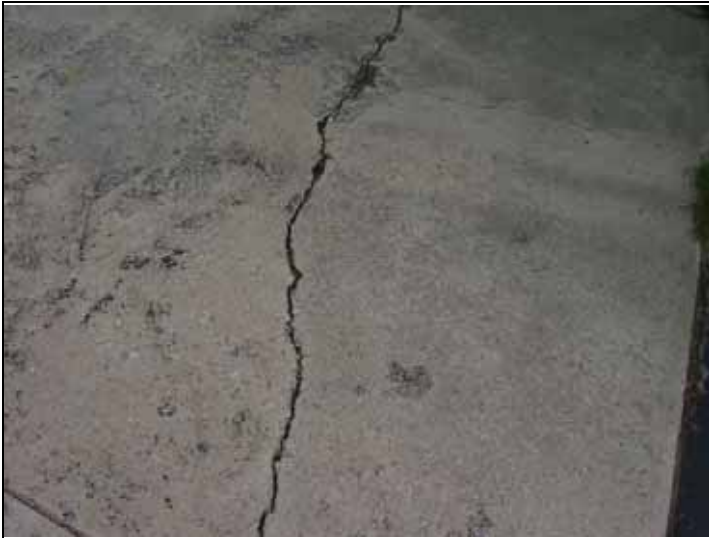
Cracks in concrete drive

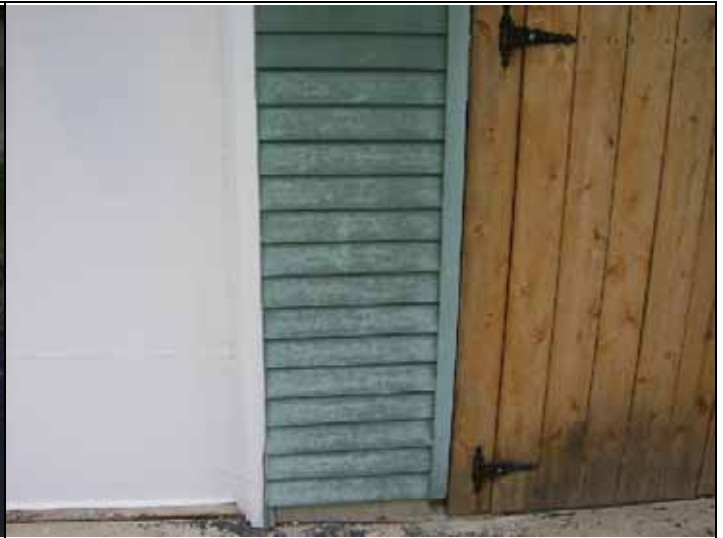
Fading siding, chalking paint

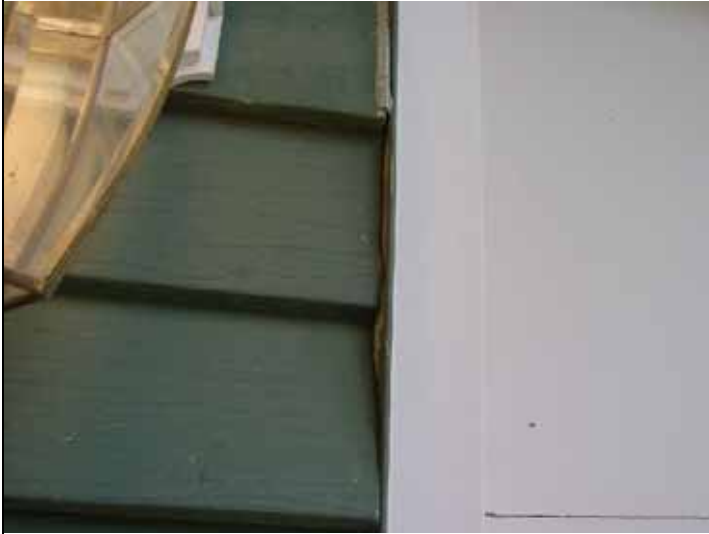
Example of caulking needed

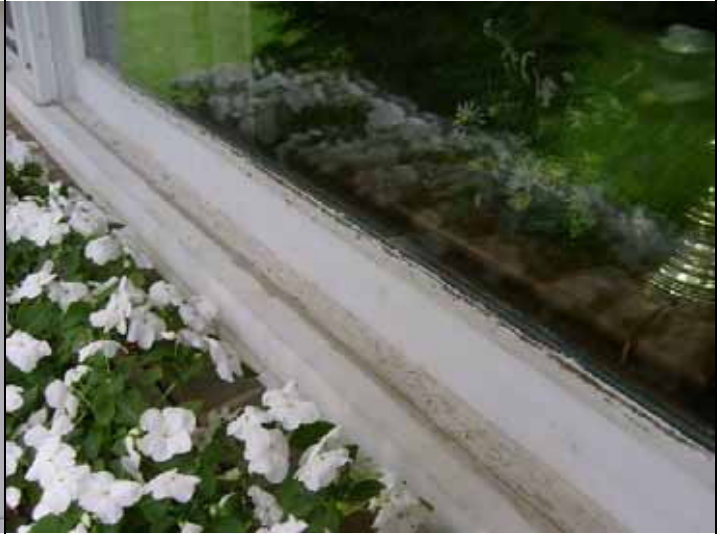
Large picture window sill, caulk and paint deteriorated.

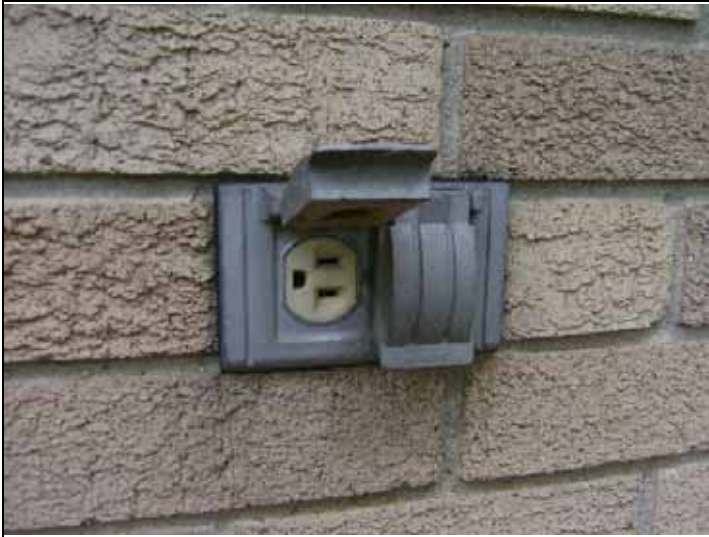
Ungrounded outlet, needs GFCI protection

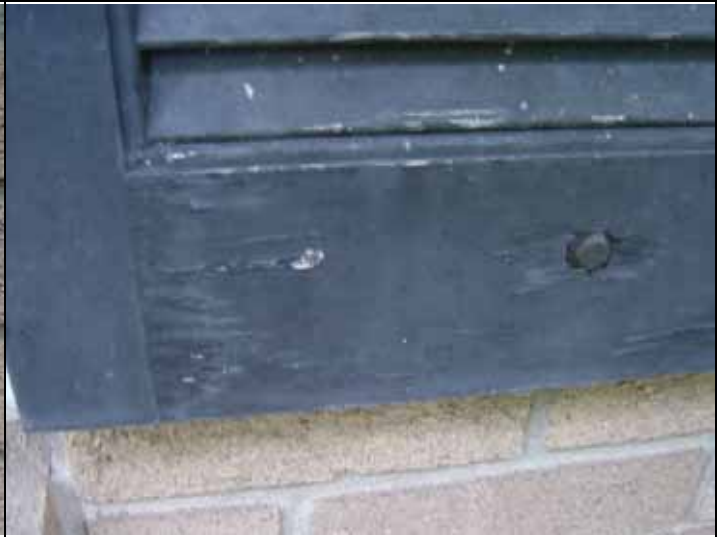
Example of shutter condition

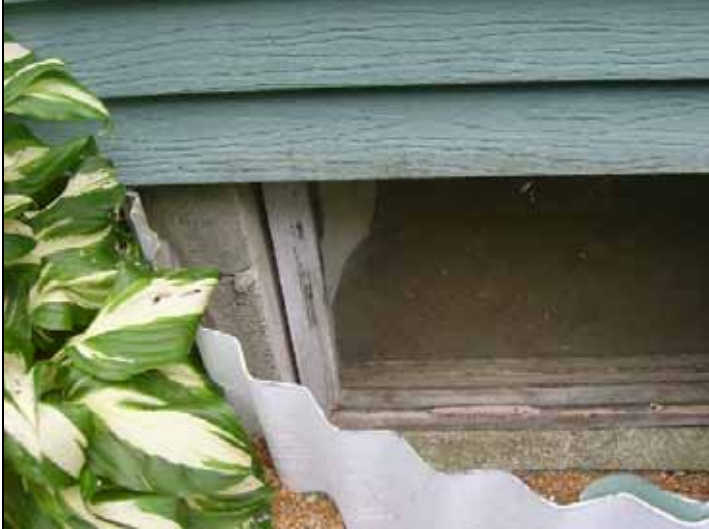
Basement windows deteriorated

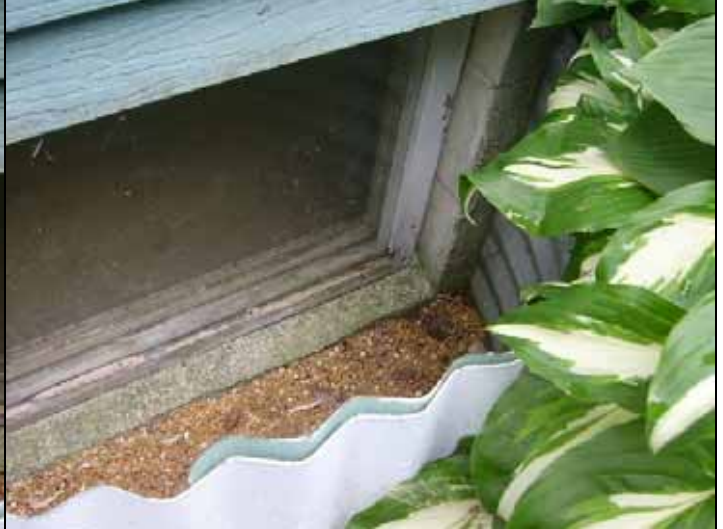
Wood rot evident in basement windows

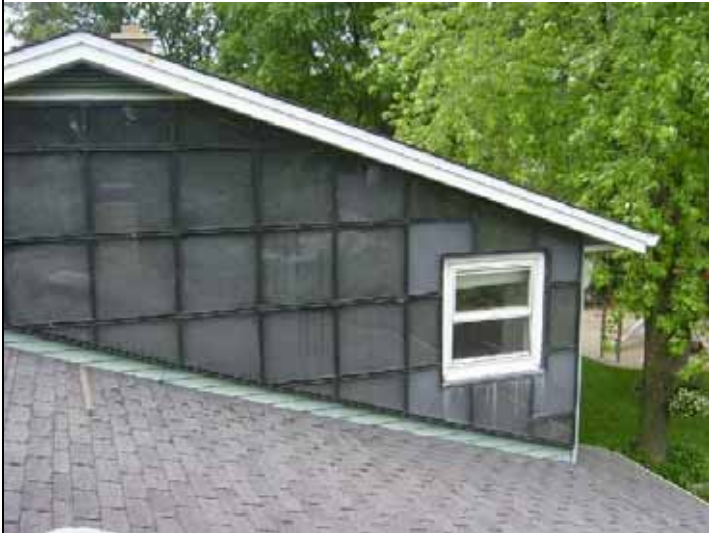
Solar heating panels damaged near window

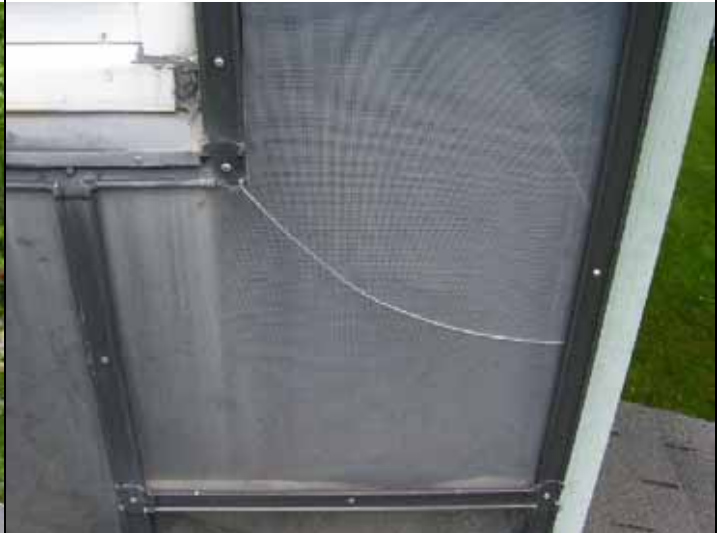
Several panes cracked

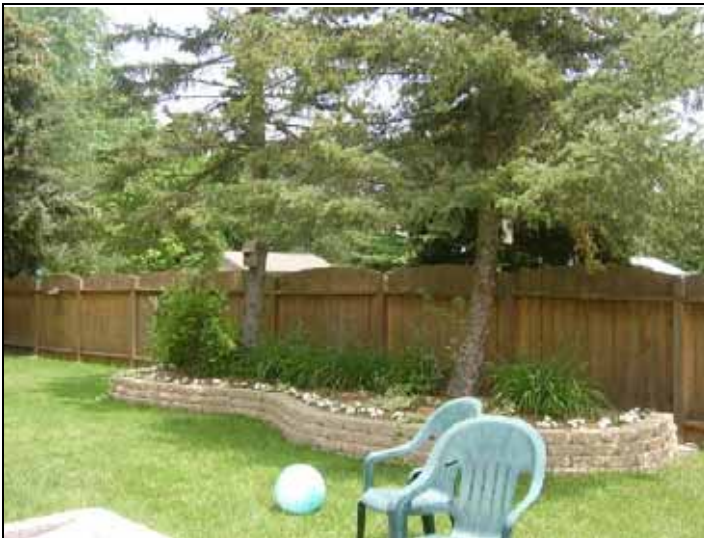
Flower bed, trees stressed

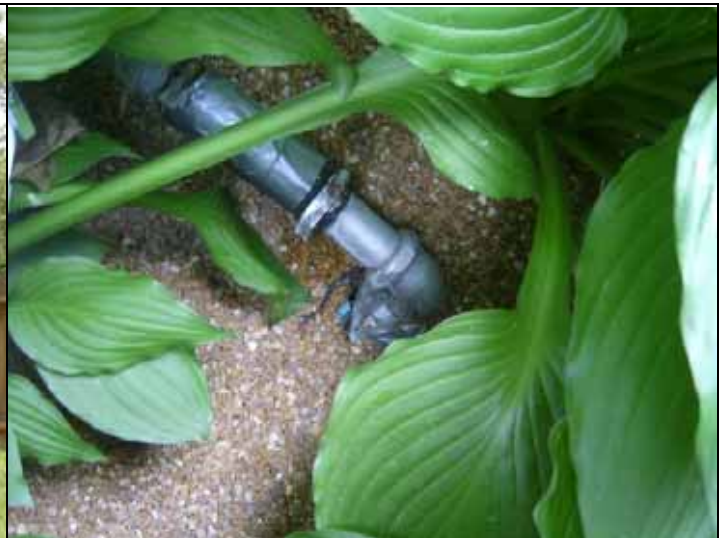
Sump discharge line

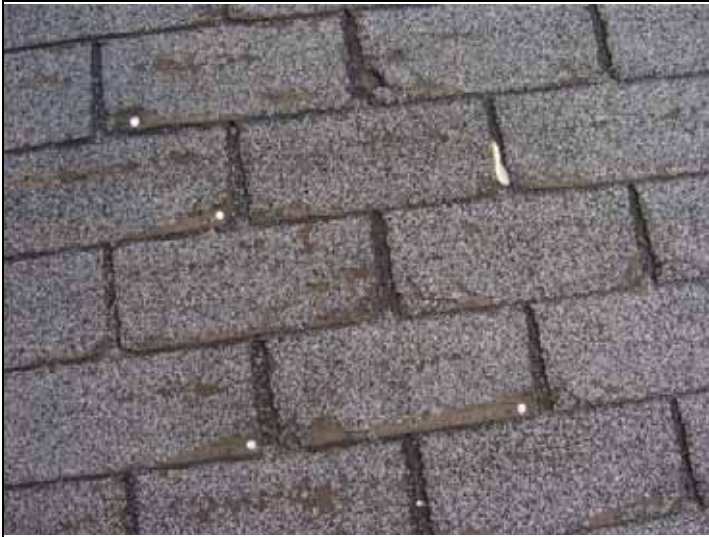
Deteriorated shingles

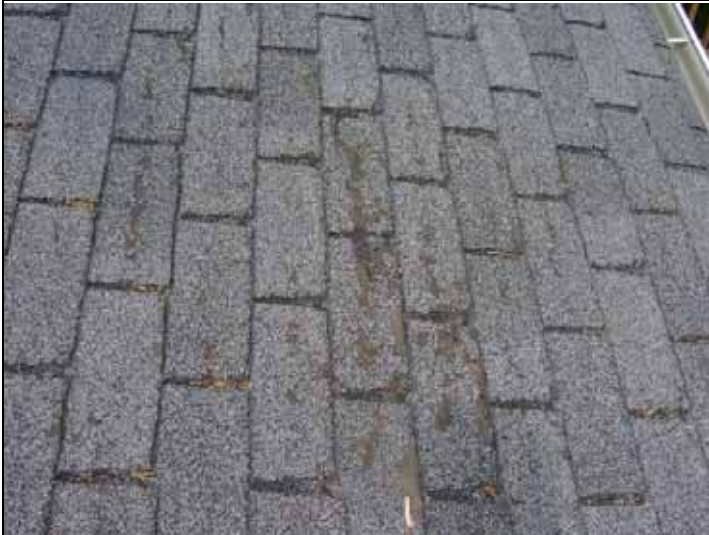
Deteriorated shingles

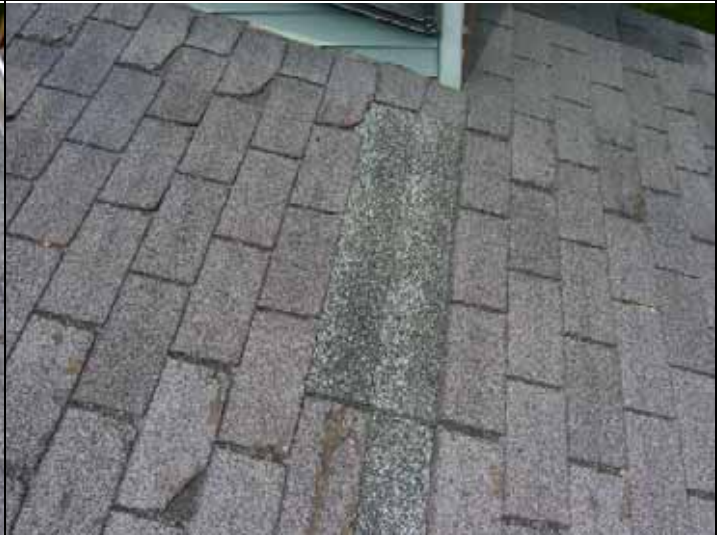
Deteriorated shingles

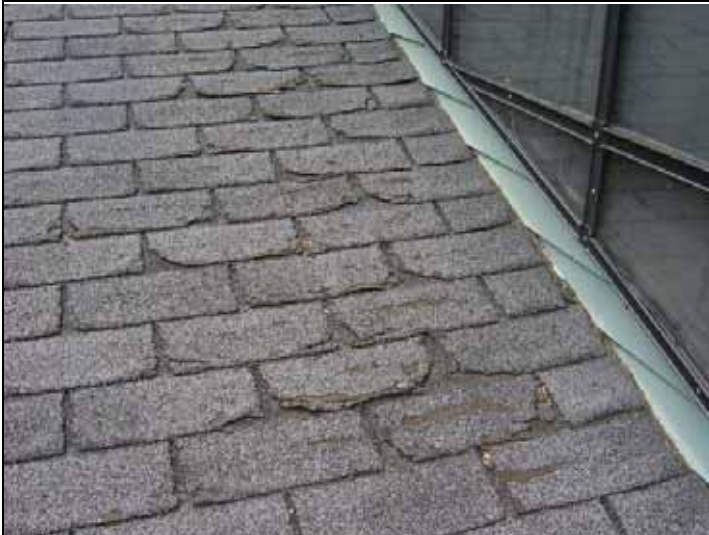
Deteriorated shingles

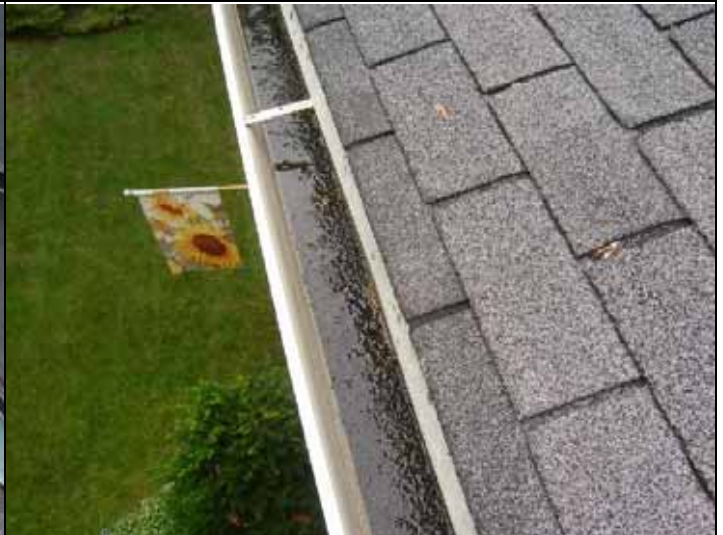
Gutters improper slope and granules

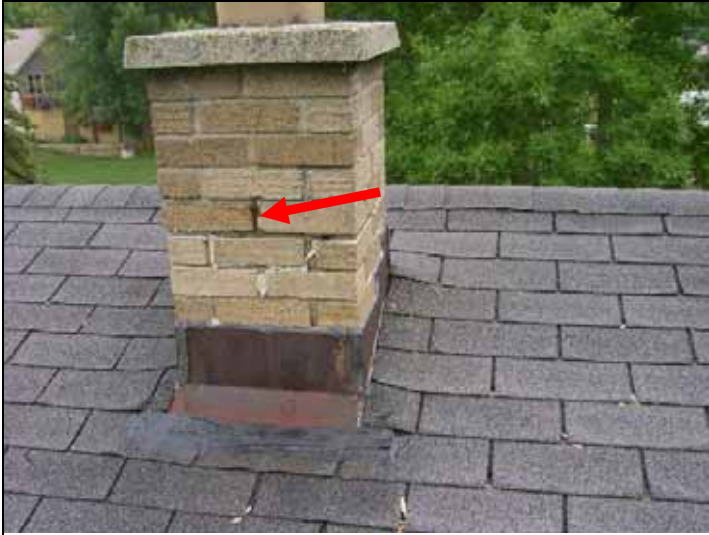
Chimney needs minor repairs and cap

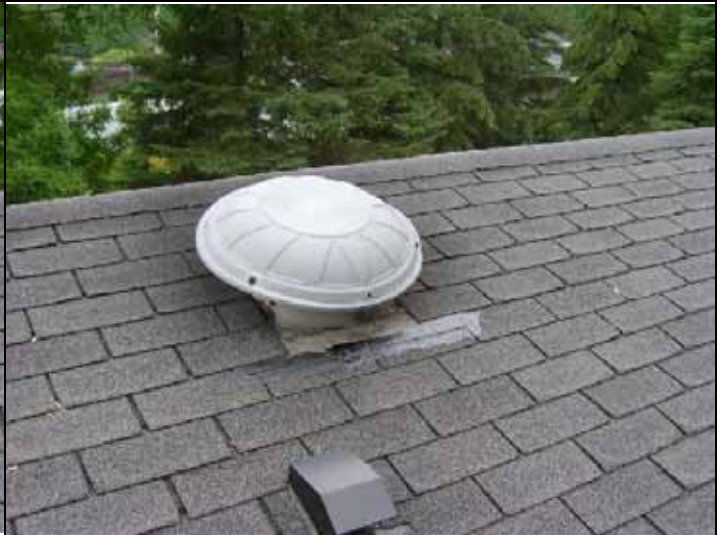
Power vent hood

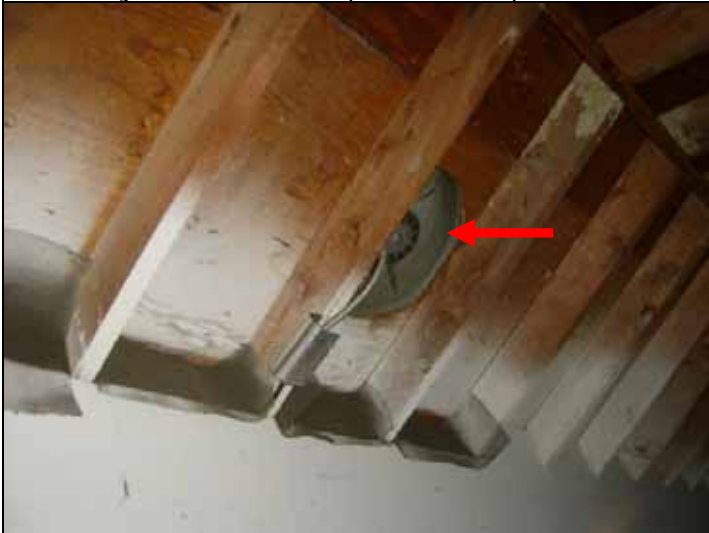
Attic vent fan in garage

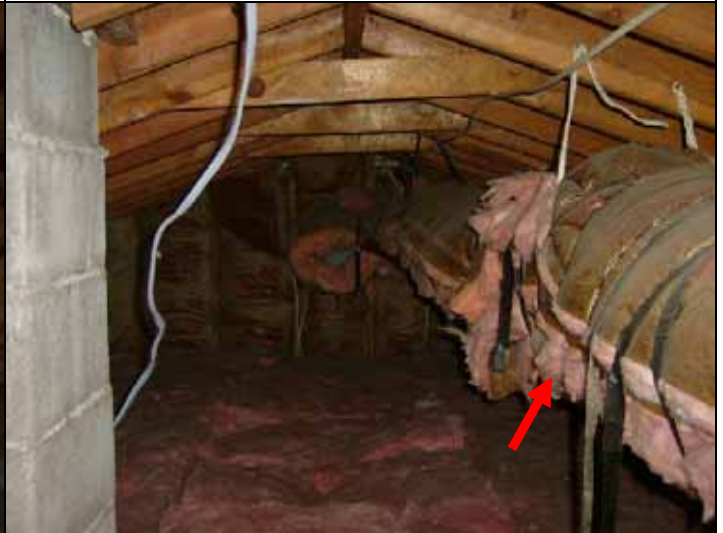
Solar ducting in attic

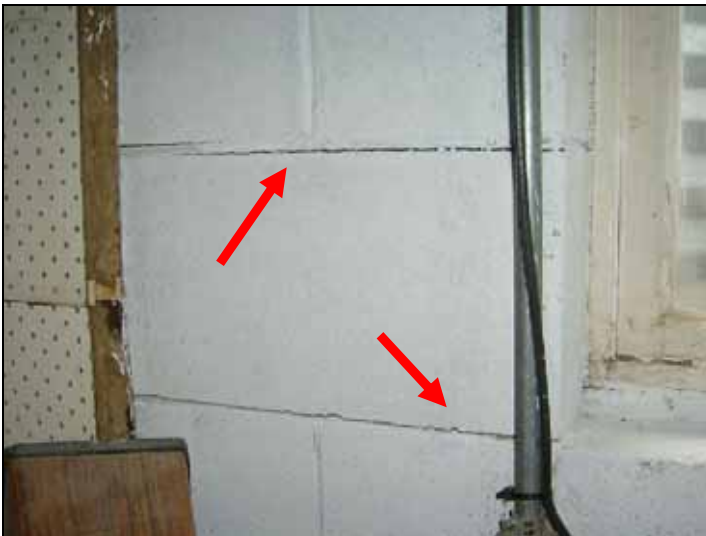
Horizontal cracks in wall

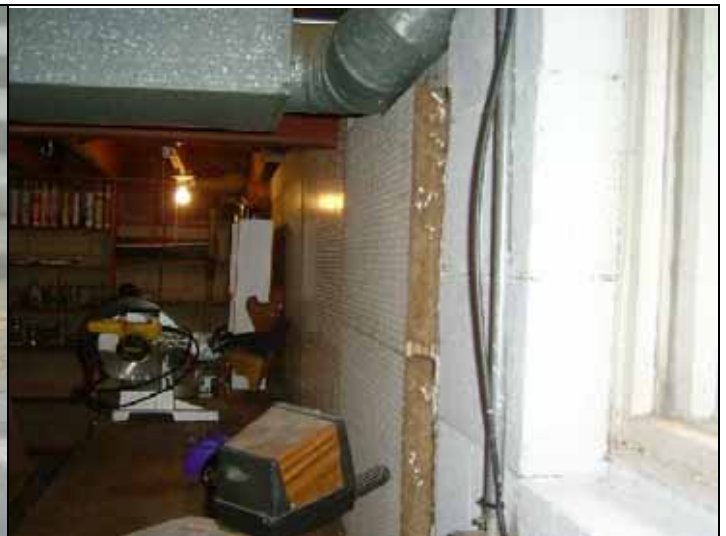
Bowing visible in peg board area

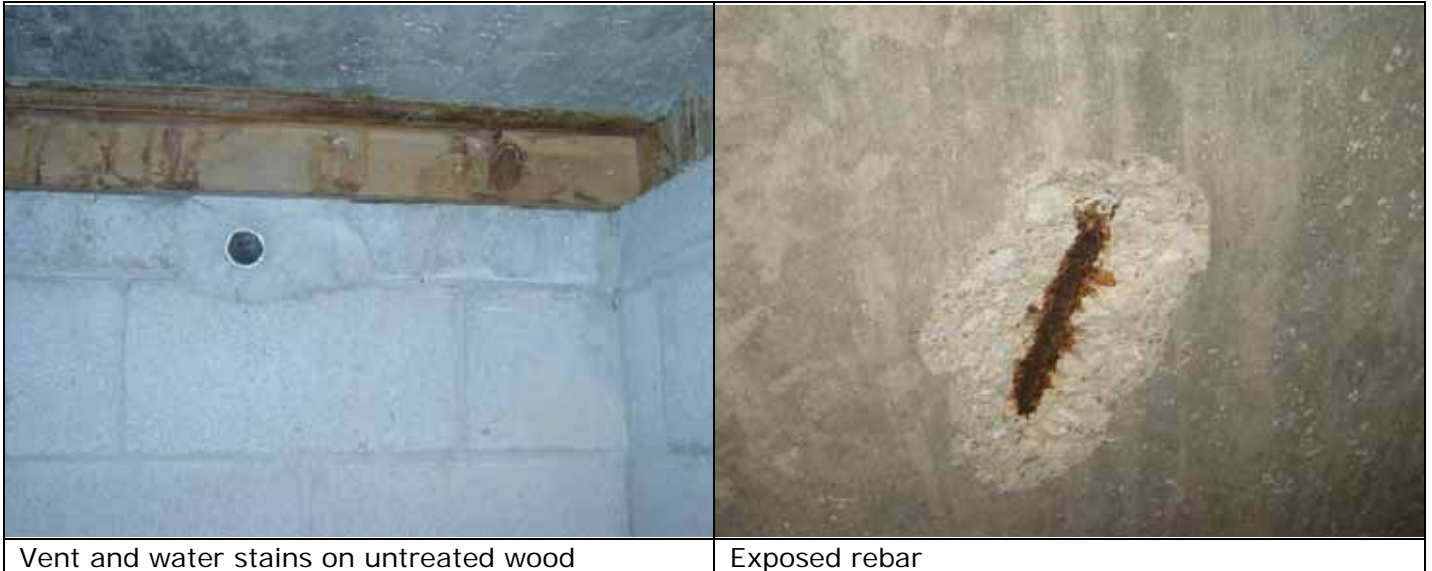
Vent and water stains on untreated wood

Exposed rebar

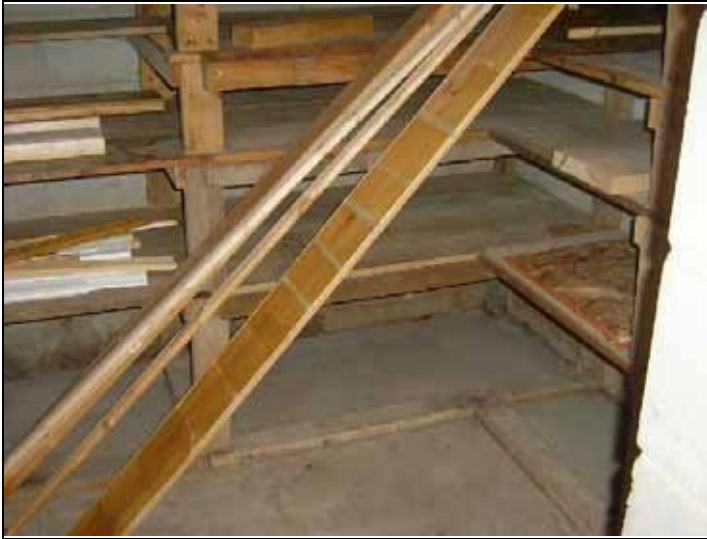
Untreated wood in contact with masonry

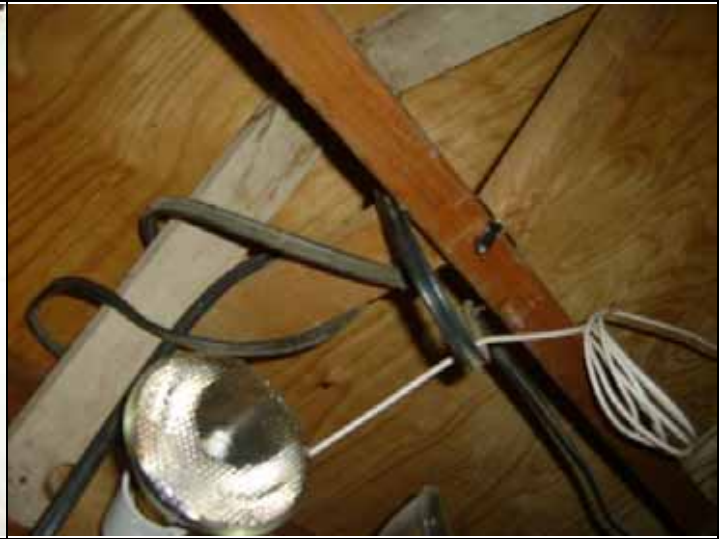
Flood light for crawlspace is fire hazard

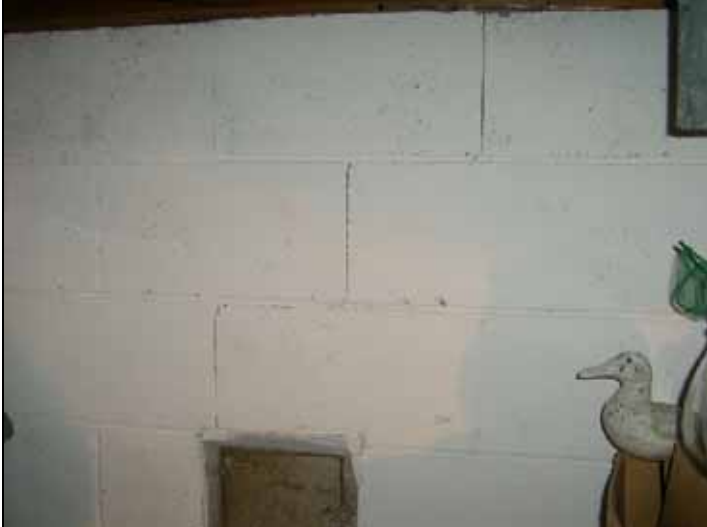
Step settlement cracks under chimney, fireplace

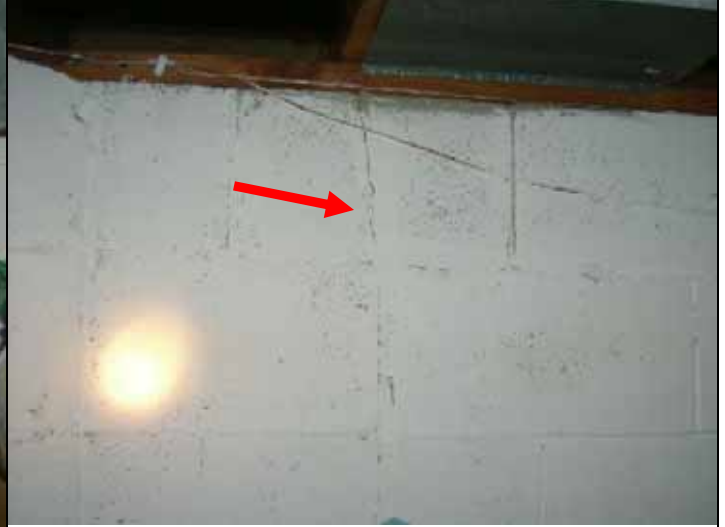
Old crack repair

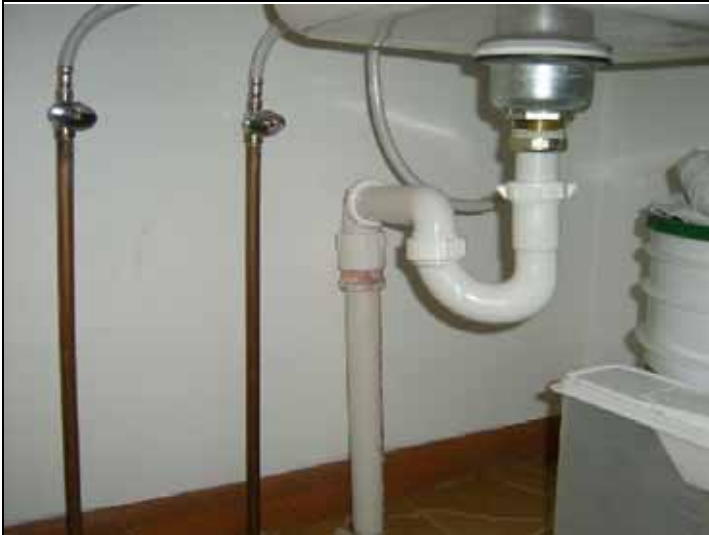
Hallway utility sink unvented

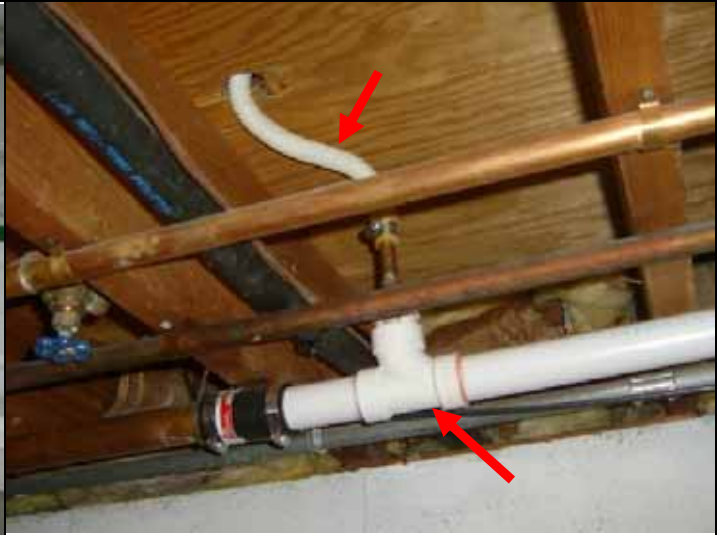
Improper dishwasher drain

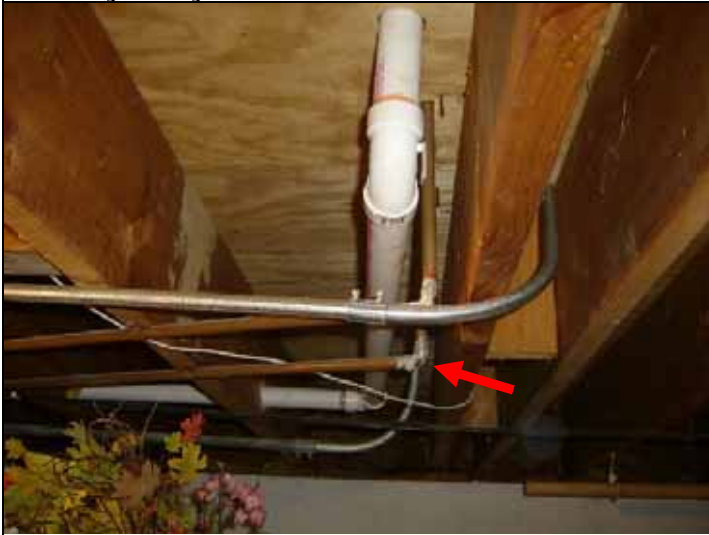
Improper drain, poor connections

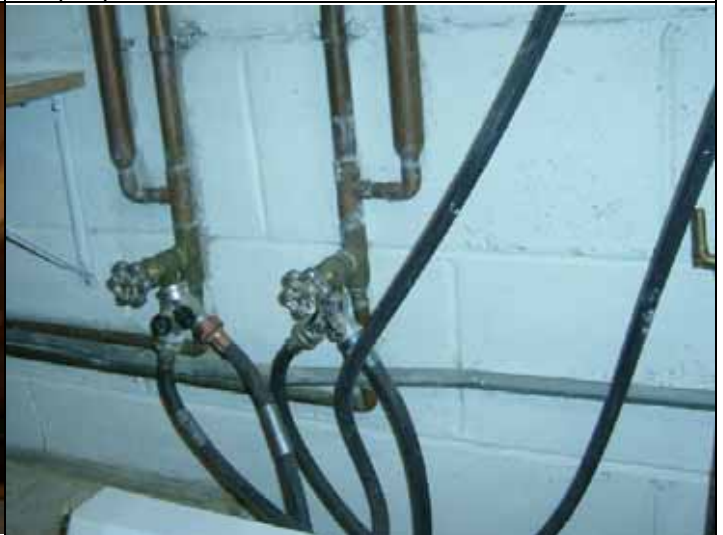
Washer and utility sink supply

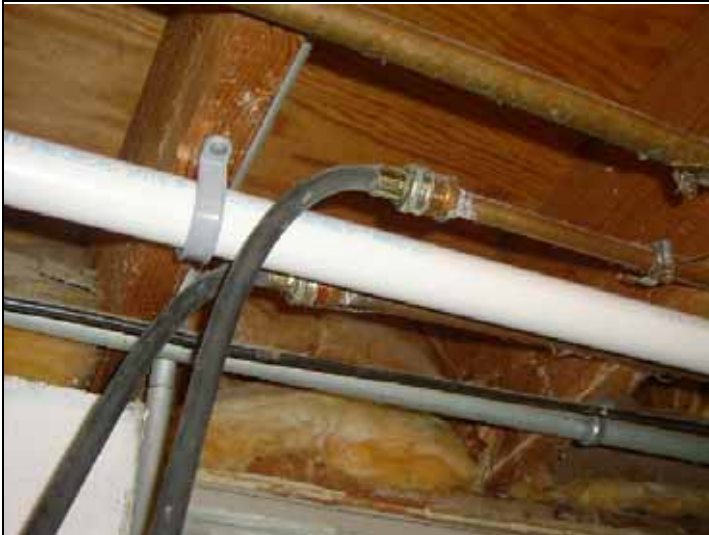
Hoses supply utility sink

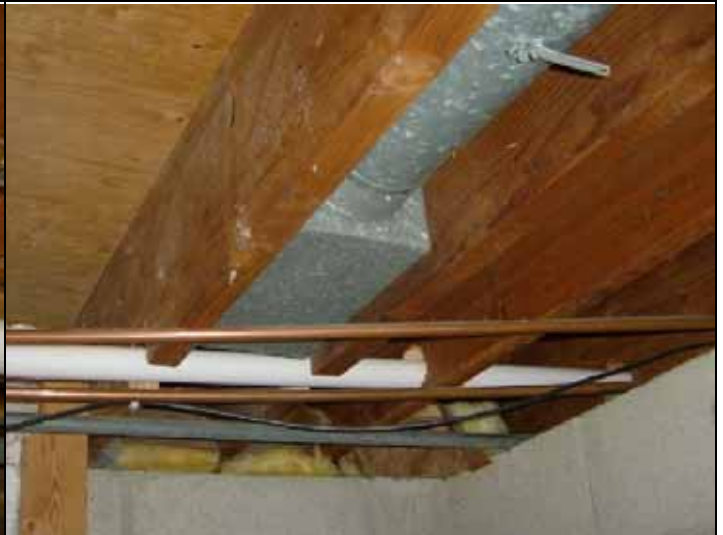
Improper drain and joist notching weakens joist

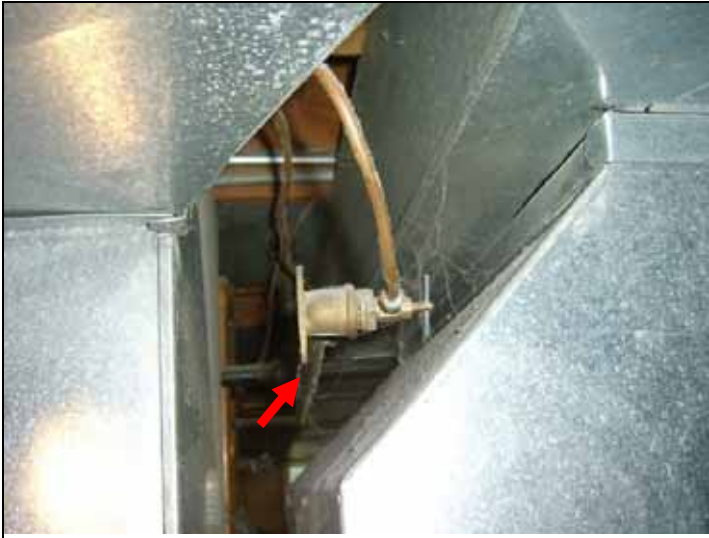
Unsupported pipe

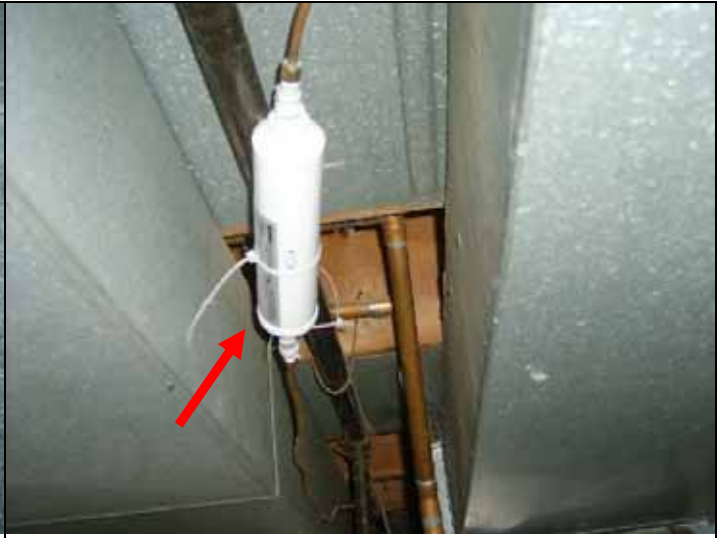
Needs better support

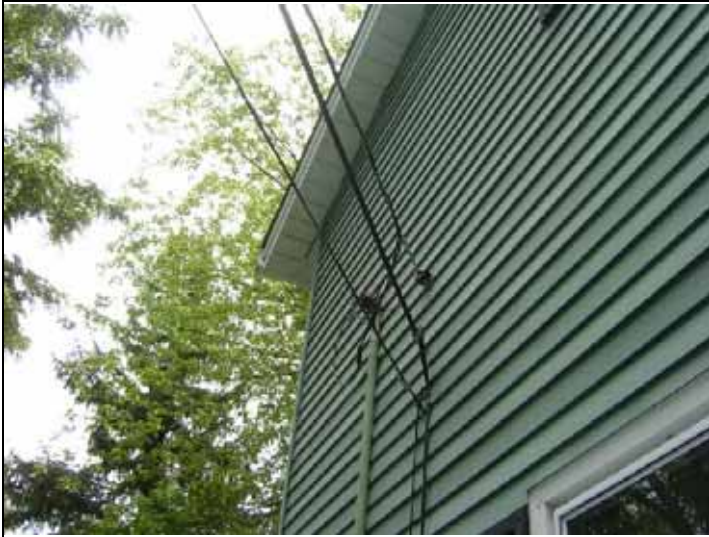
Service drop appears to be 60 amp

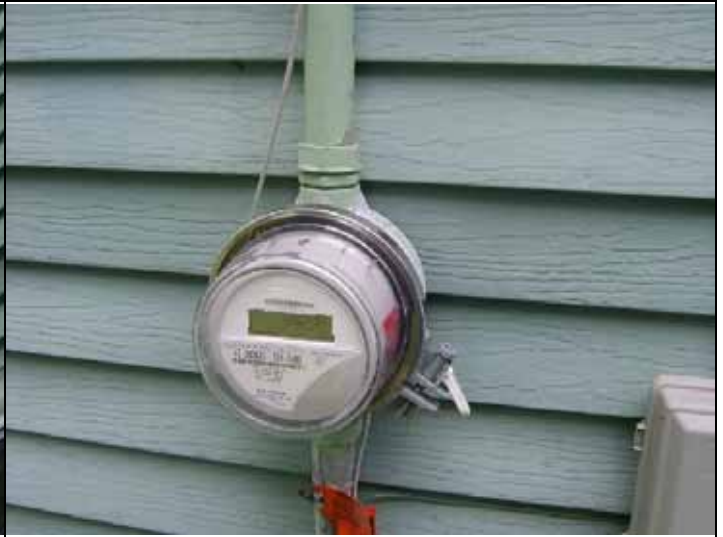
60 amp meter socket

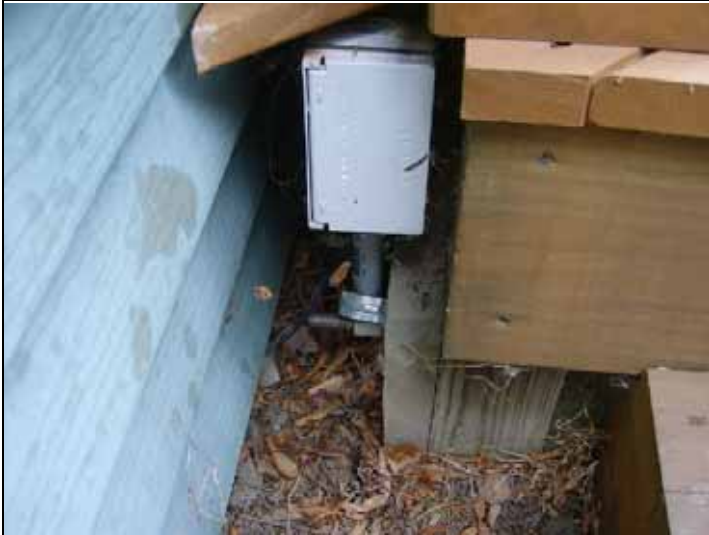
GFCI outlet not operational

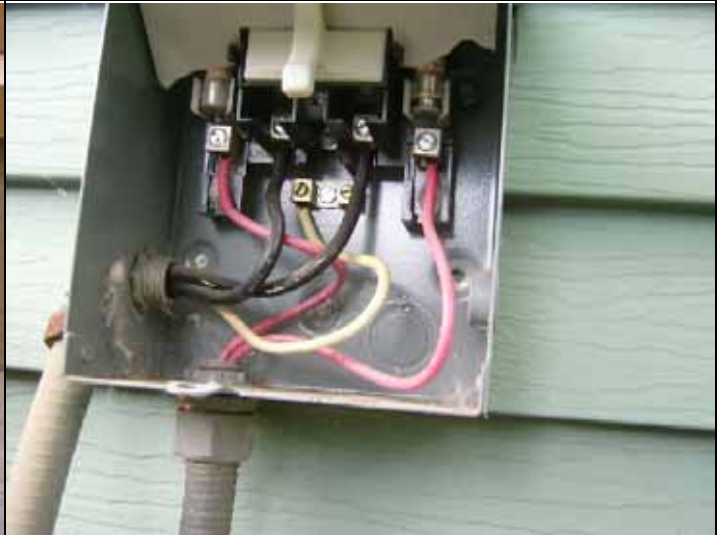
Ungrounded AC disconnect

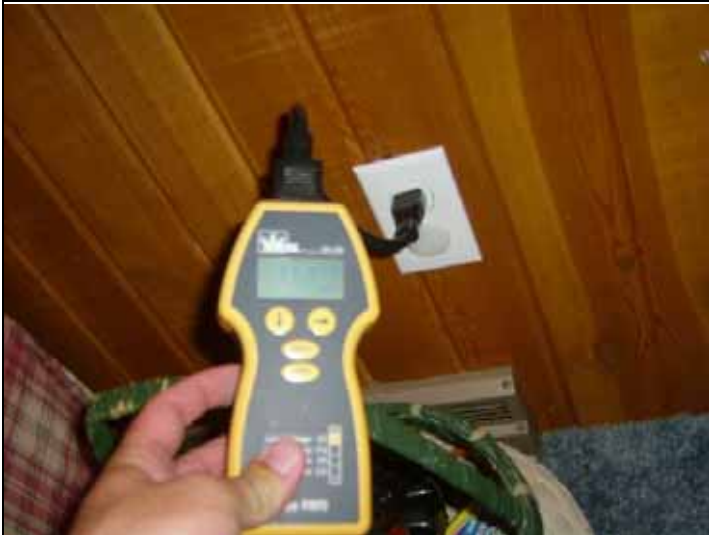
Voltage drop 11.5% in living room

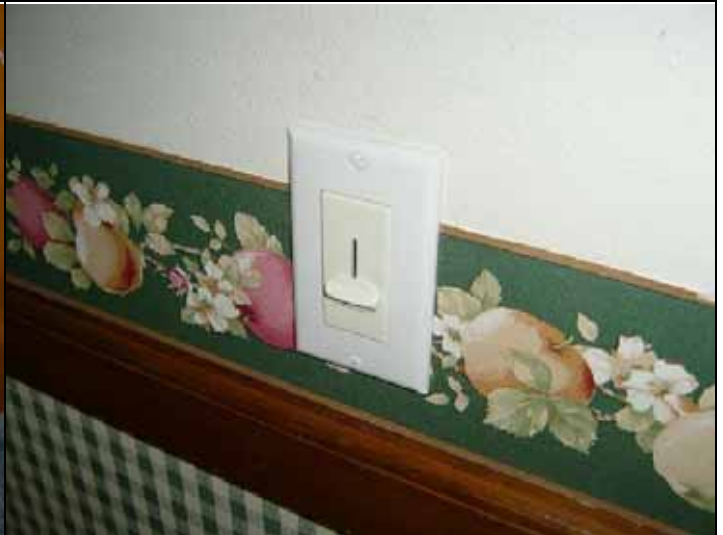
Dimmer feature not operational

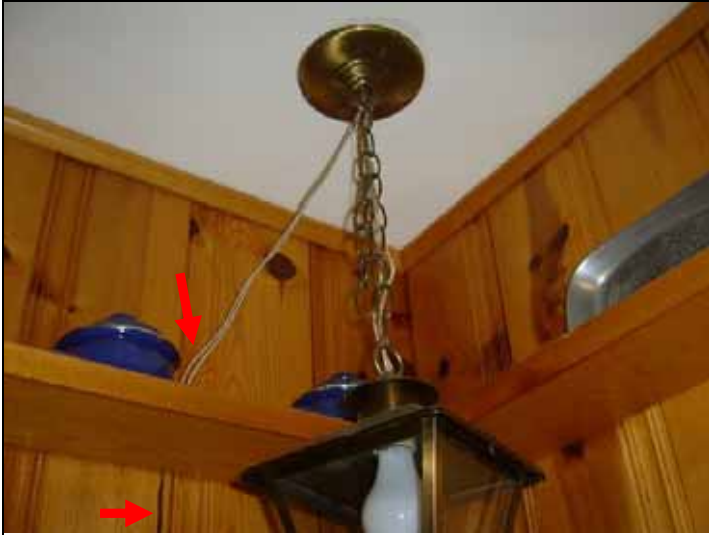
Improperly wired lamp

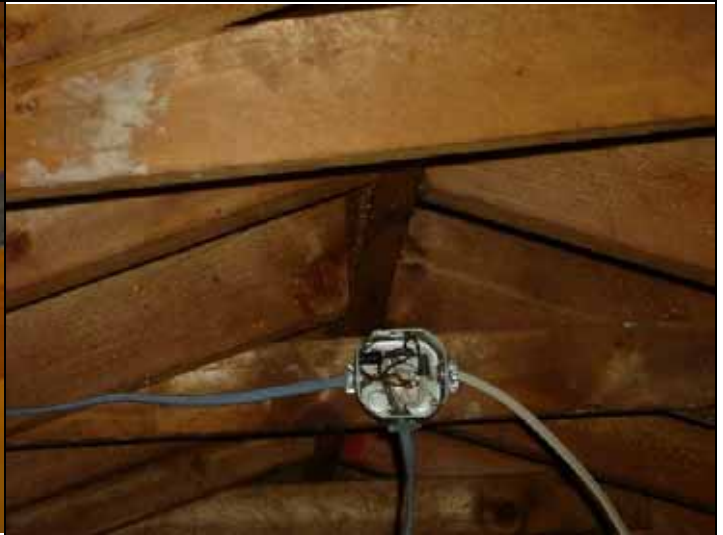
Open junction and unsupported wires in attic

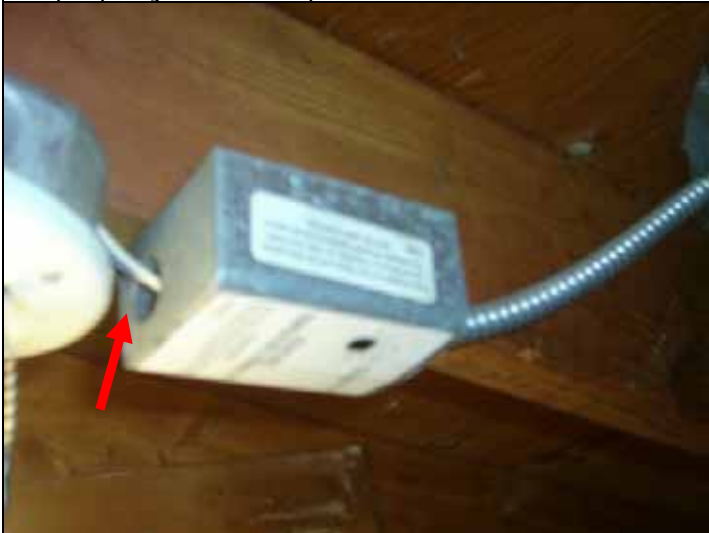
Improper wiring to attic fan thermostat

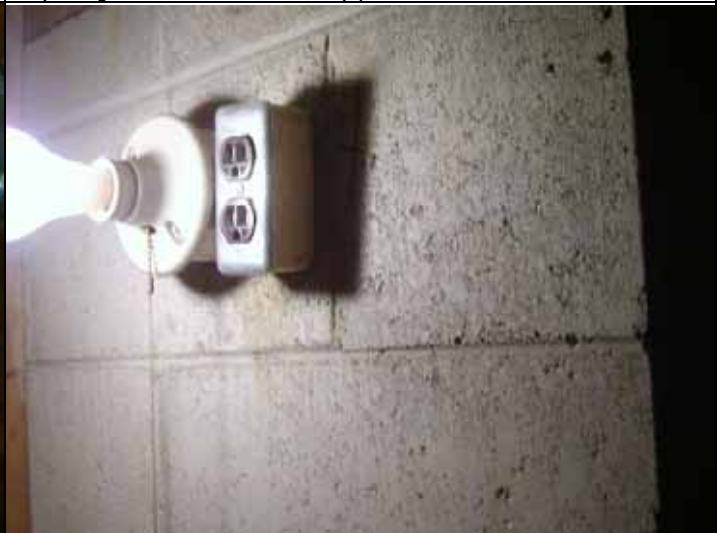
Cellar outlet, lighting, needs GFCI, damp location

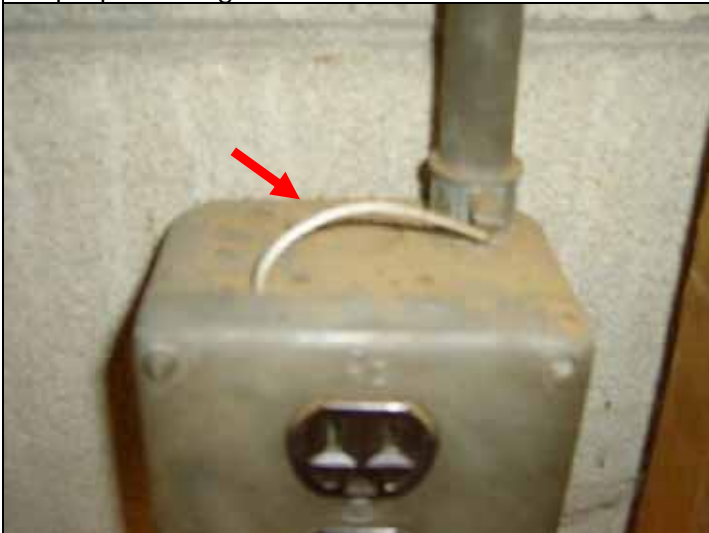
Small wire acting as ground

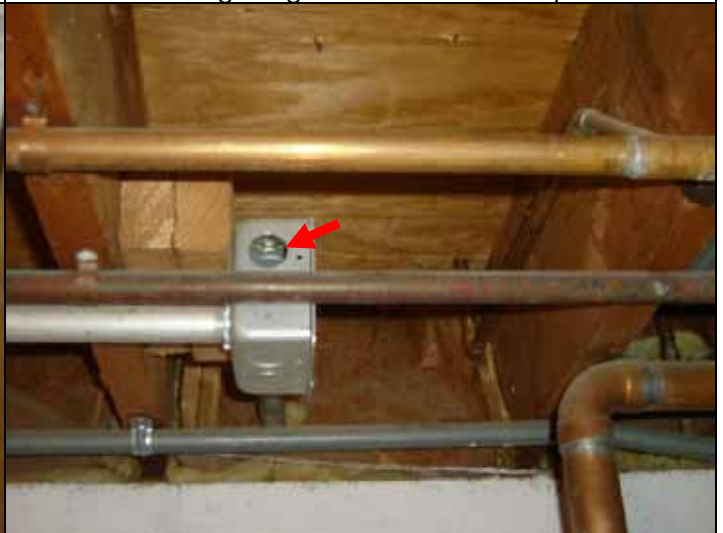
Knockouts missing

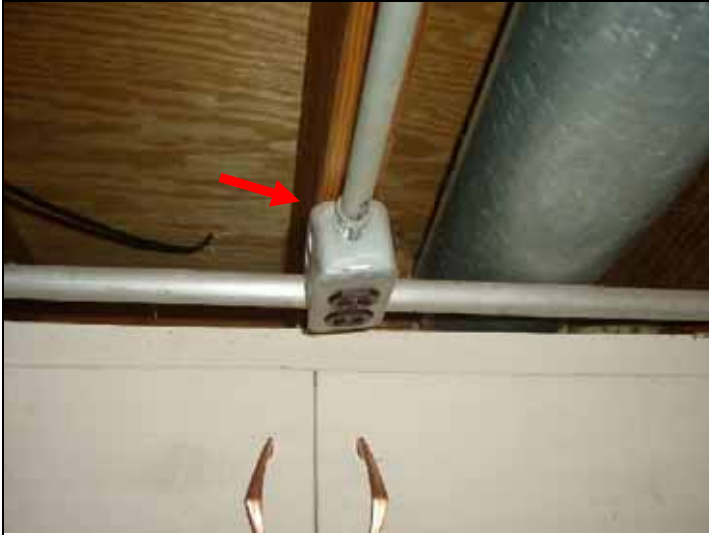
Loose outlet box

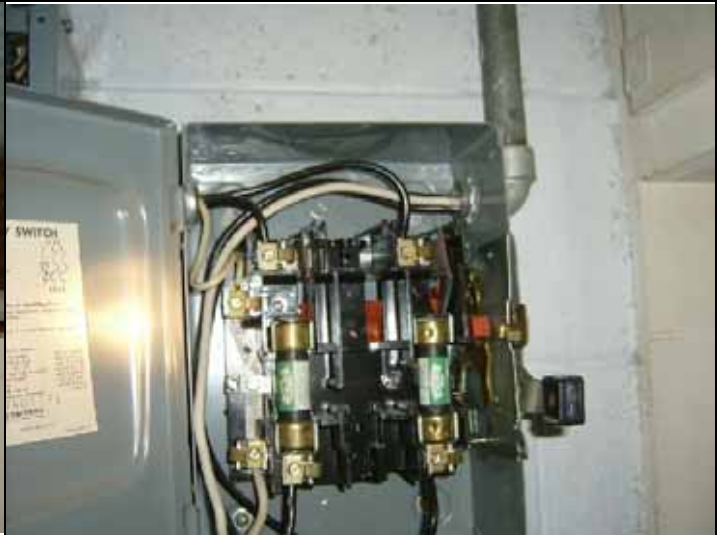
Ungrounded Disconnect

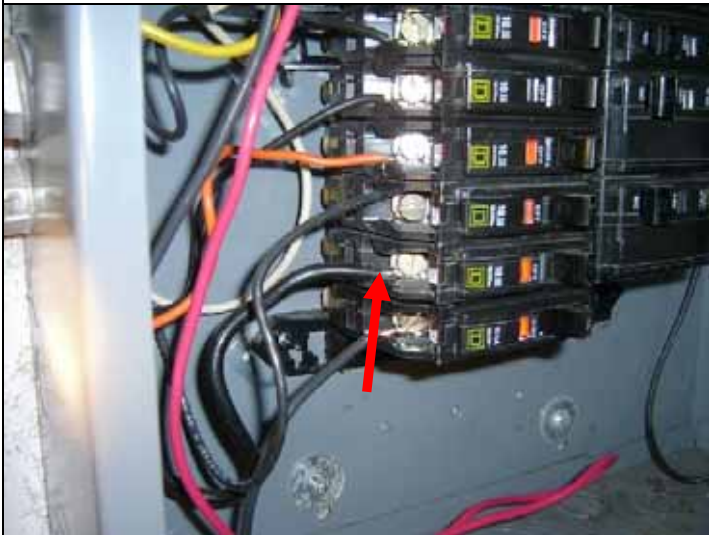
4. The main panel had an aluminum circuit wire this could be one a single circuit or it could be present in other locations not visible. The problem with aluminum wiring is the connections corrode and can cause resistance and heat. Aluminum wiring has been the cause of numerous fires and needs to be evaluated by an electrician to determine its condition or replace as needed.

Aluminum wiring present

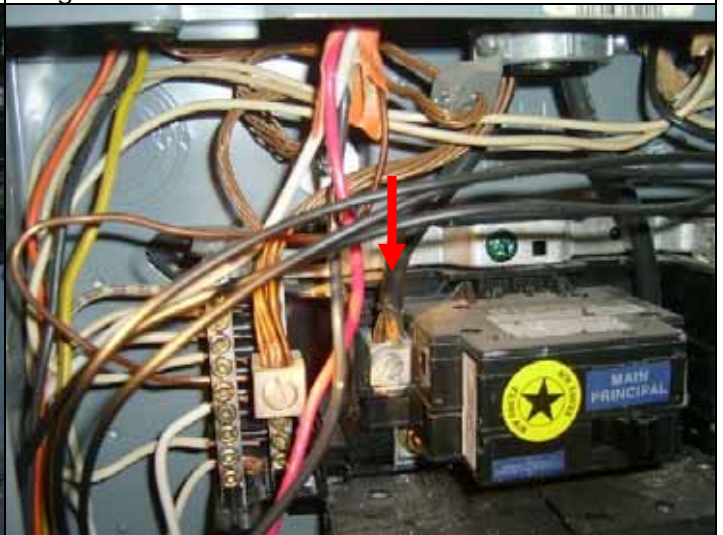
Poor connection, sloppy wiring

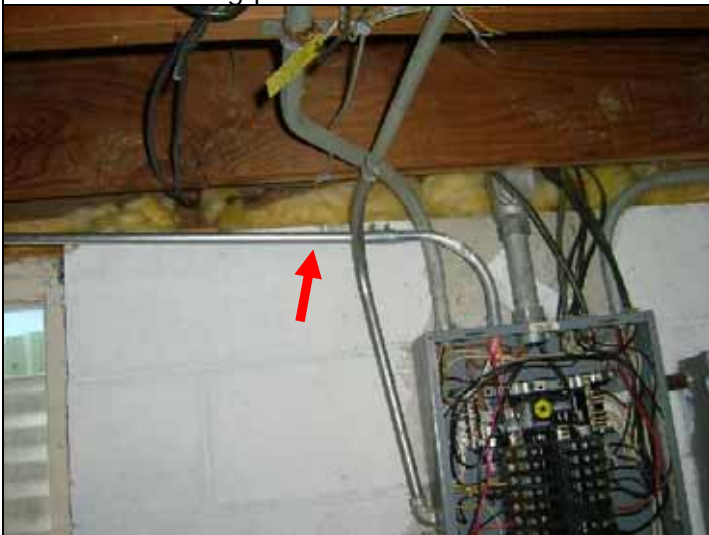
3. The conduit to the whirlpool tub circuit is not supported or secured adequately. The circuit is rated for 20 amps but the panel label indicates it serves lighting also. Since the wiring appears amateur I suspect the wire size was not configured properly in lighting circuit. Have an electrician evaluate circuit.

Poor conduit support, wire to whirlpool tub

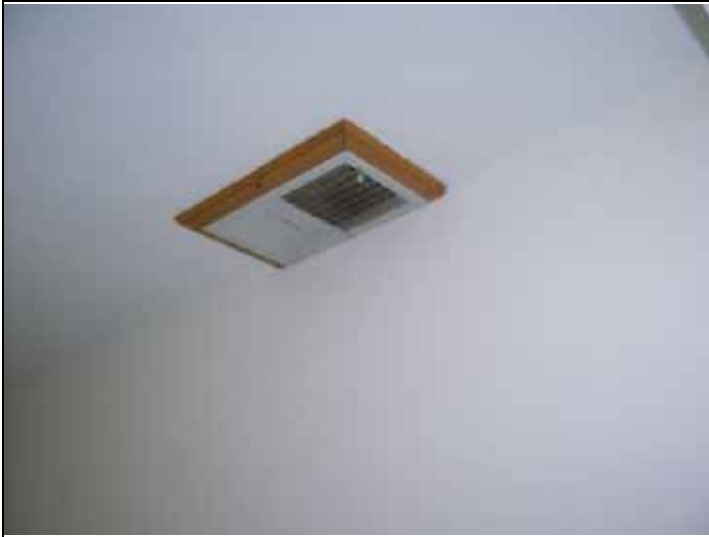
Solar air vent, possible moisture leakage

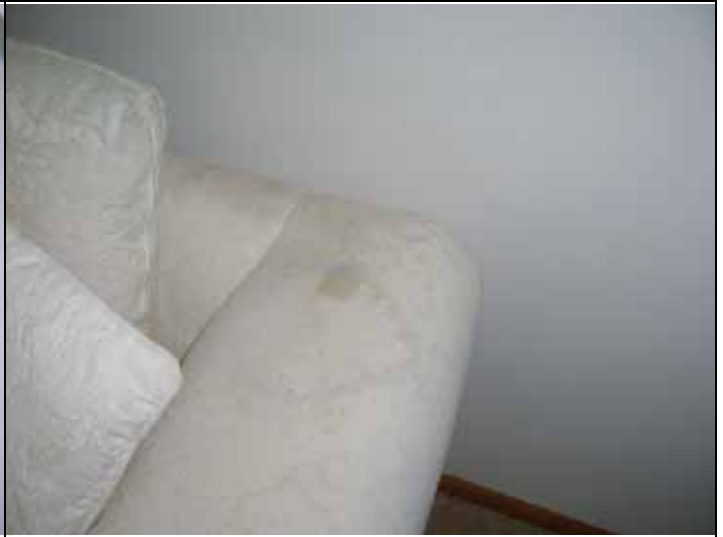
Drips on couch beneath vent

1. It appears that the ductwork for solar heat leaks. The couch under had a water and rust stain. This may not be related but appears to be from duct above. Water vapors can condense in ductwork and drip. This could indicate a condition where the solar panels are creating a moisture concern as noted above.
2. There were some minor blisters and blemishes to the paint in these rooms. None were consistent enough to determine exact cause.
3. No additional concerns noted.

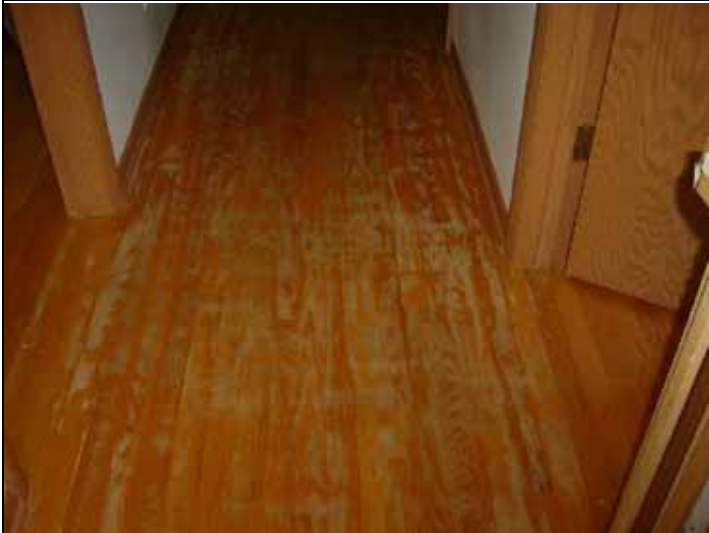
Deteriorated finish on wood floors

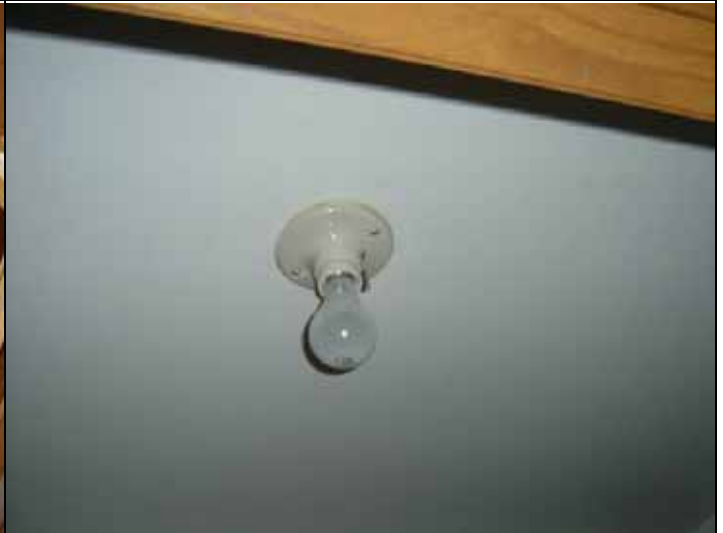
5. Whenever an open bulb light is located in a closet or storage area it is a hazard for fire and needs to be replaced with a covered florescent fixture to reduce chance of breakage and fire.

Open bulb in closet
