Dedicated Home Services LLC

This is an actual inspection report

Aaron Pfaff, Dedicated Home Services LLC

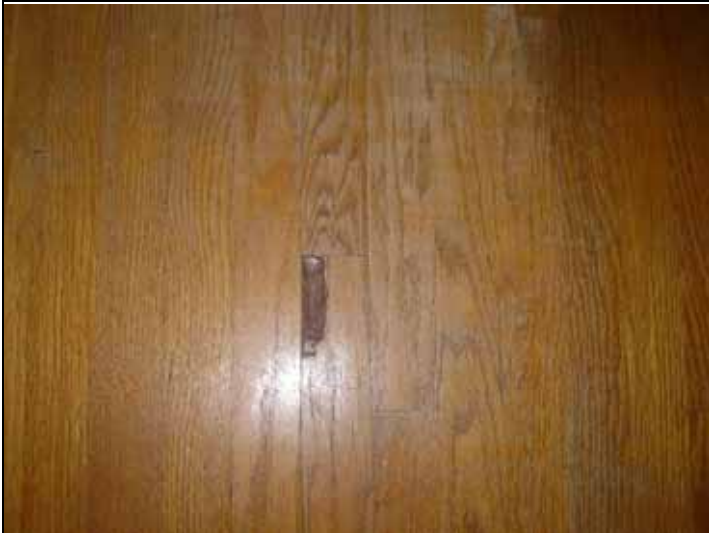
Minor defects in floor

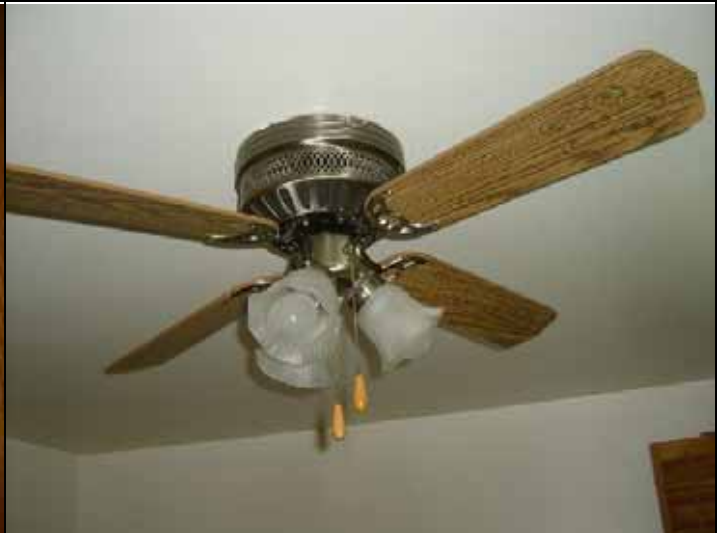
Typical fan, several rooms, wobbles and vibrates

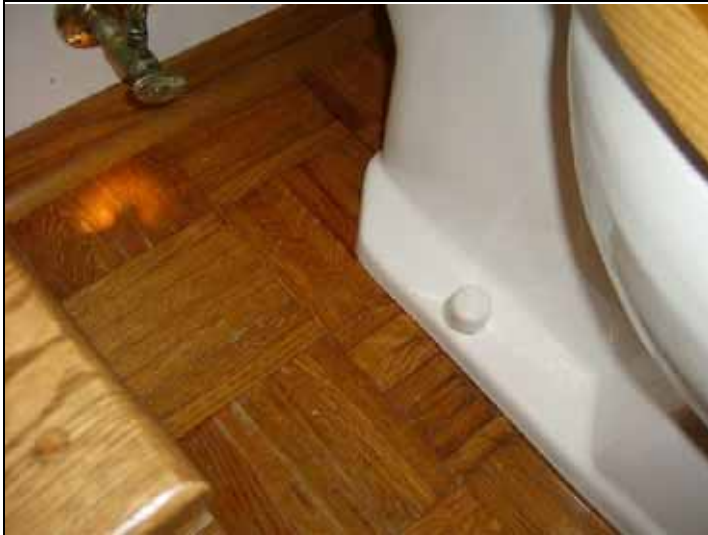
Water damage to floor

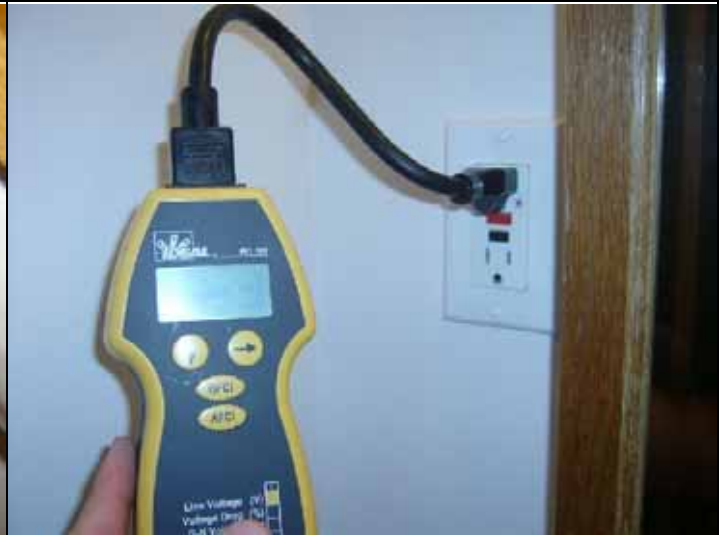
Failed to trip

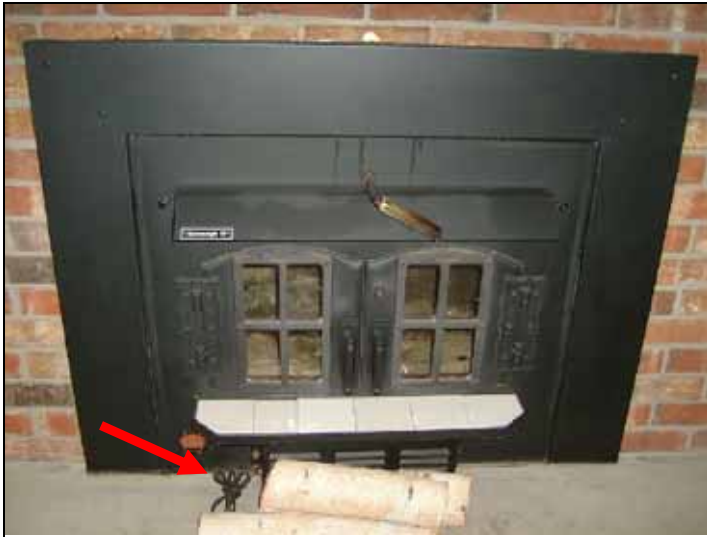
Cord for blower

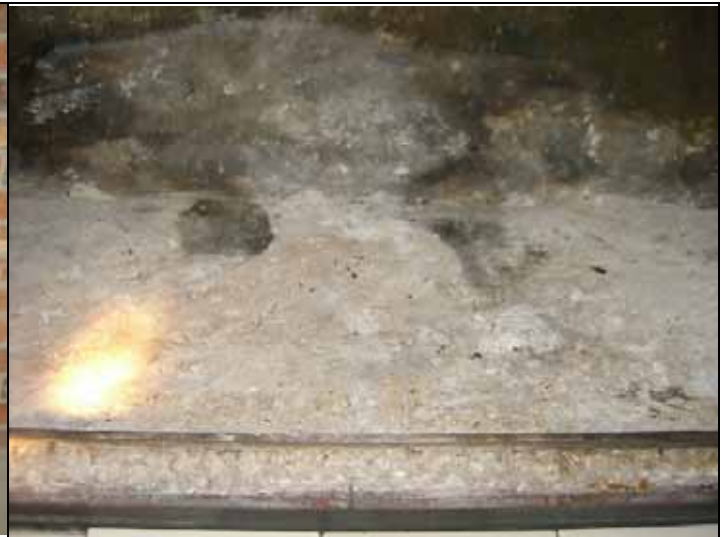
Firebrick deteriorated

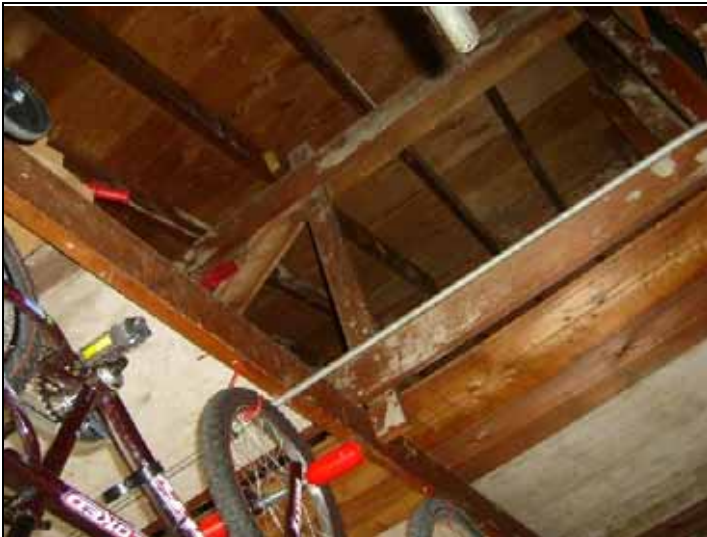
2. The storage area above garage was not properly framed and will need significant alteration to adequately support storage. The framing of the roof was done lightly when originally constructed and several rafters have splices or joints resting on a beam that is insufficient in size. Then the storage area was added which compounded the problem. The roof was visibly sagging several inches when observed from driveway. The weight of storage and roofing material, and inadequacies in framing over the years has made the roof sag. There are several repairs necessary. And the special considerations if storage space is desired. Consult a qualified contractor, and have the design reviewed by a structural engineer or architect.

Storage area, inadequate framing

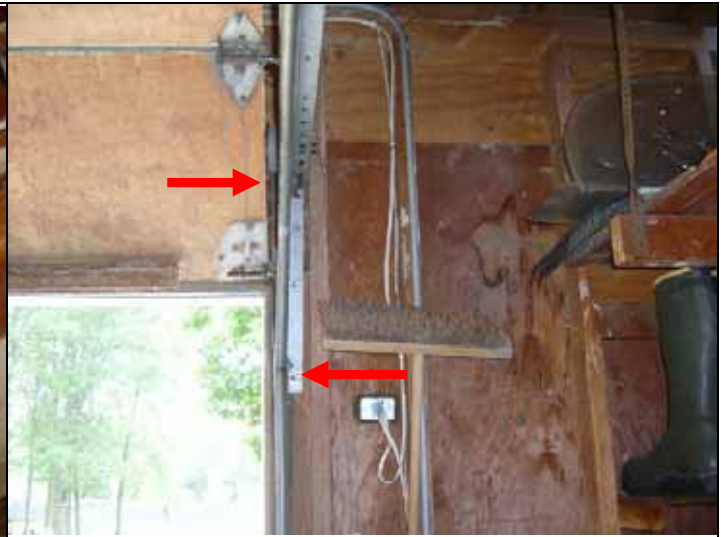
Garage track misaligned

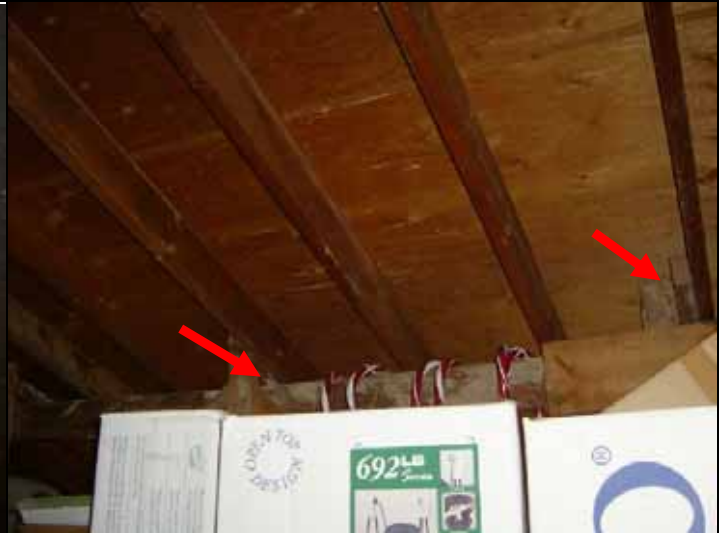
Splices above beam, roof rafters
