# Dedicated Home Services LLC

**This is an actual inspection of a condominium**

**Report Prepared By:**

Aaron Pfaff, Dedicated Home Services LLC

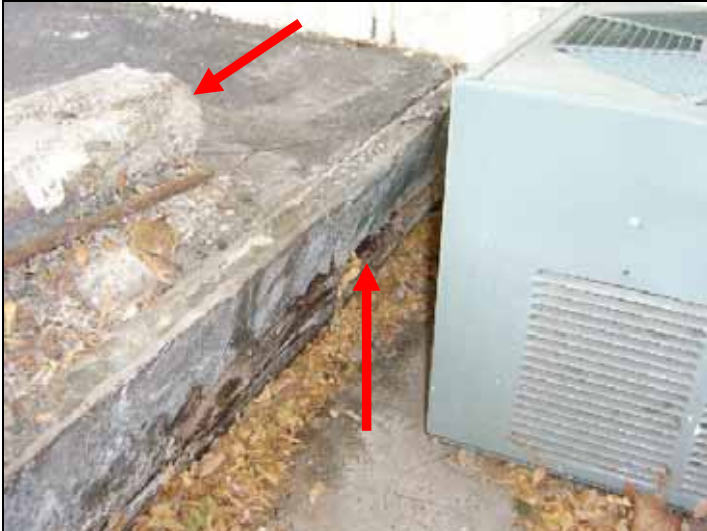
1. The cedar shakes on the upper portion of the building are in need of general paint and maintenance.
2. The parking area is sloped toward the building and the parking block and steel retaining plate are deteriorated. The slope of the parking area directs water toward the foundation where it can seep into the basement. The slope can also cause icy conditions.

Parking area, deteriorated block and steel

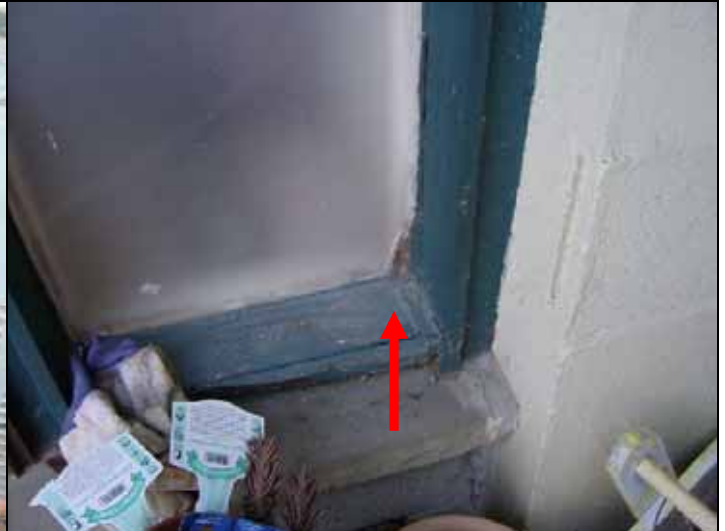
3. The side window near the rear door had a piece of Plexiglas installed as a storm window. The window was not properly installed and moisture has been trapped between the panes of glass causing the wood sill and trim to decay. Since the interior window is only a single pane of glass and the wood is deteriorated it may be necessary to replace the entire window with a more efficient unit.

Sidelight window near rear door, wood damage

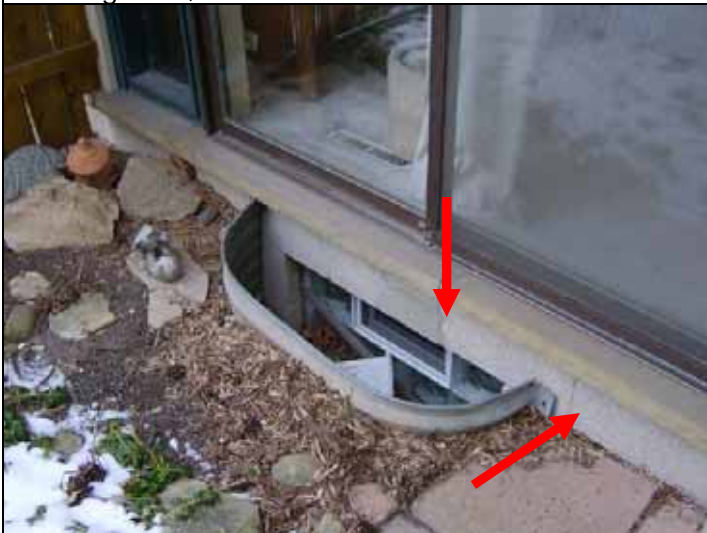
4. The rear patio door had no step for the walkout. This is not the only door on this wall but it would be a hazard for tripping since a window well is located beneath it. The basement window would need to be removed to correct this. There are several other concerns related to the drainage of this area. The patio was generally in poor condition and to address the issues it may require a comprehensive approach that would require reconfiguring the patio area to promote better drainage. The small retaining wall has also failed and the bushes are overgrown and touching the siding.

Missing step, trip hazard

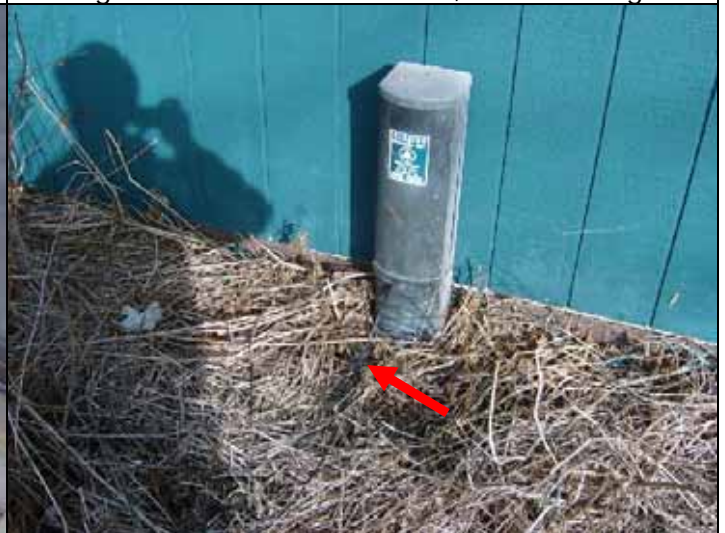
6. The phone box on the exterior had a wire routed through the yard and around the parking lot in the rear of the building. I did not determine the use of this wire, but if it is the phone service to this unit it is exposed to possible physical damage, notify utility company and condo association for advice.

Phone cable

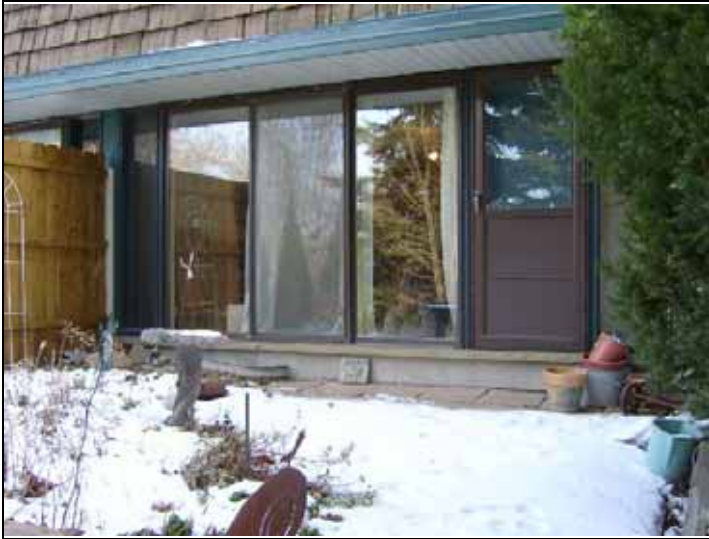
5. The second floor walkout area had several concerns. The rubber roof has a drain that needs to be monitored to ensure proper drainage. The plywood siding above the patio door was severely warped and deteriorated. The wood will most likely need replacement. The patio doors are older models and less efficient than modern patio doors. The tracks were dirty and the guides caused the door to operate poorly. Clean and adjust door guides as needed. The outlet on the exterior needs to be GFCI protected. The single pane window to the bathroom is deteriorated and in need of maintenance. This type of window is also very inefficient, consider replacement of the window.

Patio area

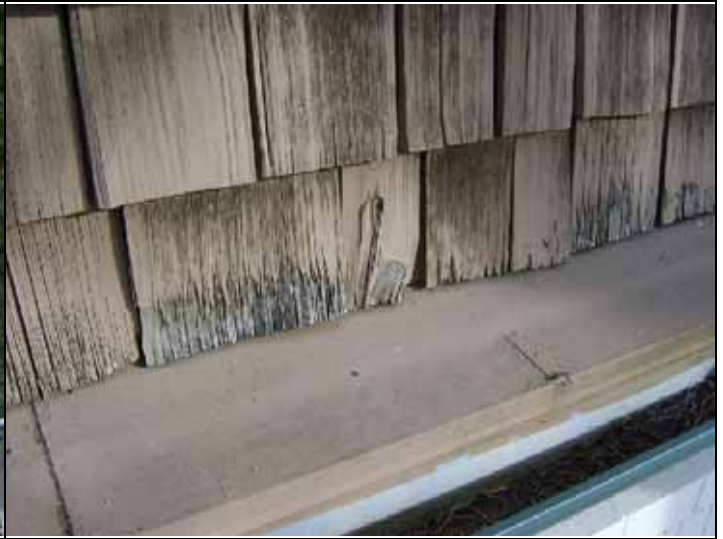
Deteriorated siding and loose metal flashing

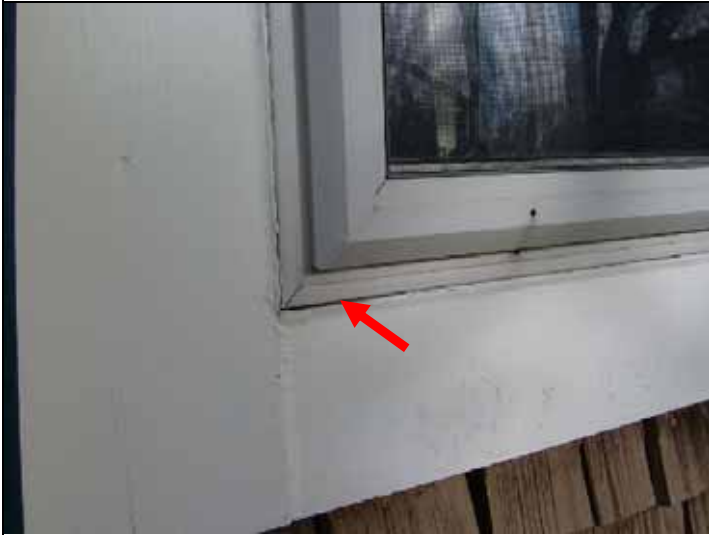
Minor caulking around windows

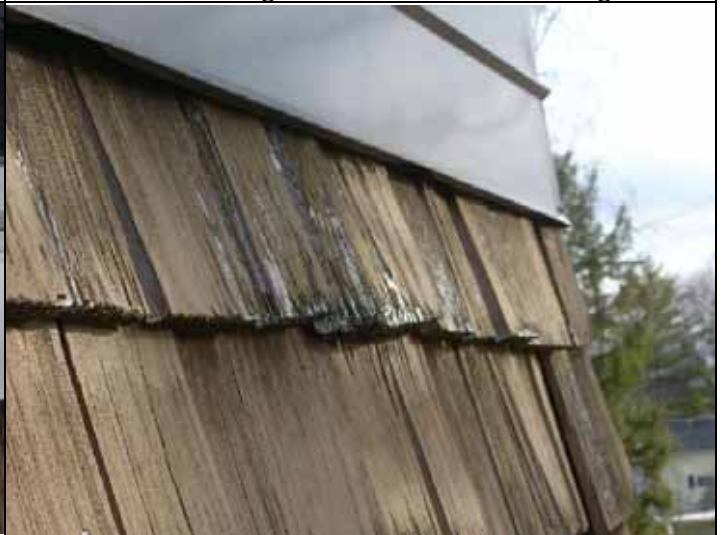
Deteriorated cedar shakes

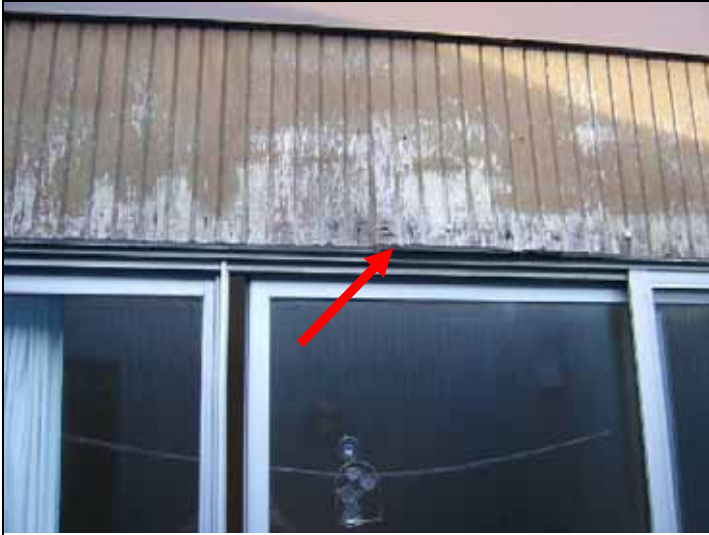
Deteriorated plywood above patio door

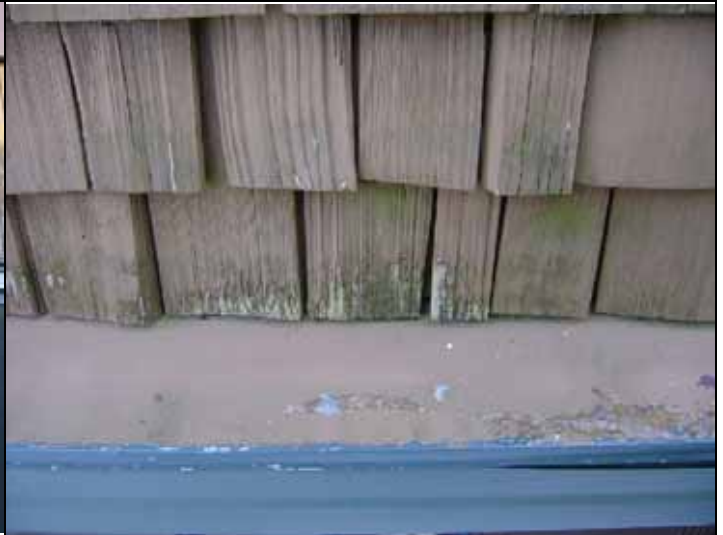
Deteriorated cedar shakes

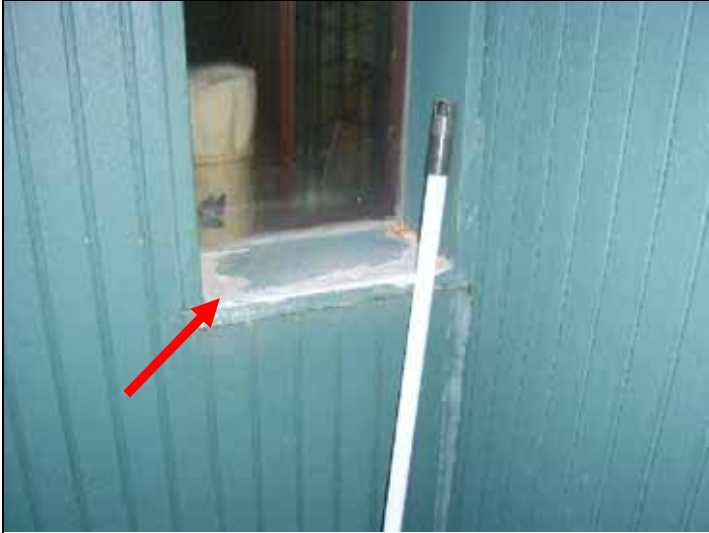
Deteriorated bathroom window

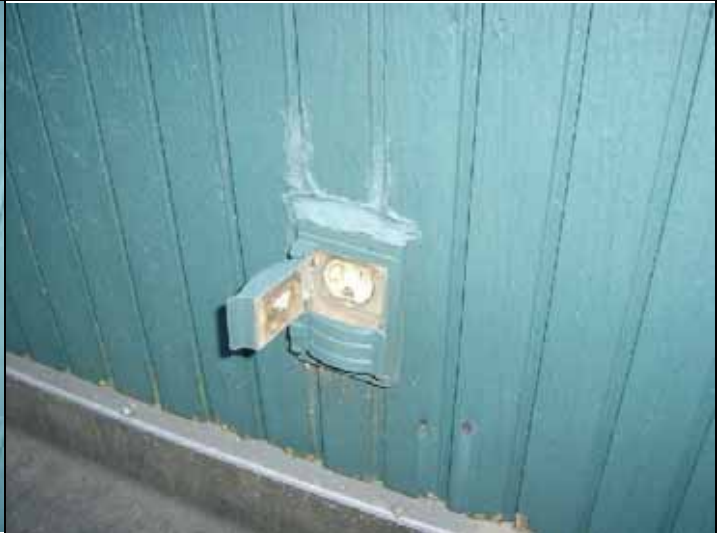
Needs GFCI

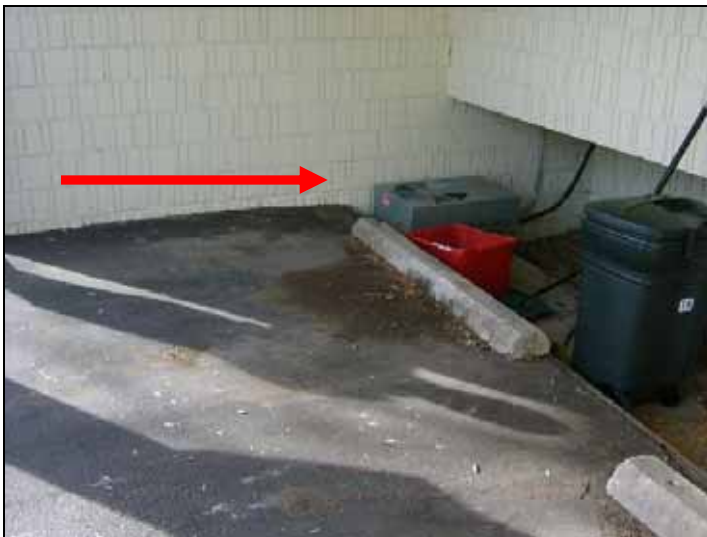
2. The parking area is sloped toward the building. The slope of the parking area directs water toward the foundation where it can seep into the basement. Signs of seepage were noted in the basement. The agent noted the driveway was listed as an area the condo association was scheduling improvements. This would be the time to bring this to the attention of the association to pitch the driveway away from the foundation.

Parking area sloped toward the foundation

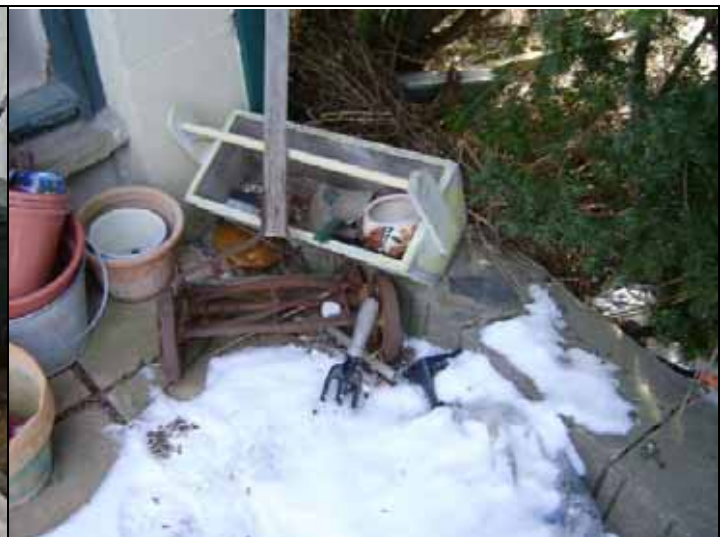
This area sunken and sloped toward the foundation.

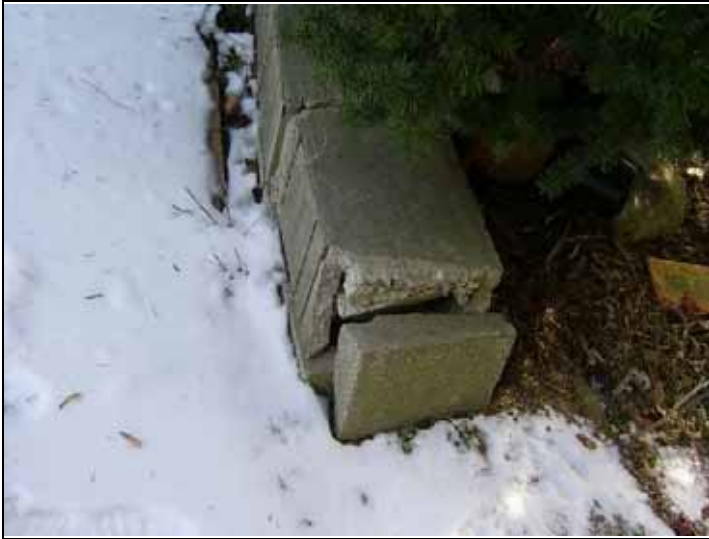
Retaining wall failed

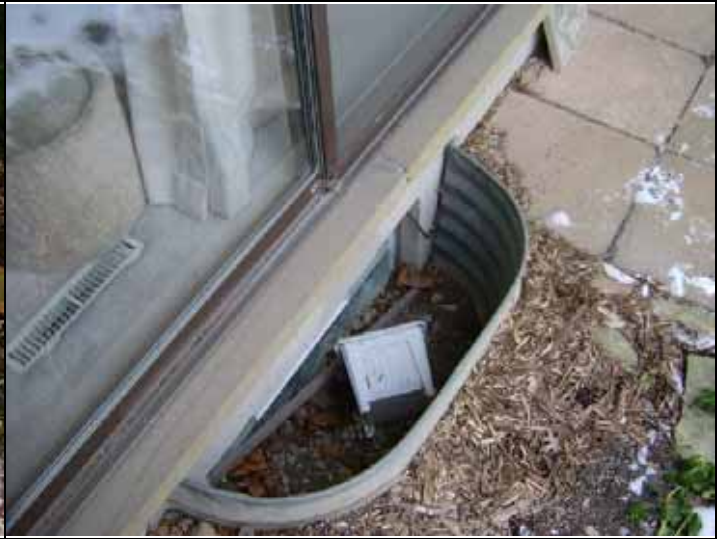
1. The building has some water seepage in the basement. The foundation has had past movement and repairs. The patio area in the rear was in poor condition and several low spots and reverse slope was noted. The area at the corner near the patio had a low spot and a gutter setup that is problematic. The area and the drainage configuration may be contributing to the signs of water seepage noted in the basement. The whole patio area should be redesigned to promote proper drainage.

Window well low areas around patio and window well

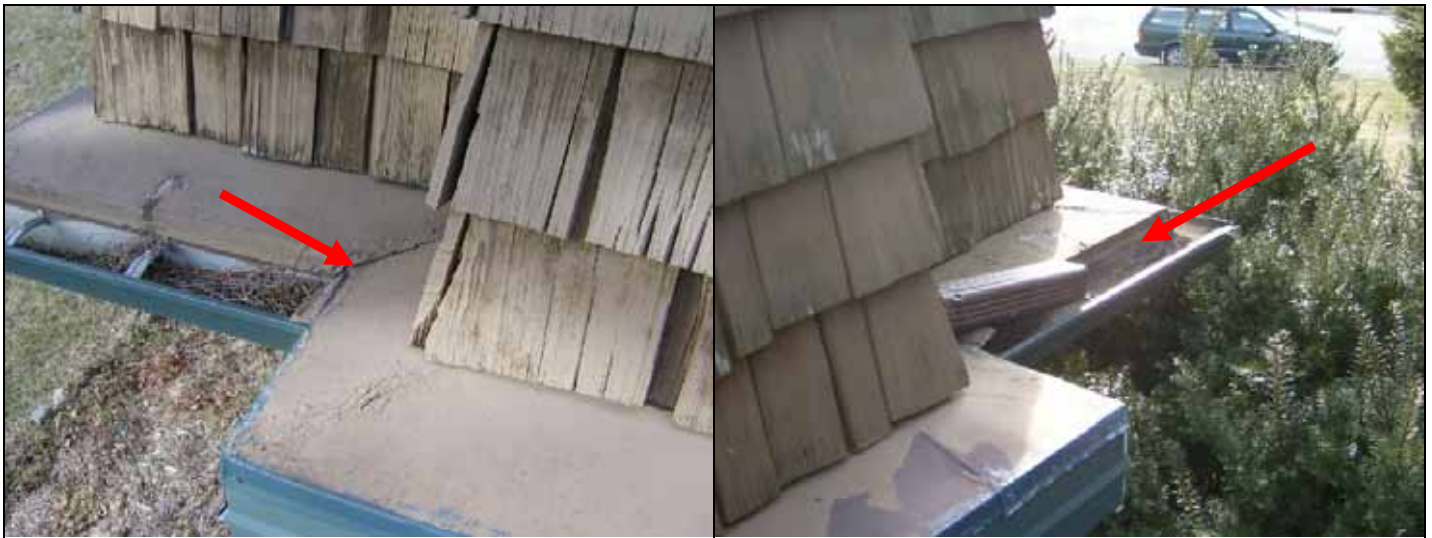
<p>Damaged flashing seam</p>	<p>This gutter configuration is prone to overflow and could be contributing to seepage noted in basement.</p>
------------------------------	---

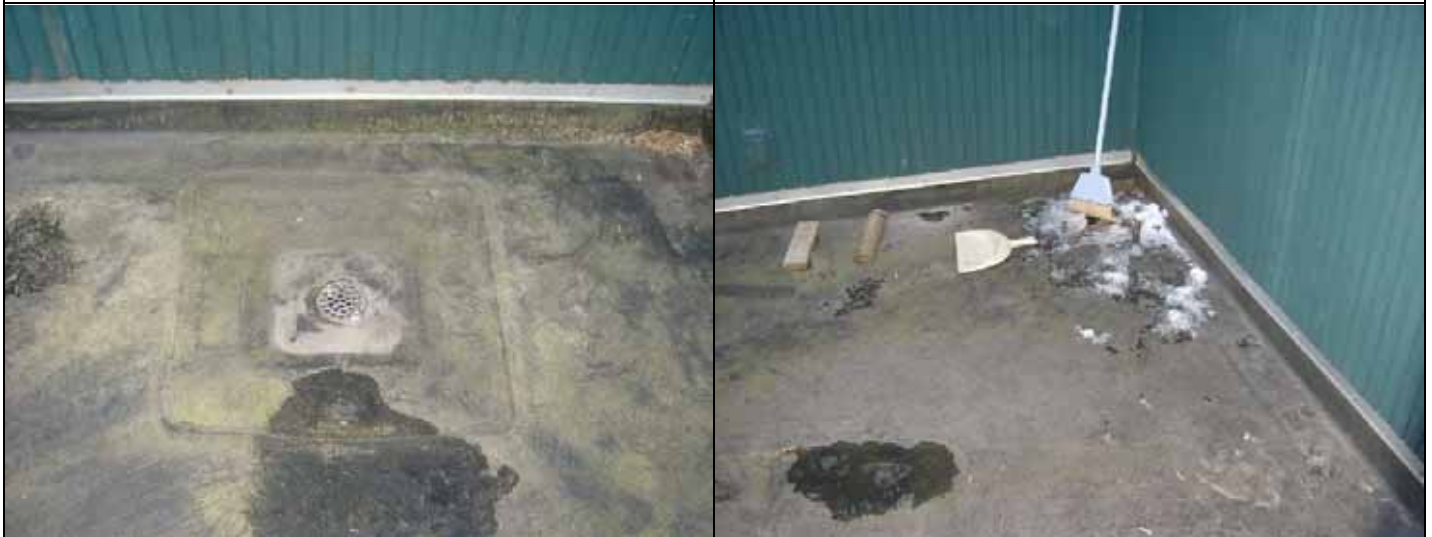
<p>Keep drain clear</p>	<p>Caution of ice build up and sharp objects.</p>
-------------------------	---

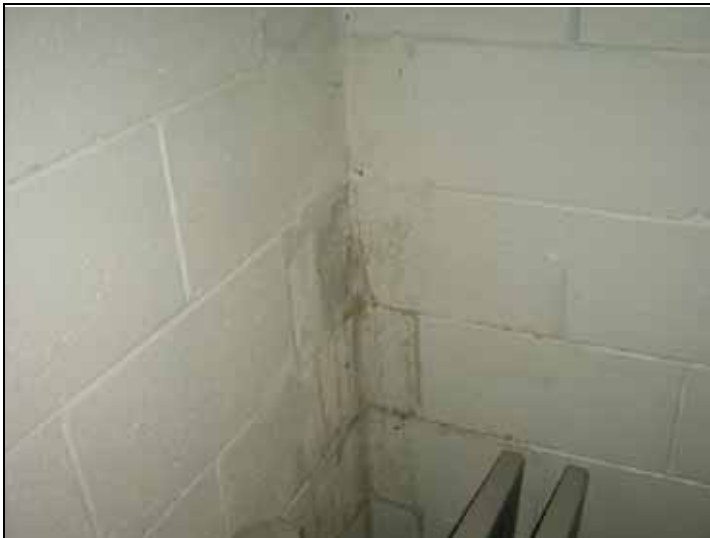
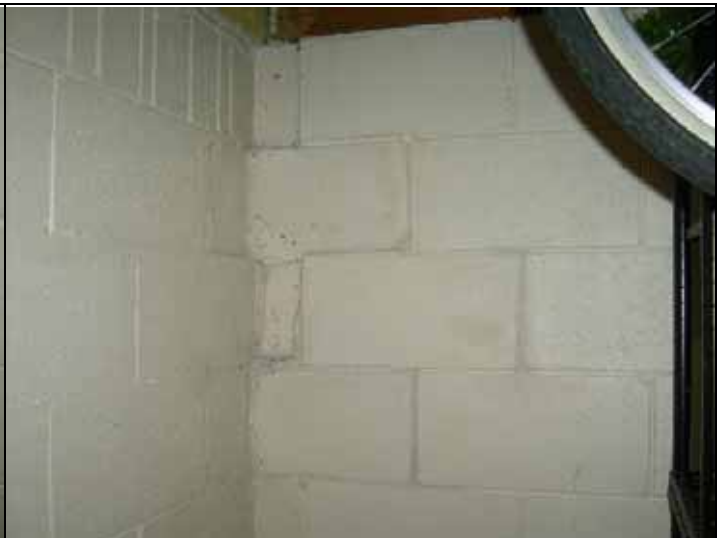
1. The basement walls had several signs of both structural movement in the past and seepage. The Northwest corner has caulk and minor cracking that looks like past repairs. There were stains from water seepage on walls and floor. This area on the exterior appears to be caused in part by poor landscape and drainage. The gutter from upper section transition to lower gutter appears to be problematic also. The patio needs some attention to reduce likelihood of water seepage.

Northwest corner water stains	Minimal displacement of blocks northwest corner

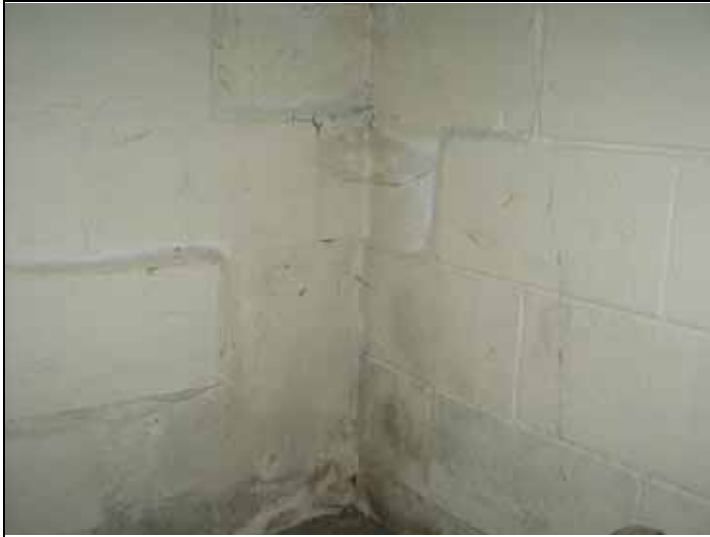
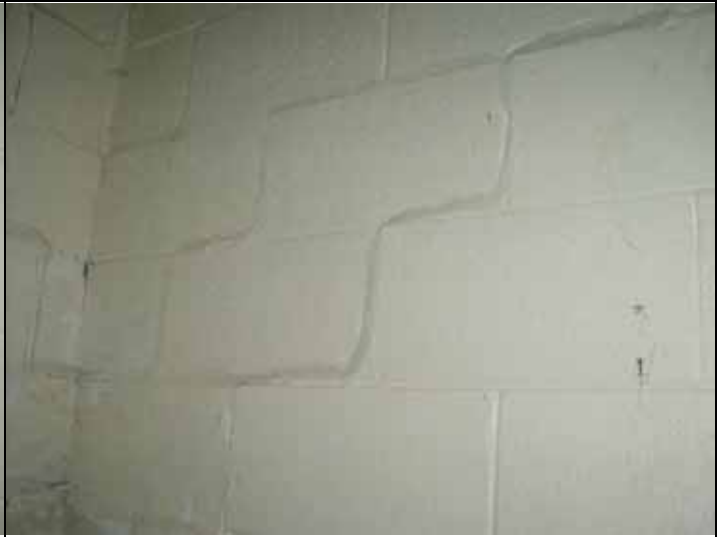
2. The south west corner of the foundation had a large section of concrete block that has been displaced. This does not appear to have happened recently and repairs have been made. There were minor cracks noted. Since there were few indicators that this has happened recently I am not concerned about this being an ongoing problem but the wall has been displaced enough to warrant further evaluation by a structural engineer with foundation experience. This is to get a second opinion and to document displacement and cracks. This documentation will help alleviate future concerns.

Southwest corner blocks displaced wall bow	Southwest corner displaced blocks, past repairs

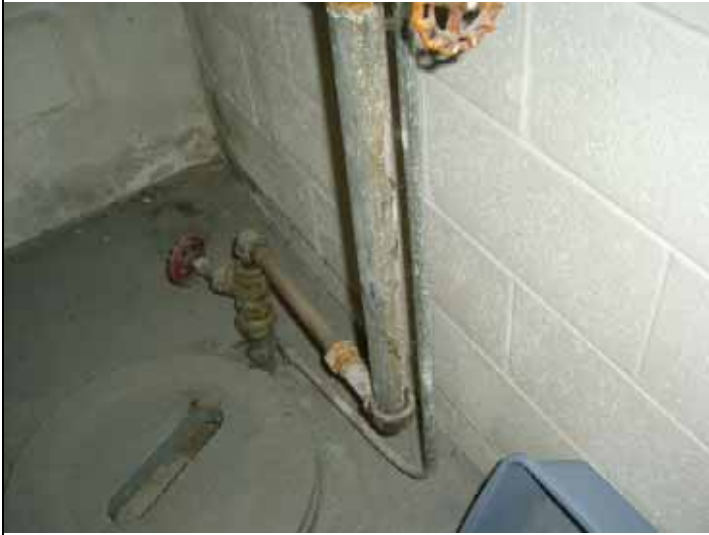
Southwest corner, sump crock, wall displaced

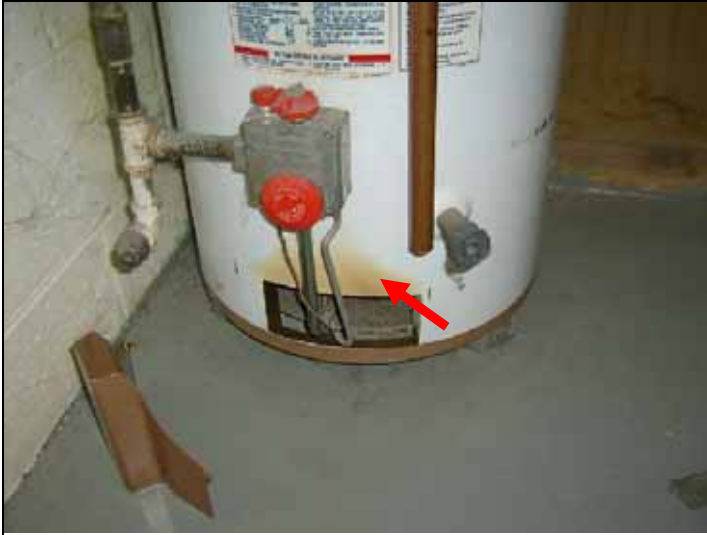
2. The water heater showed early signs of deterioration. It was approximately 13 years old and the typical life expectancy is 8-12 years. It would be prudent to replace the water heater in the near future to save cost by not requiring emergency replacement or risk of water damage if leakage would occur. The other concern is related to the venting. The water heater had scorch marks around the burner openings which can indicate poor draft characteristics. This will need to be evaluated by a HVAC technician to see if the flue is adequate and if proper draft exists. I did not the presence of a draft but there may be some carbon monoxide being emitted under certain circumstances in the current configuration if draft is restricted or changes with wind conditions.

Scorch marks

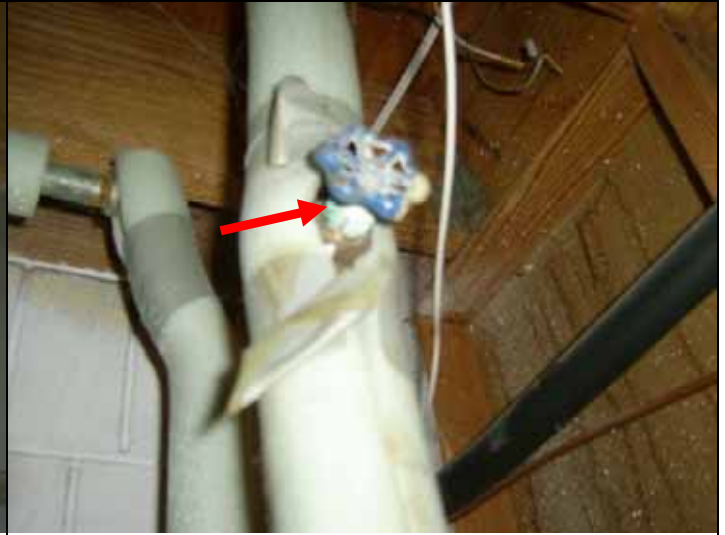
3. Minor corrosion on shut off valve on water heater. Corrosion can cause premature failure of pipe or leakage.

Corroded shut off on water heater

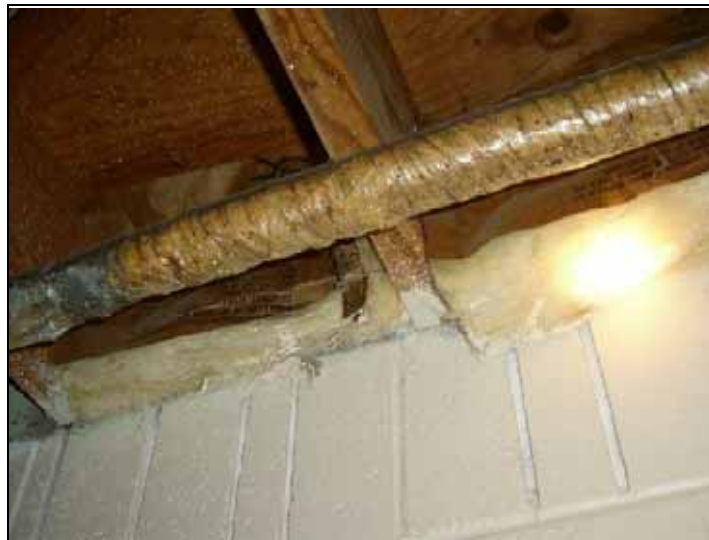
1. The water main for the building originates in this unit. The galvanized pipe had fiberglass insulation wrapped around it that traps the condensation and has black spots that is most likely mold. Remove the insulation and replace with a nonabsorbent foam insulation to prevent condensation on the pipe.

Fiberglass insulation and mold on pipe

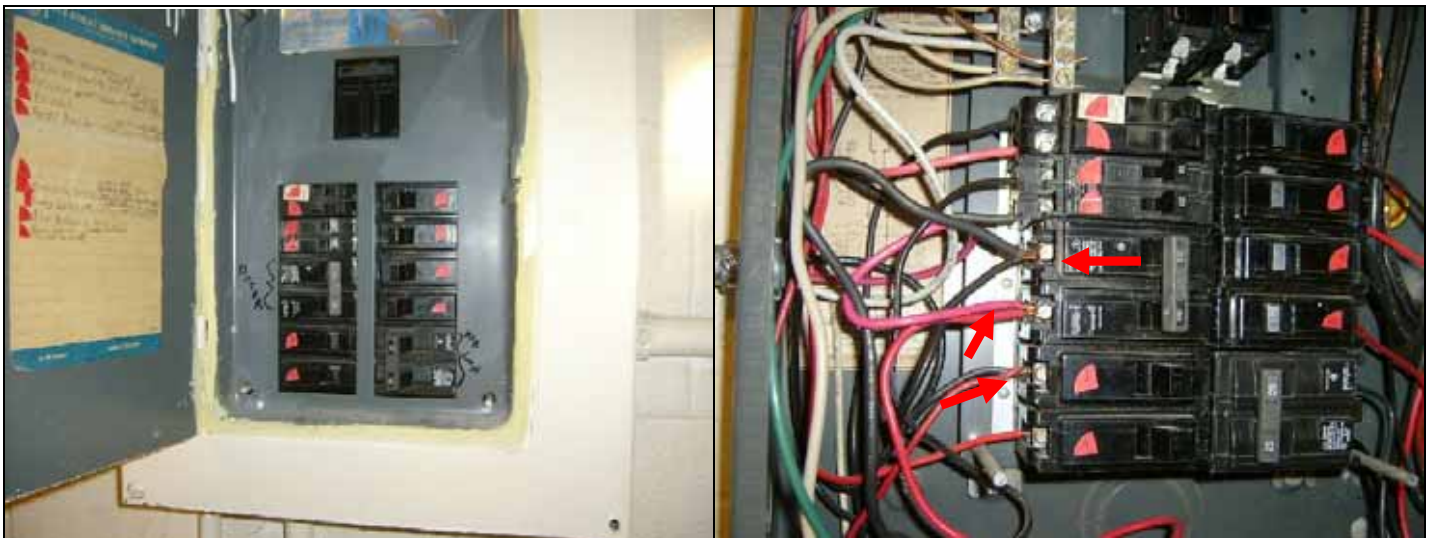
1. There were several concerns with the main service panel. The panel had several double tap breakers. This can cause poor connections and exceed the capacity of the breakers design. The panel overall has exceeded the intended capacity of circuits several space saver breakers have been used and sine there are also double tapped breakers the panel may need to be upgraded to a panel with more available space and number of circuits. The service is 100 amps which is the minimum standard and should be sufficient for the homes needs but the panel is limited in number of spaces for circuits. Have an electrician evaluate and recommend upgrade to a larger 100 amp panel.

Main service panel full, space saver breaker in use	Double tapped breakers
---	------------------------

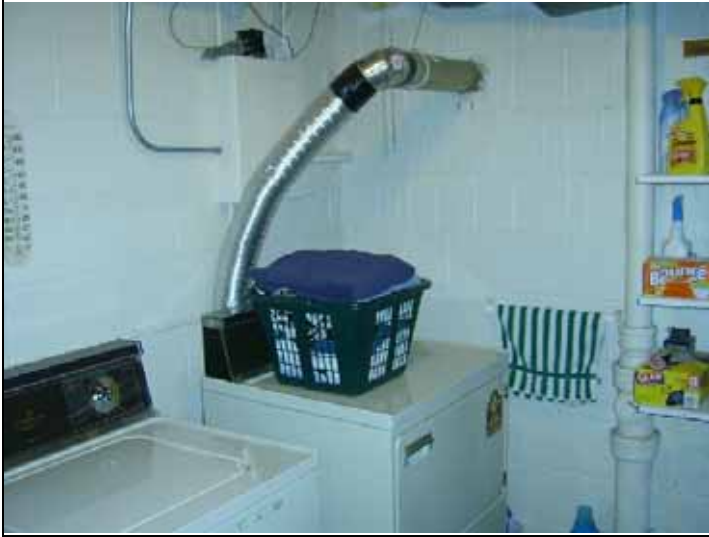
2. The location of the dryer and its venting blocks safe access to the service panel. Have the dryer moved to another location.
3. The water pipes, gas pipes, and duct work lack proper electrical bonding to ground. This is done by using a wire to connect the metal components to a good ground whenever isolated by a non-conductive union. The water heater would be a place where the pipes should be bonded to ground. Ask an electrician to verify and install proper bonding.

Dryer and vent obstructing panel

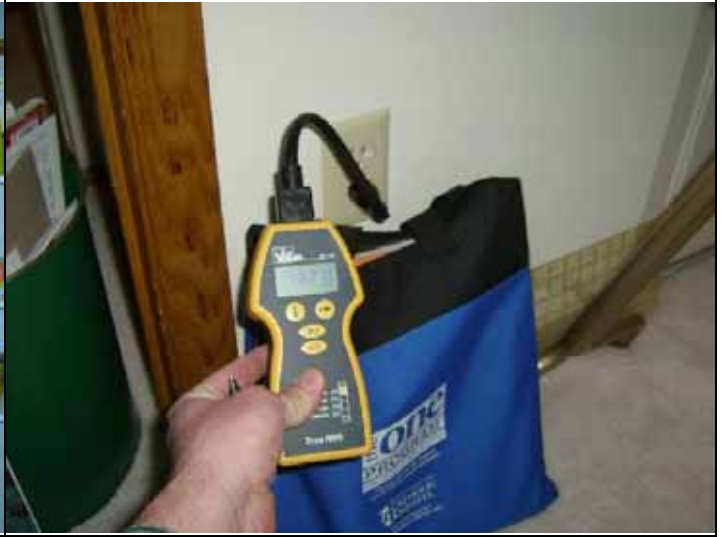
7. One outlet in the bedroom with roof walkout tested to have a voltage drop of 10.9 % under a 15 amp load. This can cause problems for certain appliances but usually indicates a loose connection within the circuit. Unfortunately I was not able to test every outlet in the home since many of them were obstructed by seller's belongings. Other outlets may have a similar problem. Have an electrician check connections.

This outlet tested 10.9 % voltage drop.

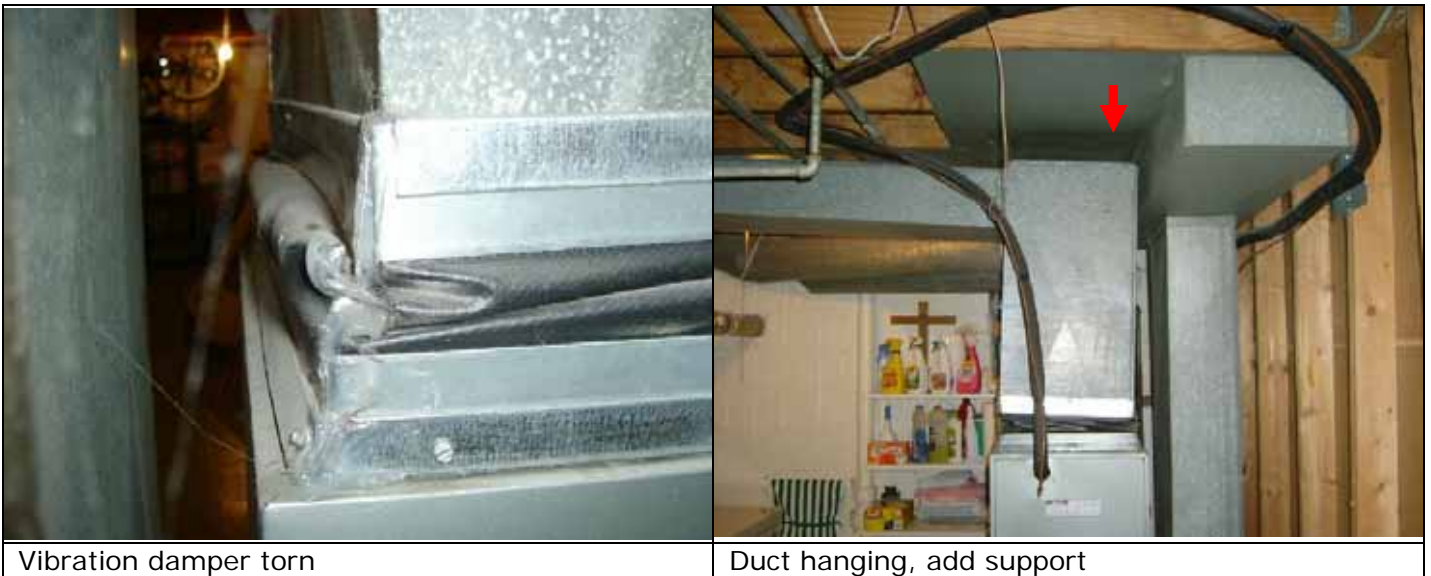
1. The duct work is not properly supported. The ducts are hanging and the vibration damper has been stressed and a tear was noted. The tear was caulked. Add supports to hang the duct work properly.
2. The filter was minimal protection for equipment. Consider upgrading the filter for better protection of equipment and better indoor air filtration.

Vibration damper torn

Duct hanging, add support

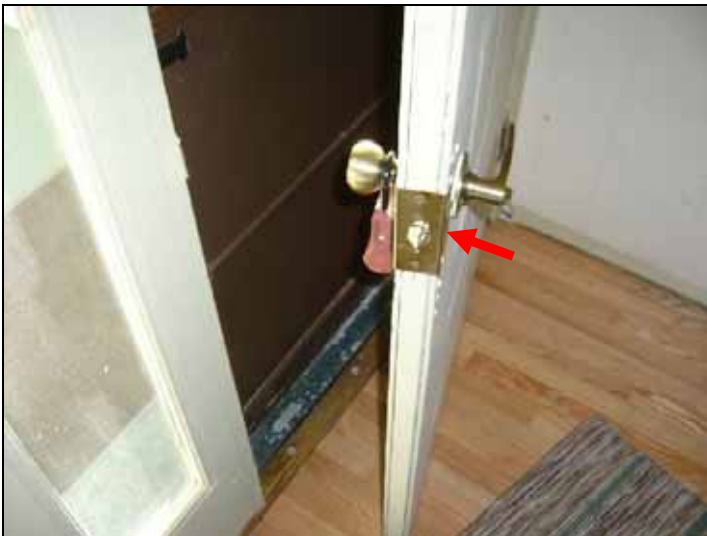
Repair to damaged door

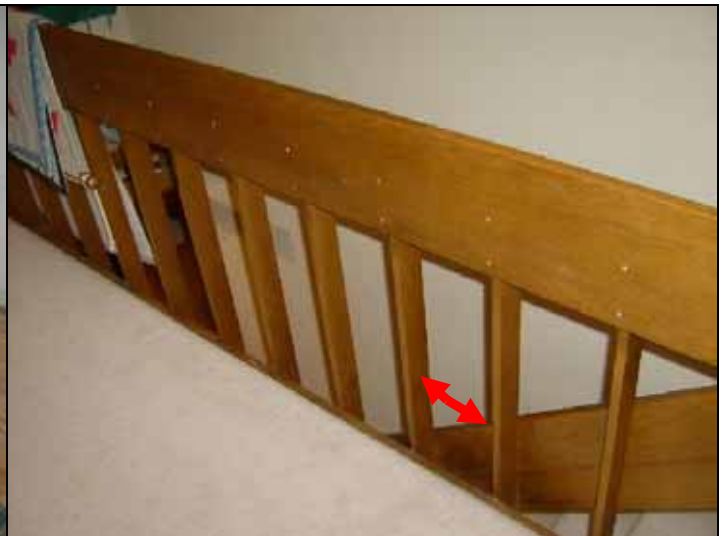
3. The stair railings between the floors had balusters with very large openings. The recommended size is less than 4" spacing between balusters. I recommend adding a protective barrier to prevent a child from falling between balusters. The stair treads and risers are open this is also a hazard for young children. Add risers to block access between treads.

Balusters too wide

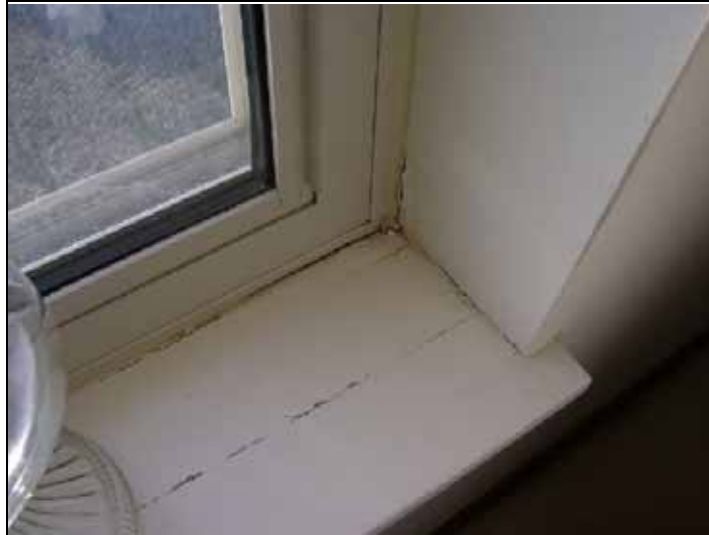
5. The shoe molding was missing in the main floor area where the wood floor is installed.
6. Several window sills exhibited some water damage and deterioration to paint and wood surface. This appears to be related to the operable side of the windows. Repair to prevent further damage.

Sill damage in most rooms

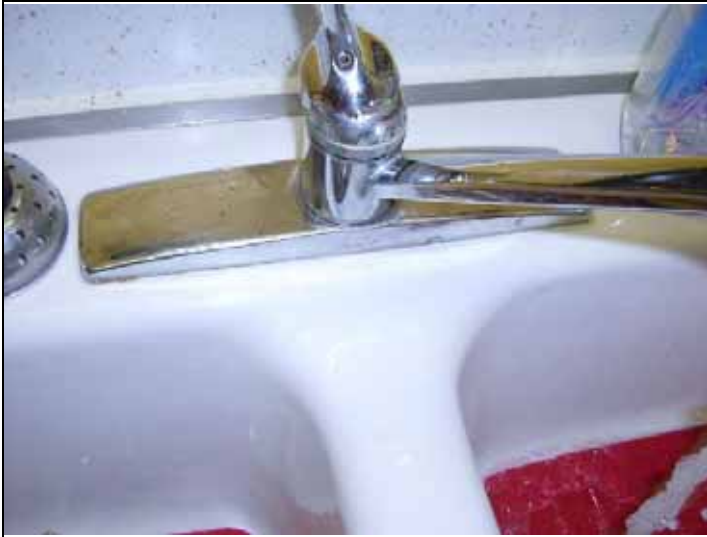
1. The sink faucet leaks repair or replace.
2. The drain trap is not proper and is more prone to clogging.
3. The sink was once equipped with a disposal. The wiring was not properly abandoned.
4. The drawer guide bracket was detached on at least two drawers.
5. Change outlets to GFCI's type.

Leaking faucet

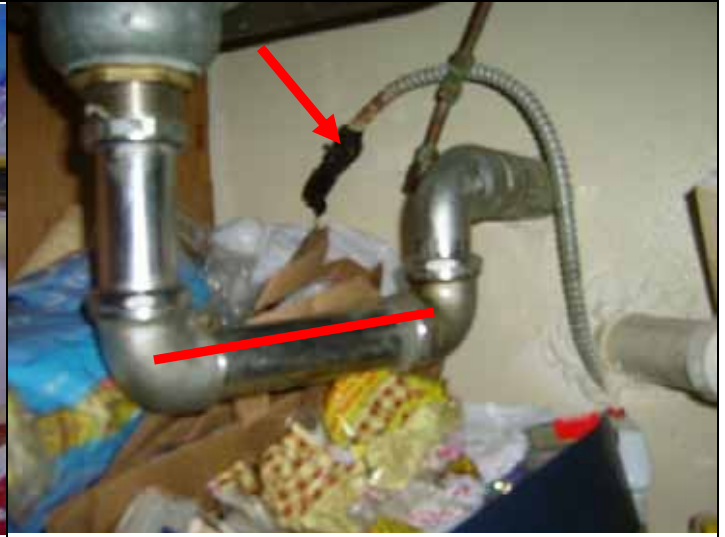
Improper trap, disposal wire

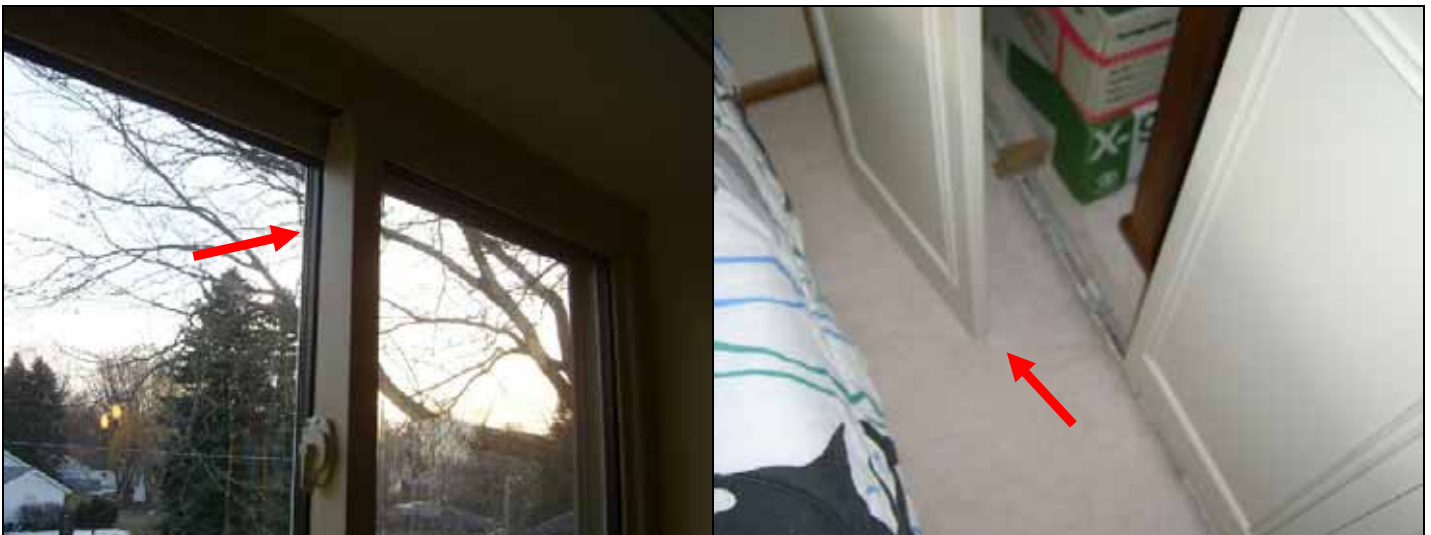
1. The window may have been installed out of square. The top latch does not catch and the windows don't line up properly.
2. The closet door needs adjustment to retainer guides at floor.

Windows not sealing, misaligned

Closet door

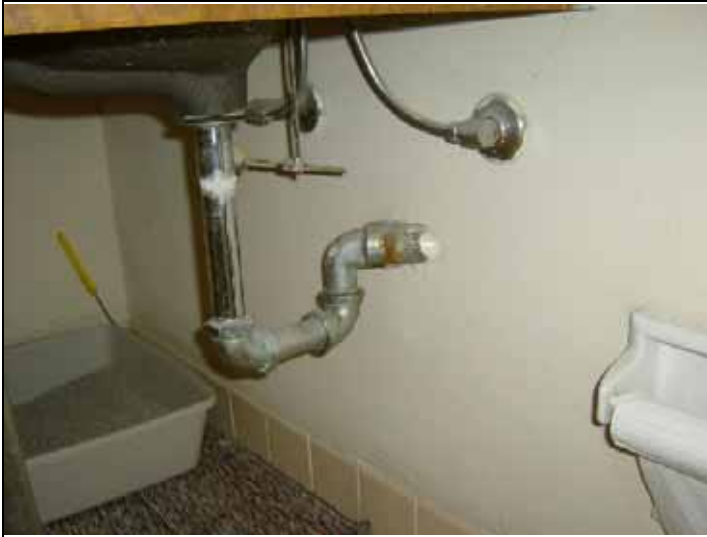
Improper drain, no shut offs

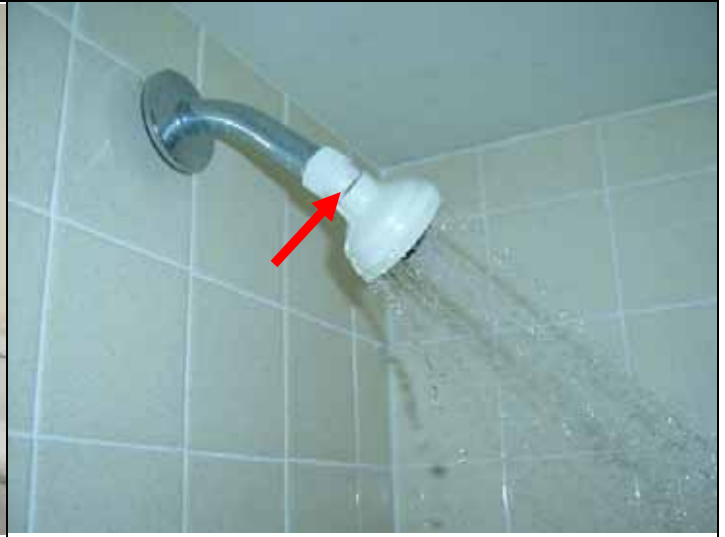
Leaking shower head.

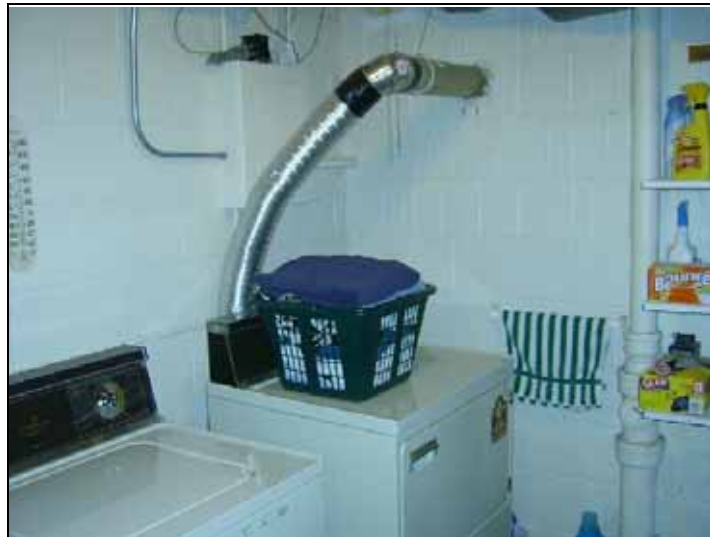
1. Replace washer hoses with stainless braided type to reduce risk of hose bursting.
2. The dryer location and ducting blocked the electrical panel. The dryer duct should be re-routed and changed to smooth metal to reduce lint build up and risk of fire.

Dryer and venting, block panel
