Dedicated Home Services LLC

This is an actual inspection of a newly constructed home

***** See roofing section*** Even new homes can have significant defects in workmanship that are often overlooked by builders and municipal code**

Aaron Pfaff, Dedicated Home Services LLC

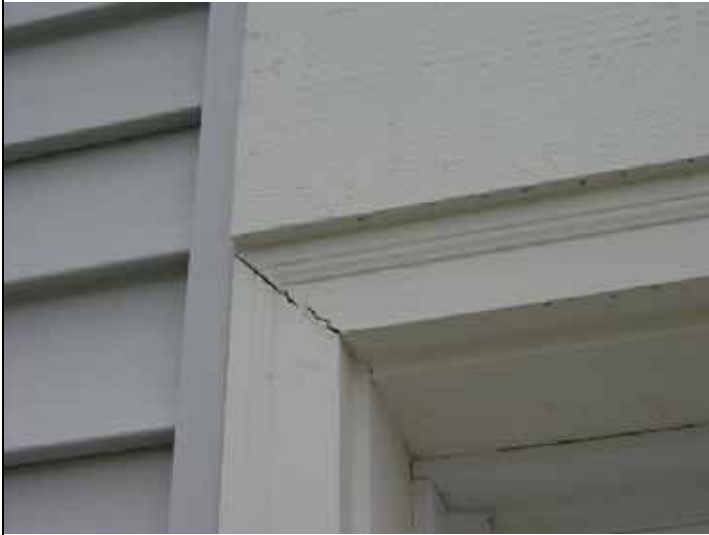
Caulk wood trim

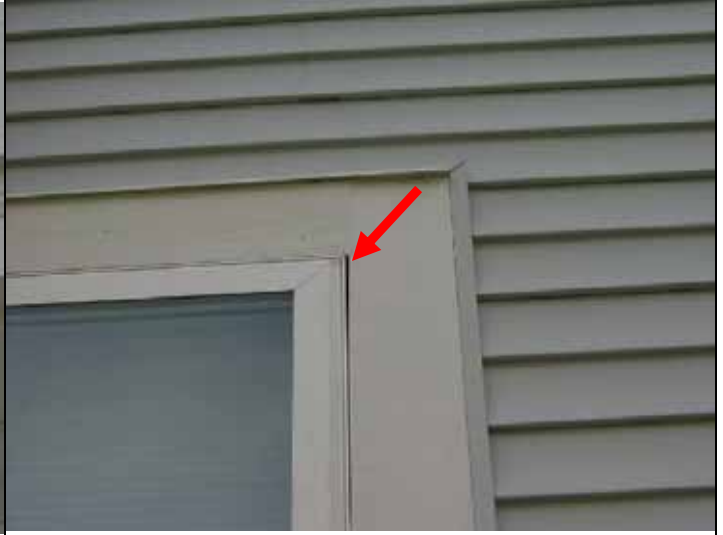
1. I noted several areas around windows that need some caulking and maintenance. Caulk and paint as needed to prevent water damage.
2. The patio door on the rear of the home has a ledger board and temporary railing. The ledger will need additional flashing and anchors when adding a permanent deck.
3. The brick veneer on the front of the home had several rope wicks protruding from the brick that will need to be trimmed. There was a gap on the north edge upper section that should also be filled to prevent water and insects from entering.

Caulk around windows

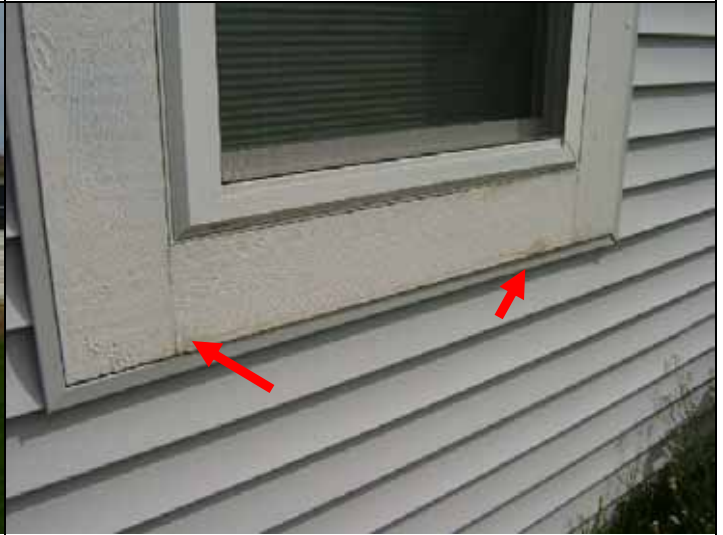
Discoloration on several wood trimmed windows.

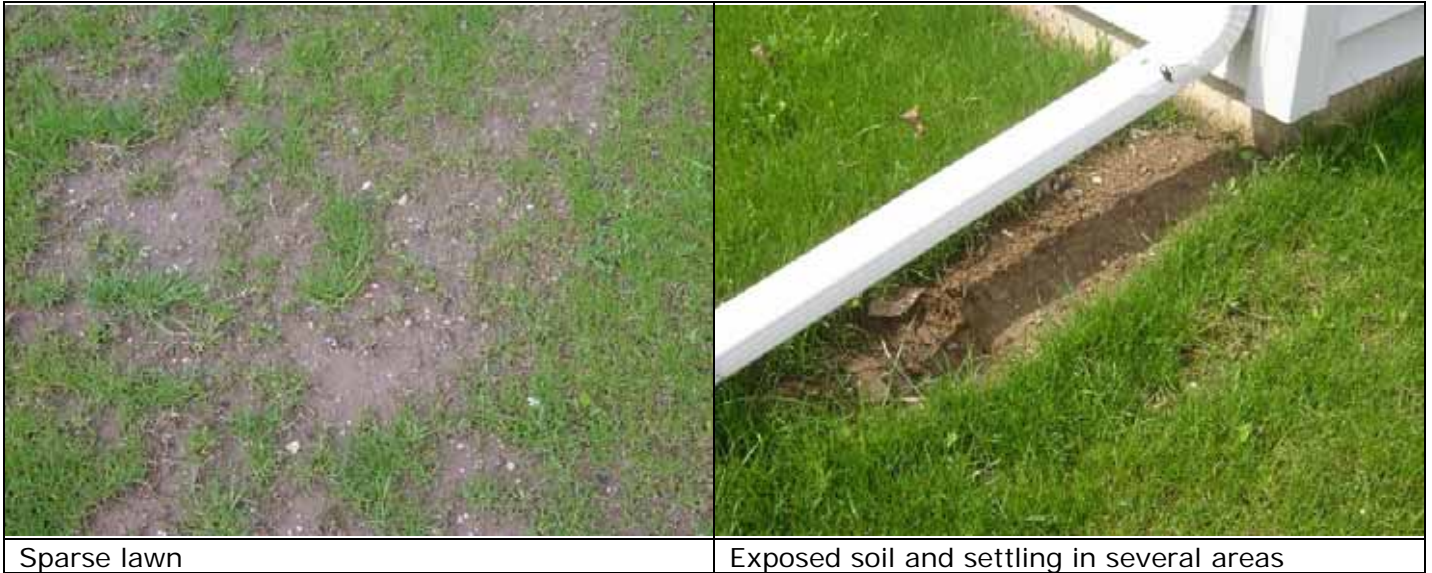
1. The home had a very sparse lawn and the soil was very soft around the foundation. As with most new homes there will be settling around the foundation and else ware in the lawn as the soil settles. Fill any depressions around the foundation and be sure to maintain a slope away from the foundation to direct surface water away.

Sparse lawn

Exposed soil and settling in several areas

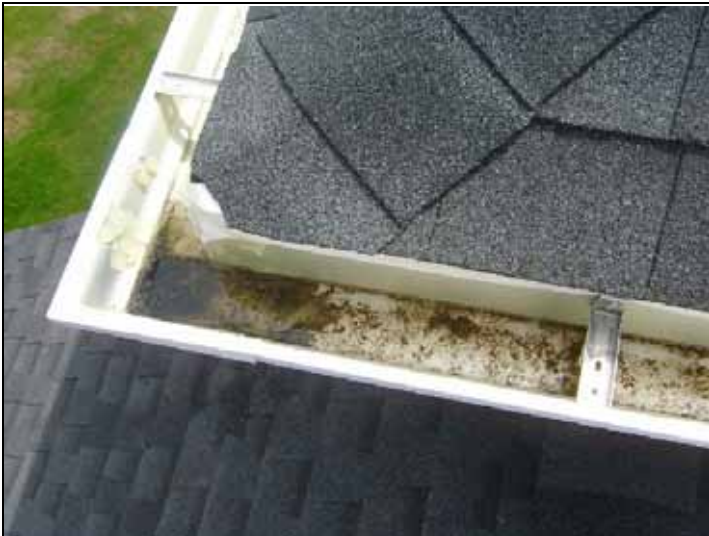
2. A truss cord was damaged in the attic and will need to be replaced.
3. One gutter had some standing water and appeared to be pitched incorrectly. The water was only 1/2" deep and a minor concern.

Improperly pitched gutter

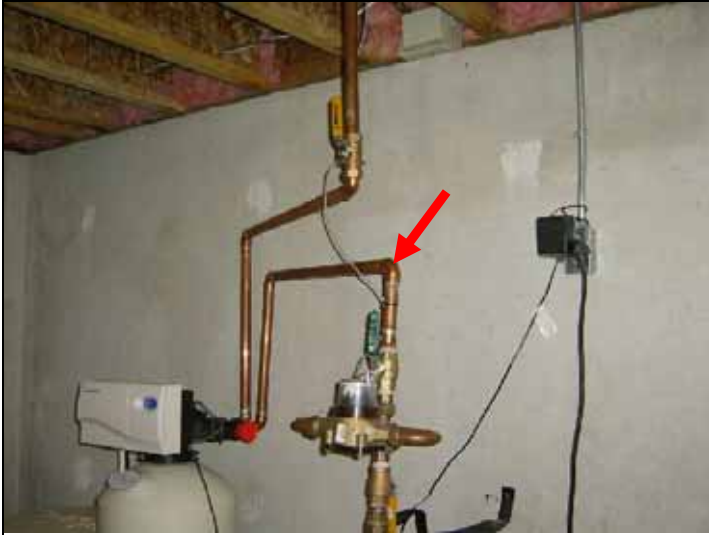
1. The water softener installation left the water main inadequately supported. If not properly supported the joints can fatigue and fail causing leakage and water damage to basement contents.
2. There were several waste pipes in the basement that were poorly supported. If these pipes were stuck they can break off at floor and be difficult to repair. Add protective supports to prevent damage.

Water softener pipes need additional support

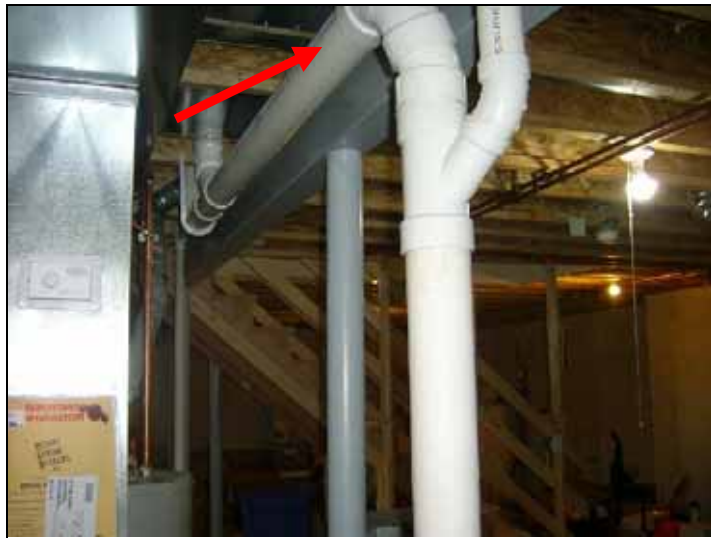
Additional support needed

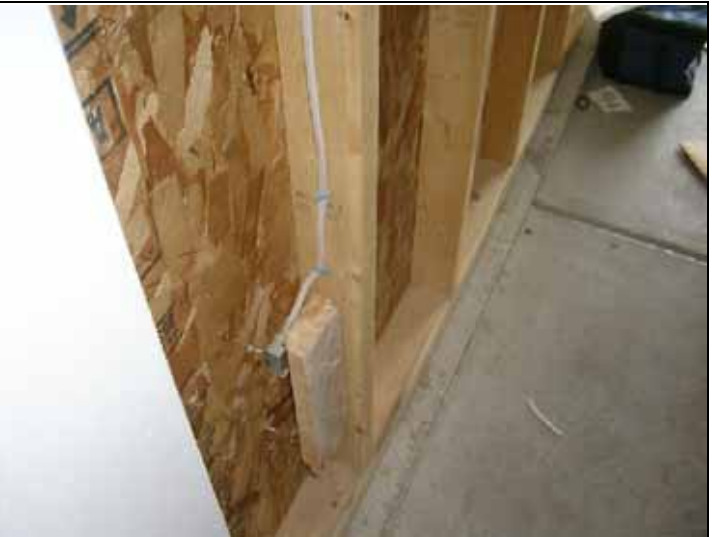
2. Wiring in garage is exposed and subject to physical damage. The wiring should be covered or run in conduit.
3. The exterior outlet in the entrance area was loose.

Exposed wiring in garage

1. The wiring in garage should be covered to prevent physical damage to wires.
