# Dedicated Home Services LLC

**This is an actual report for a typical ranch home**

Aaron Pfaff, Dedicated Home Services LLC

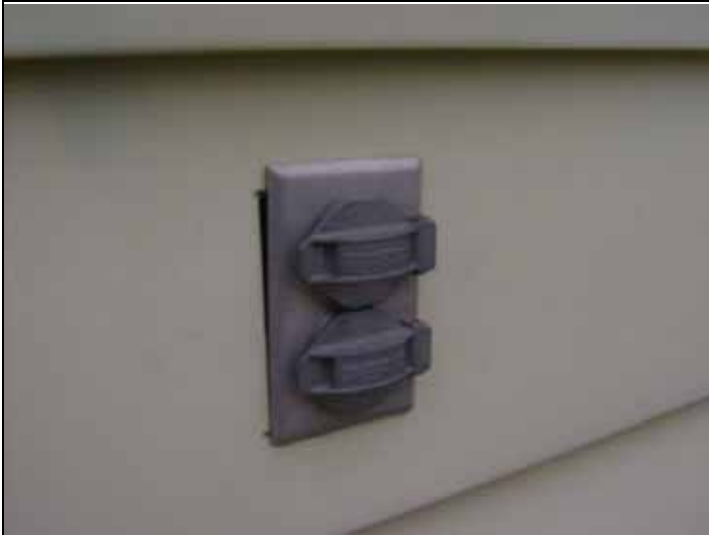
Loose outlet, needs GFCI protection

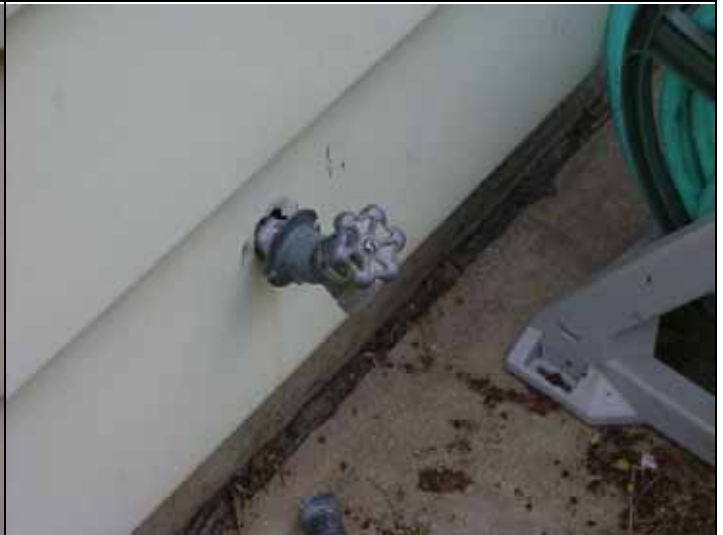
Caulk around pipe, needs vacuum breaker

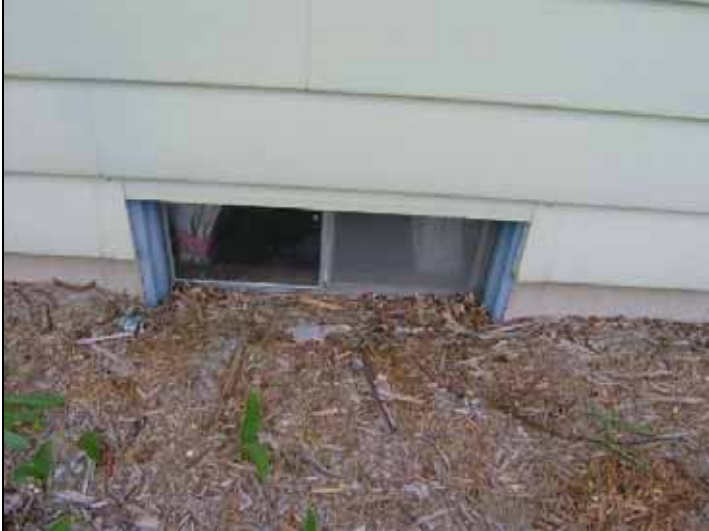
Clean and maintain around basement windows

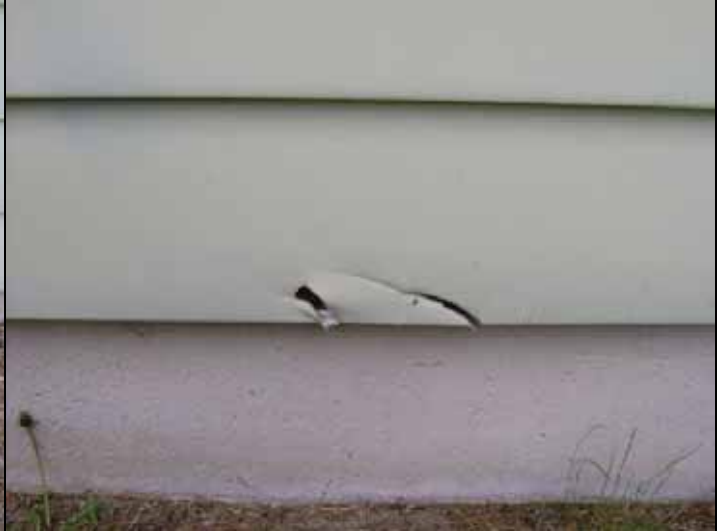
1. The exterior Aluminum siding was fading. There were several minor dents and holes that most have been filled.
2. The driveway had several cracks and pitting. It appears to have been resealed in the past few years. Fill and maintain cracks to prevent water damage from freezing and expanding.

Siding damage

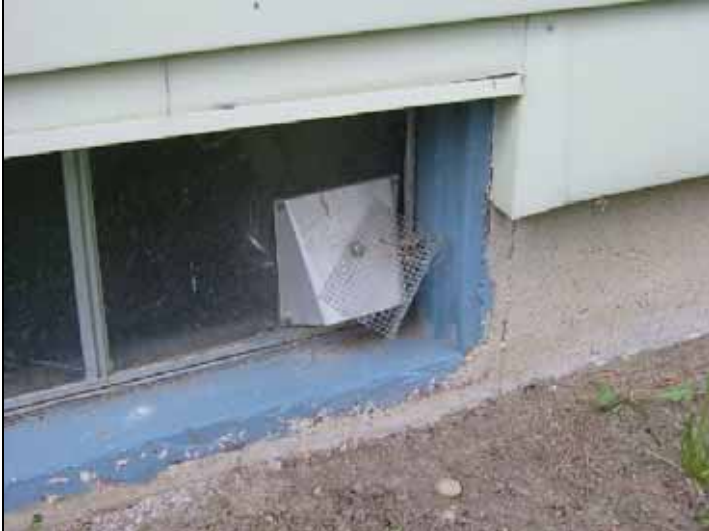
Replace dryer vent, needs damper and screen

1. The dryer venting was in need of repair. Replace with smooth metal pipe with as few joints and elbows as possible.
2. Use SS-steel braided lines for washer supply. These are less likely to fail than standard black hoses.

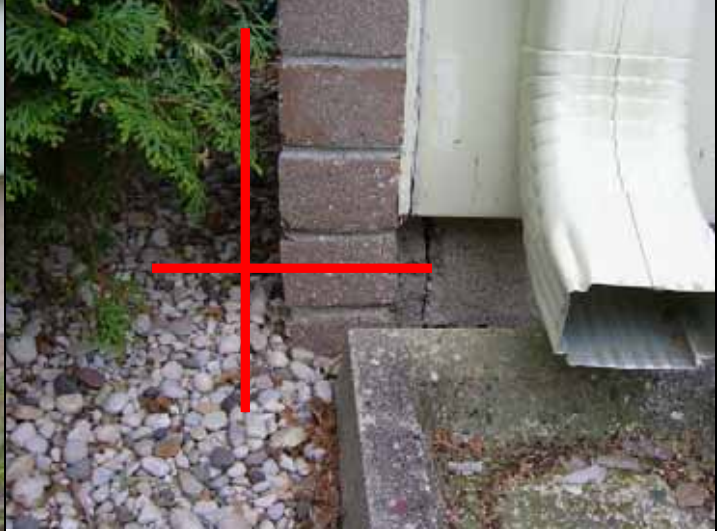
3. The front brick veneer had several signs of movement. The lower portion was not visible but showed it has had some settling and the upper portion appears to have moved as much as ½" in some places. It did not appear to be a recent event or ongoing problem. Maintain caulk and repair as necessary to prevent further movement or admittance of water which can deteriorate the sheathing behind brick veneer. The foundation ledge may not be adequate to support veneer. Some step cracks and other cracks were noted. These cracks were typically under an 1/8" in size and are of little concern. The flower box area may need better drainage. Typically they lack proper drainage and the water trapped in soil expands when freezes and pushes outward causing the cracking typical of what was noted. Have a mason look at veneer and flower box and make recommended repairs if necessary.

Minimal movement of brick veneer

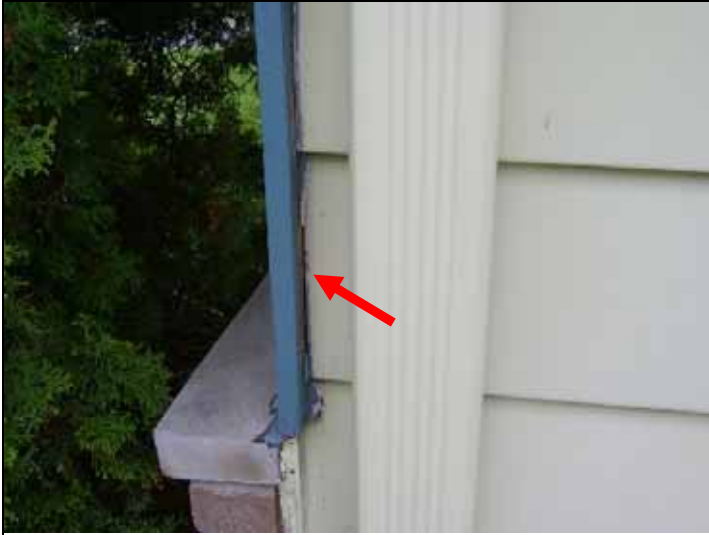
Gaps need caulk

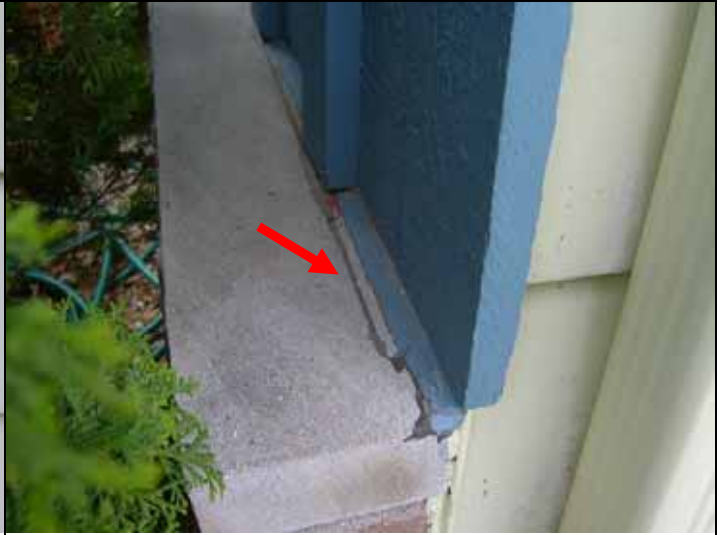
Indicates movement

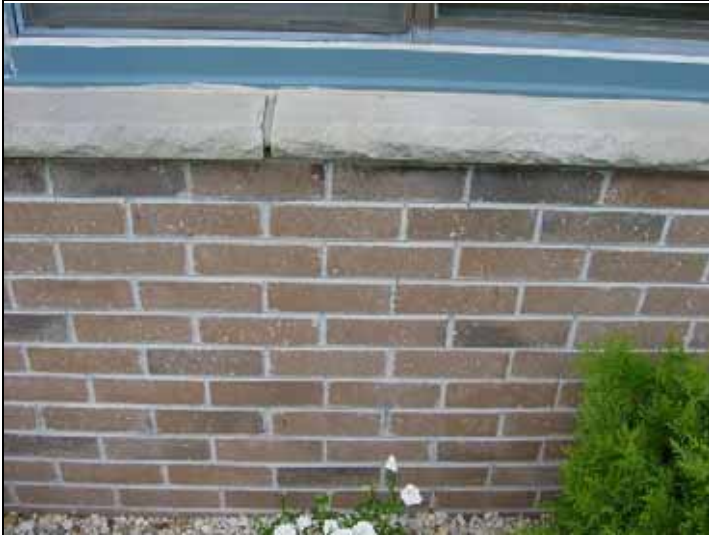
Deteriorated mortar joints, step cracks

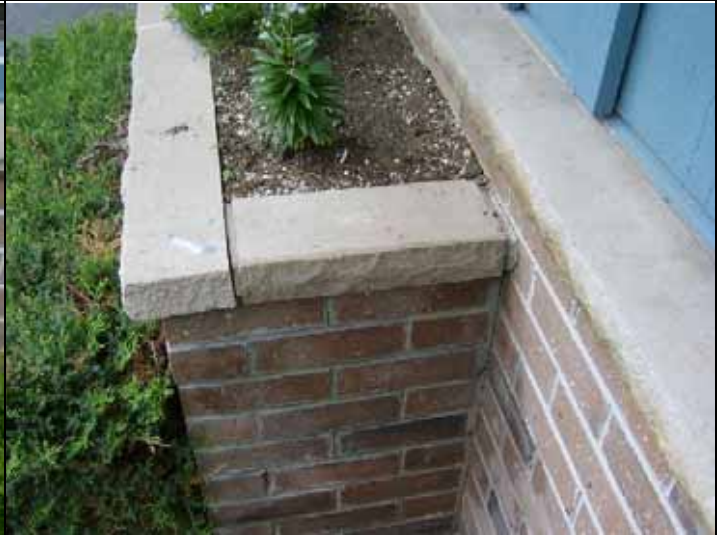
Some cracks, movement

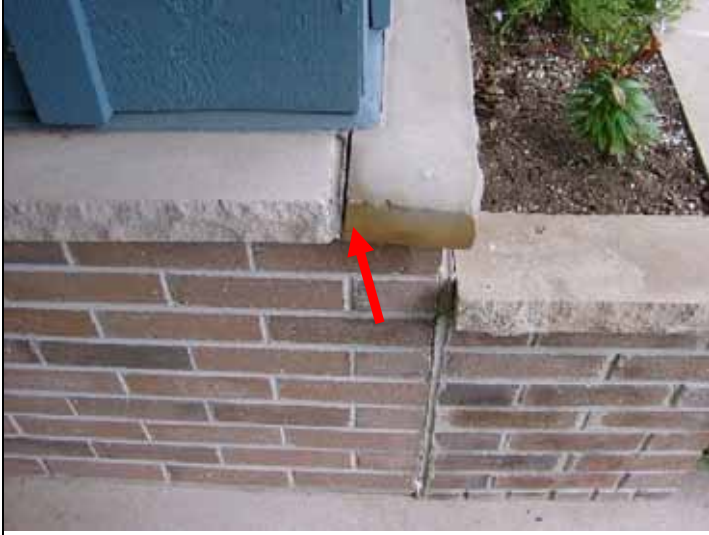
Some movement of joints

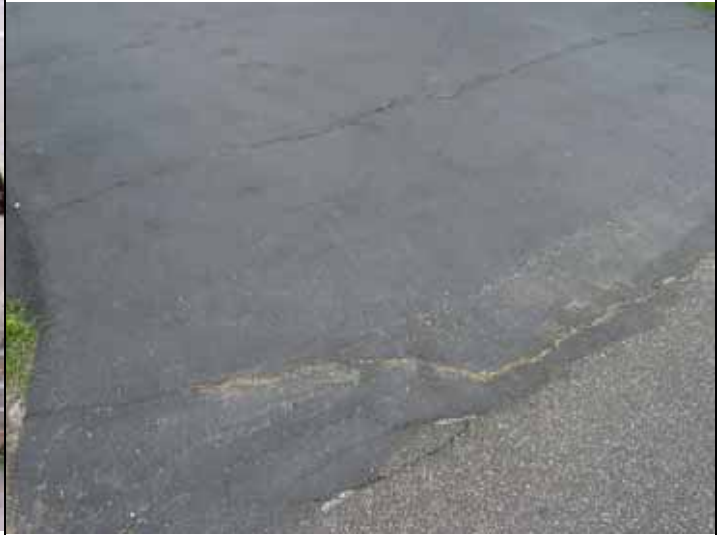
Driveway cracks and pitted

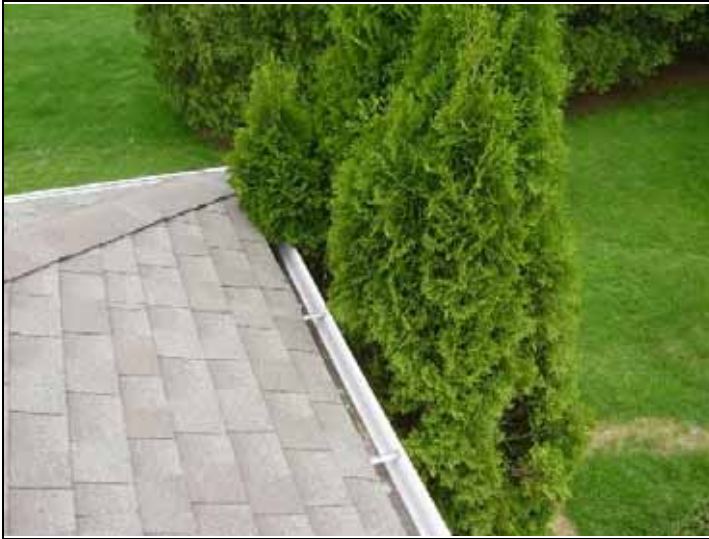
Trim trees

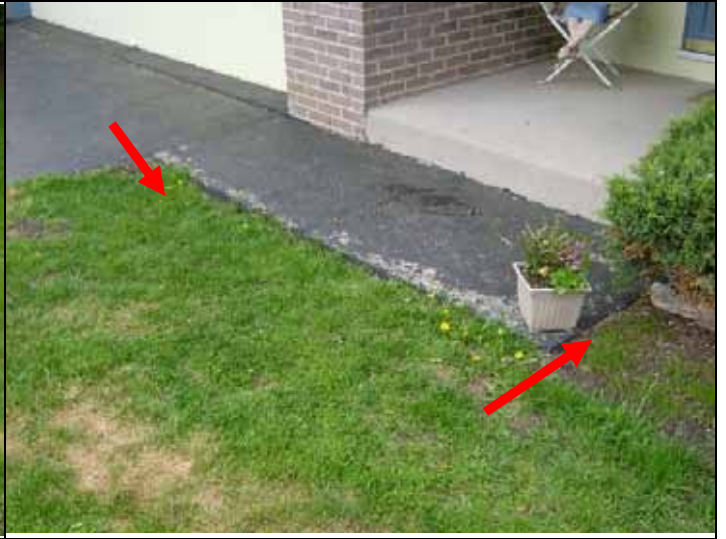
2. Several low spots and reverse slopes were noted around the perimeter of the foundation near the front of the home.
3. Trim all bushes from touching the home. This holds moisture too close and can physically abrade the siding etc.

Low spots around front of home

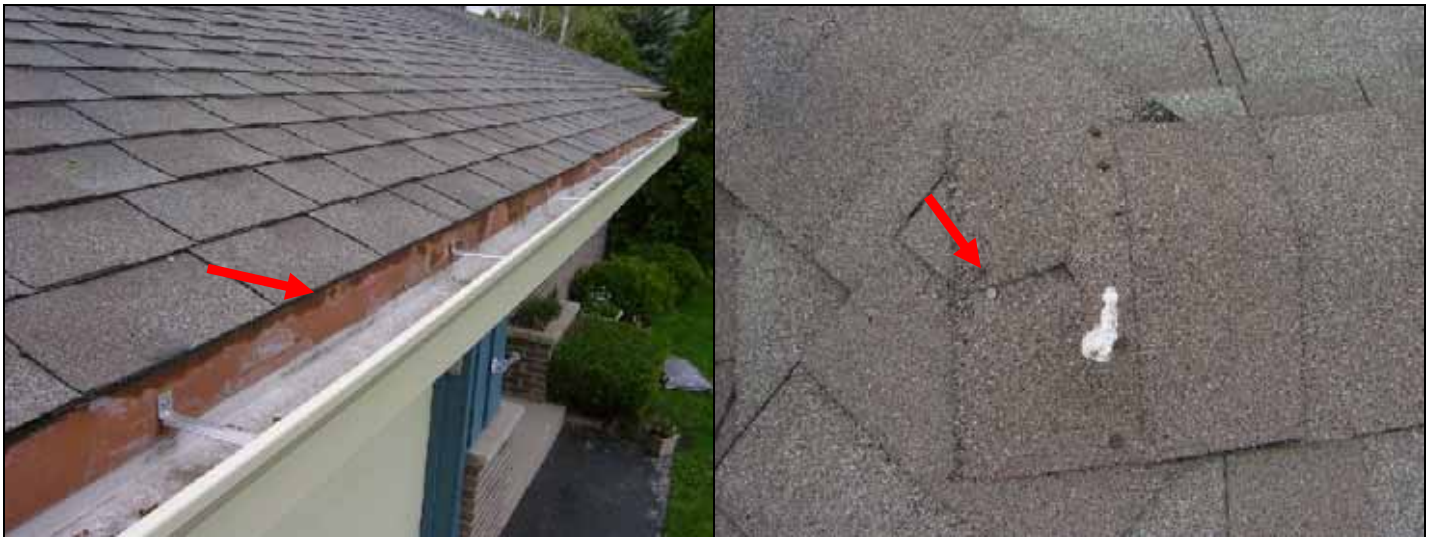
1. The roof was in overall acceptable condition. The age is hard to determine but it appears to be approximately 5 years old. Ask seller for warranty information. There were a few fasteners that were exposed and minimal concern for leakage but should be sealed. When the roof covering was replaced the flashings were not replaced. There was some rust visible and the penetrations like the chimney are susceptible to leakage. Monitor flashing areas and use roofing sealers around penetrations as needed.

Rusted, reused flashings	Exposed fasteners
--------------------------	-------------------

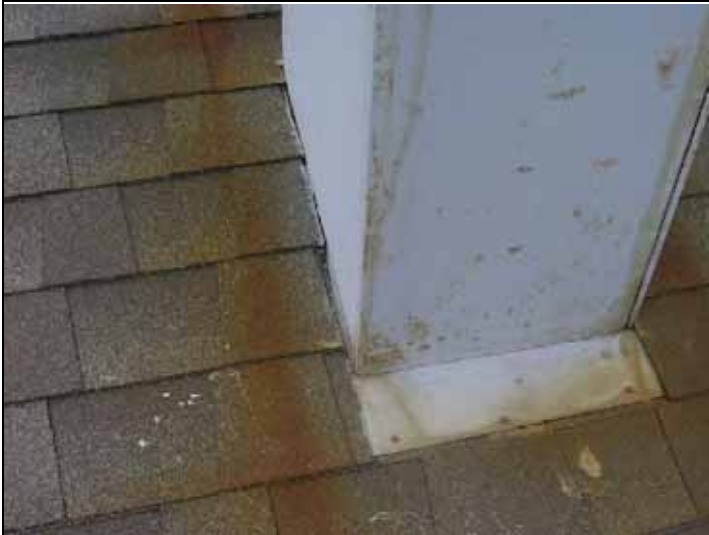
Chimney rusting, staining roof, pinhole rusted through on cap

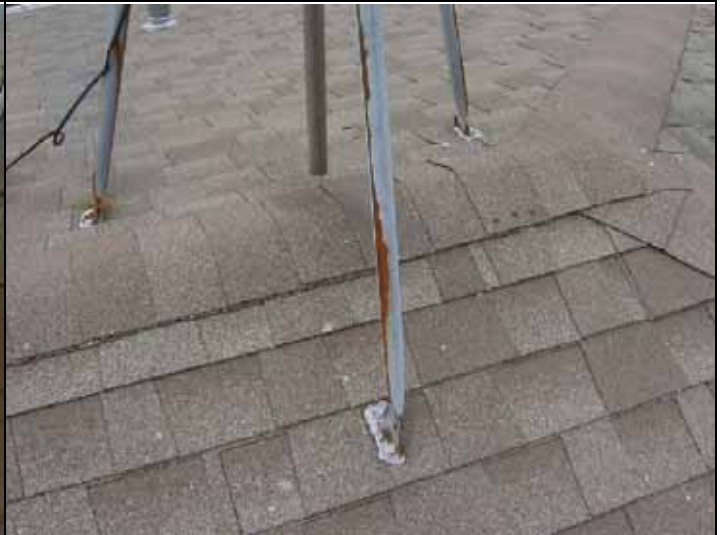
Antennae mounts need sealing

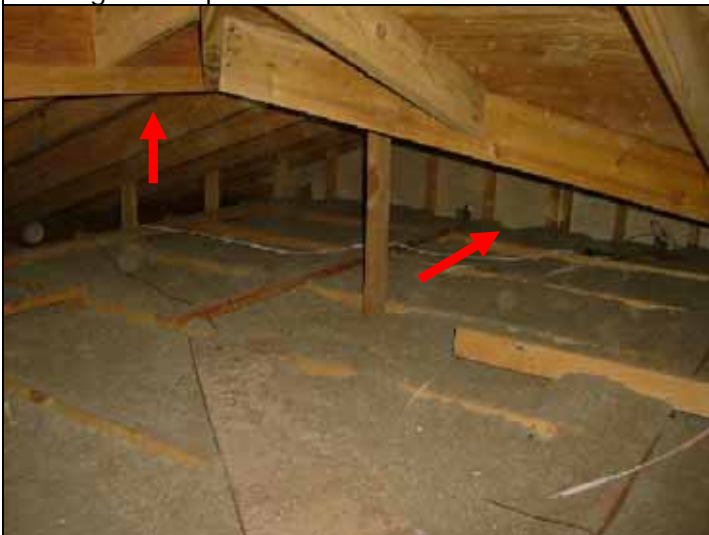
4. The roof had a few areas near the garage portion on the front that had a waviness observed. The framing in the garage revealed a need for additional framing to most likely as collar ties to prevent the spread of the outer walls. Similar observations were made in the attic. The ridge board from the garage and intersecting valley and roof section above entry had some framing that was very lightly constructed. It appears that some movement has occurred and I recommend consulting a qualified carpenter or structural engineer to evaluate the framing and recommend a method of adding additional support.

Garage wall as seen from attic, ridge board and valley framing support is improperly constructed

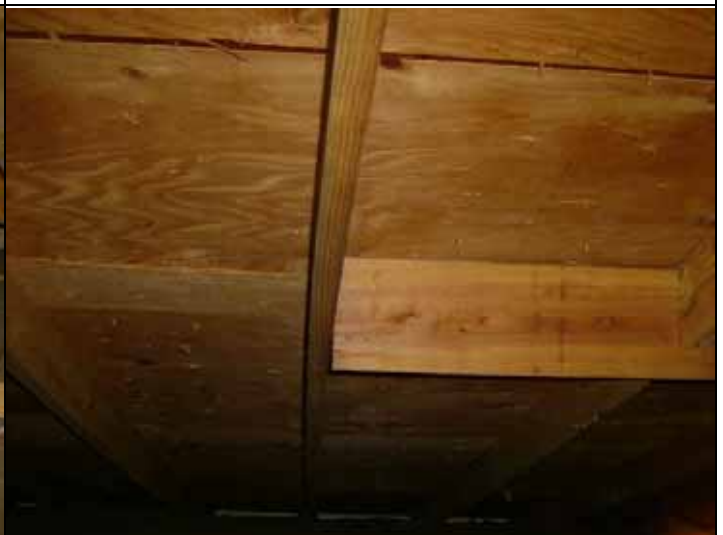
Termination of ridge on one rafter

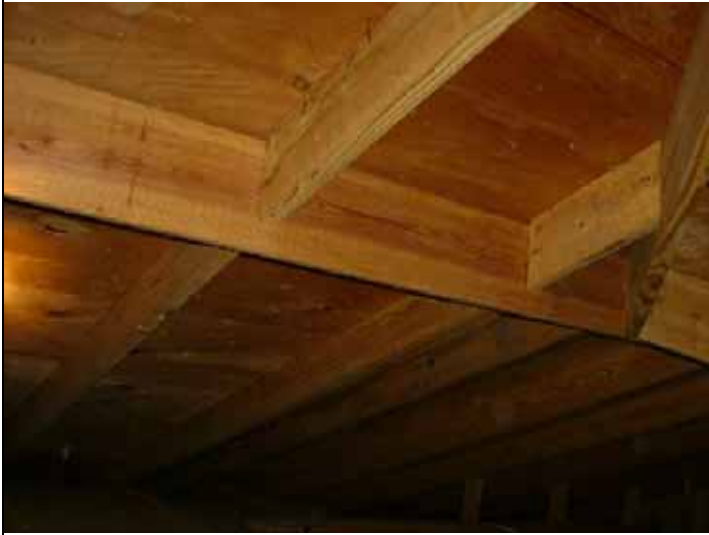
Another view of ridge and valley framing

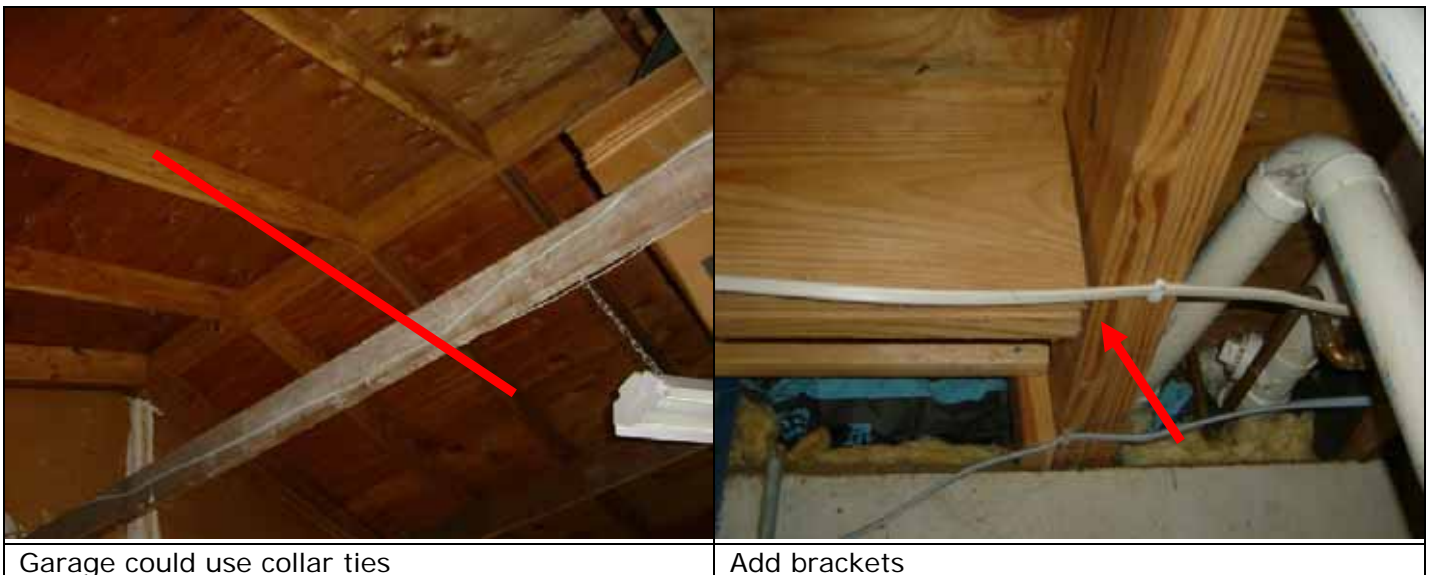
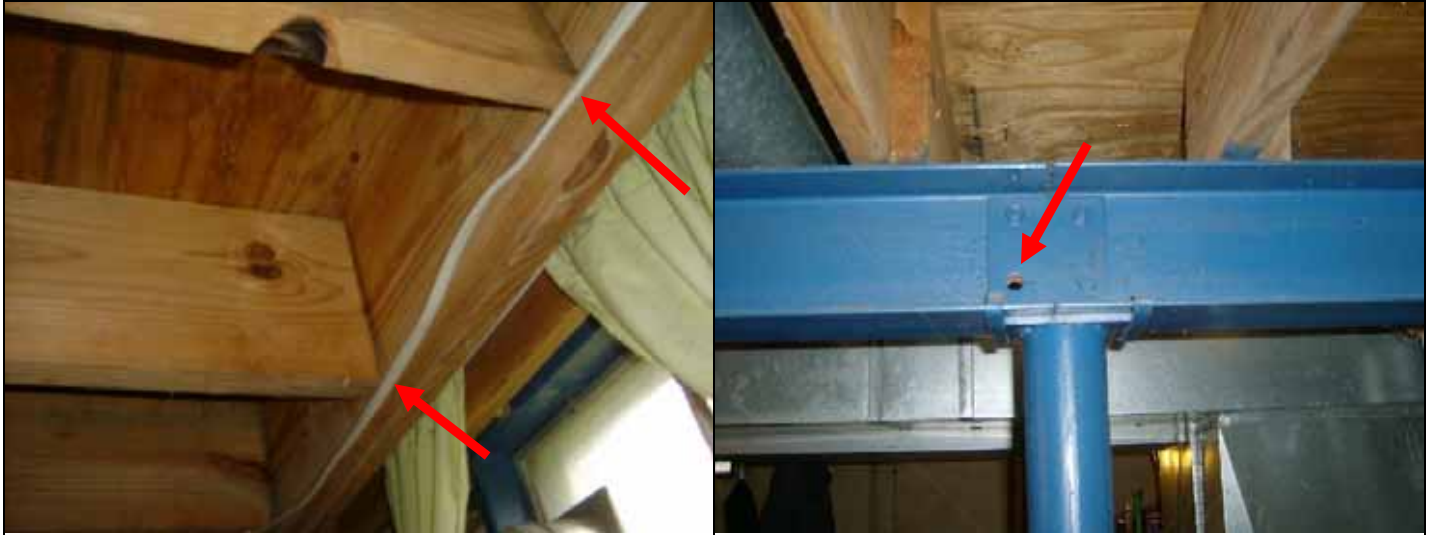
1. See notes in roof section for additional framing concerns in attic and garage.
2. There were several floor joists that need joist hanger brackets. These were not commonly used in the era this home was built but they will add support and prevent loosening and potential failure of these joints. Add hangers in all locations similar to photos below.
3. One bolt was missing in main steel support beam in basement. Add bolt.

Add brackets, several similar locations noted	Missing bolt
---	--------------

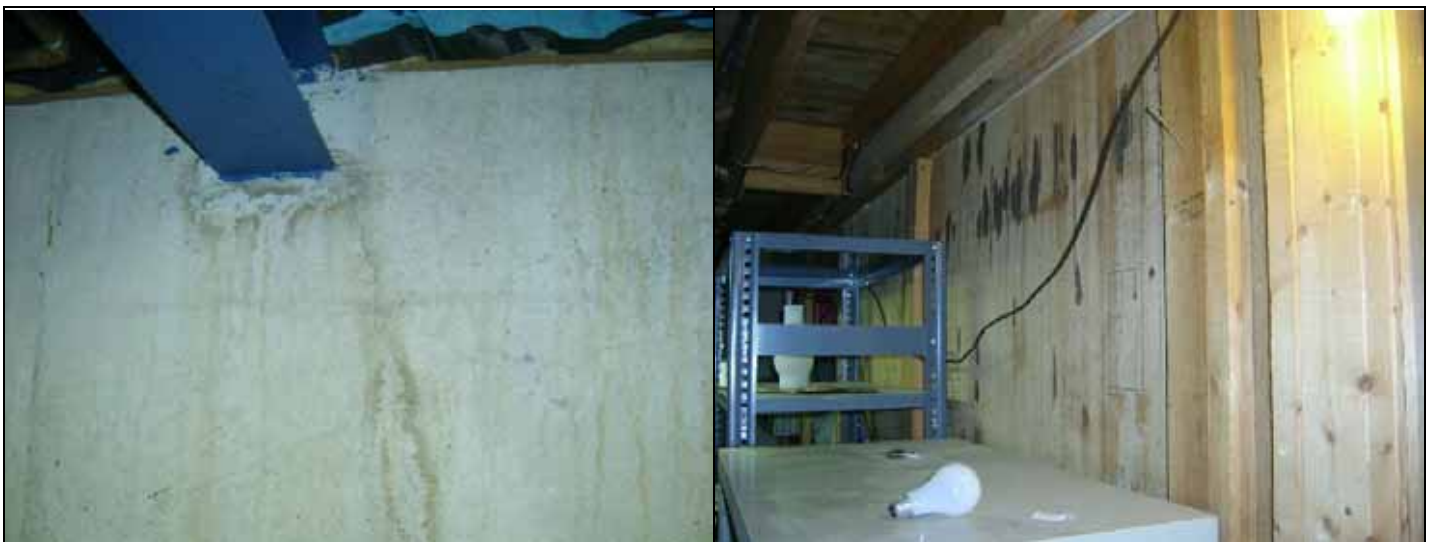
1. The basement wall had some unusual colored stains that were noted on several walls and because of the pattern and locations it may have been caused during construction.
2. The basement stairs were open on the top and had a poorly constructed partition wall below.

Some water stains on walls noted	Partition wall lightly constructed
----------------------------------	------------------------------------

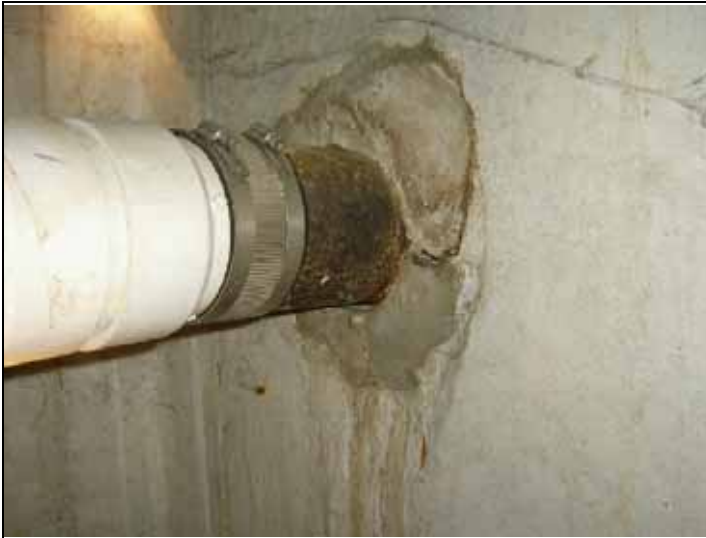
Replace mortar around pipe with hydraulic cement

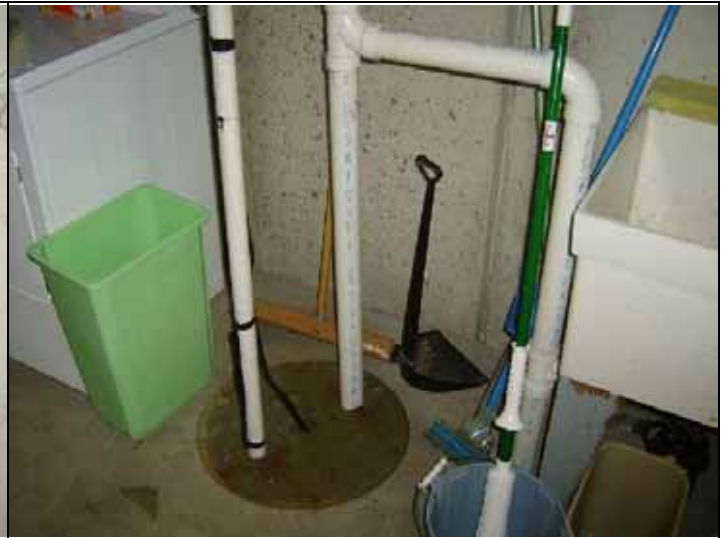
Replace cover and seal penetrations

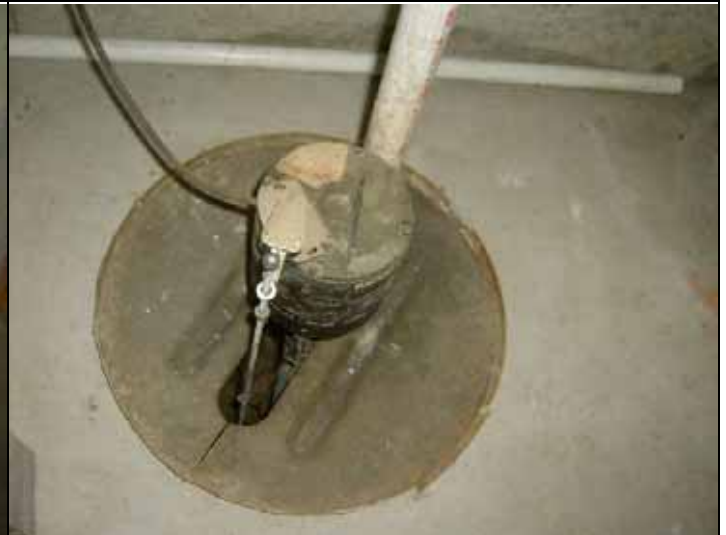
2. The sump pump in the corner appears to be connected to drain tile system. The pump failed to operate and will need to be replaced. The discharge line needs a check valve and the pipe exiting the home will need a hose attached to direct water farther away from foundation.

Sump pump failed

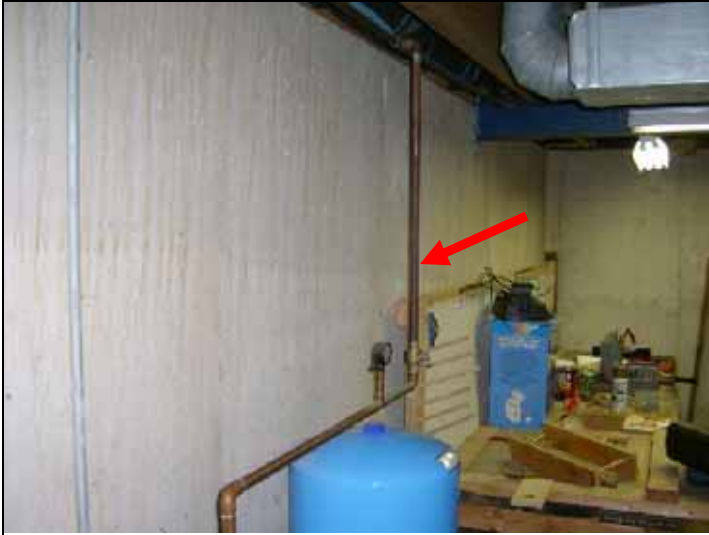
Pipes need additional support

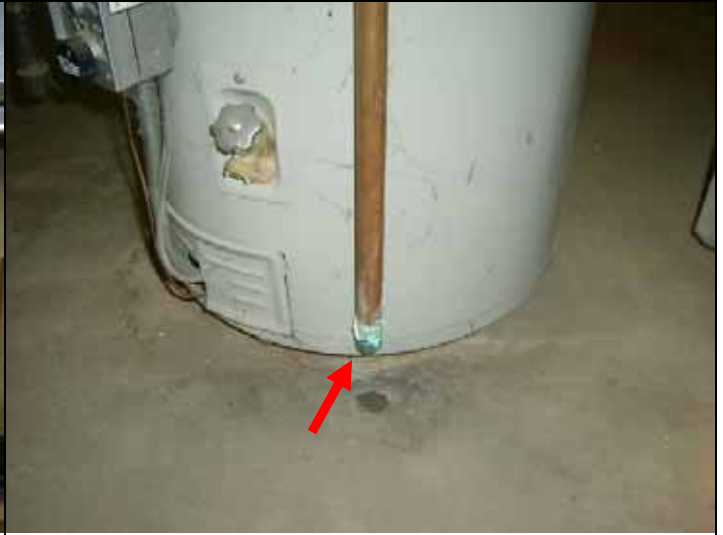
4. The water heater was operable but aging. The average life expectancy of these types of heaters is 8-12 years and this one appears to be 10 years or more. The TPR valve was leaking and may need to be replaced. Consider replacing water heater as preventative maintenance to reduce costs and risk of water damage if failure were to occur.
5. Several pipes were in need of additional support. Add hangers to reduce chance of fatigue on joints and potential failure.

TPR valve leaks

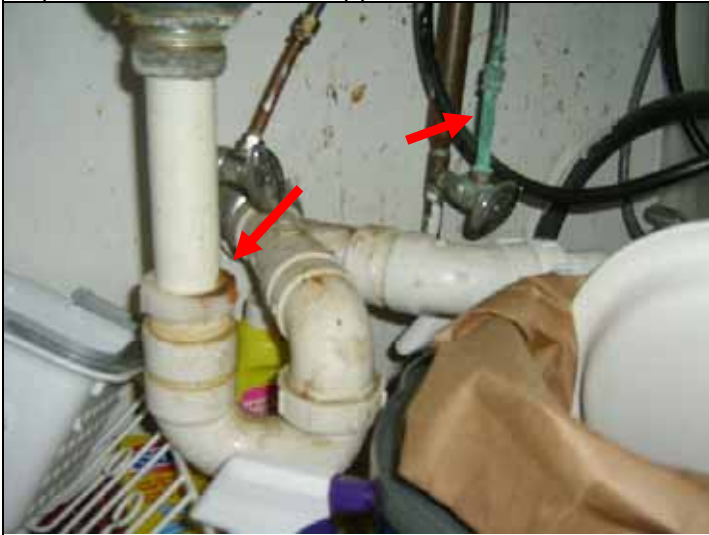
Corroded, signs of past leakage

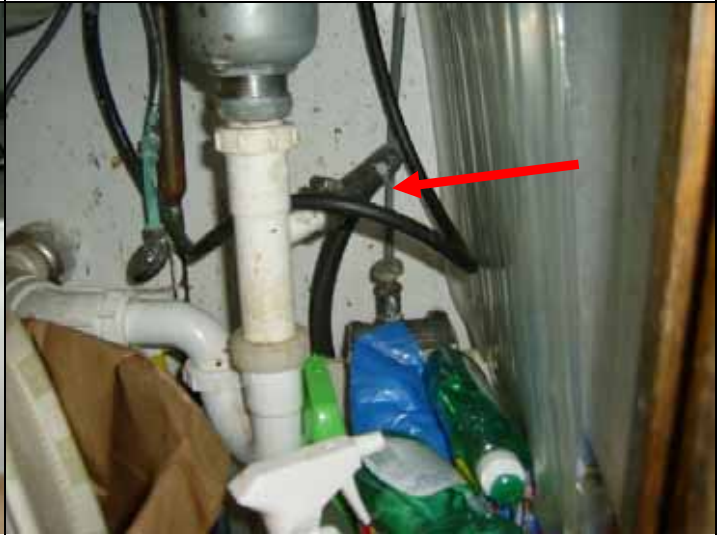
Improper dishwasher drain, add air-gap

1. The outlets in the kitchen need to be replaced with GFCI type for protection against shock.
2. The dishwasher was an older model and the drain hose was improperly connected. Have a plumber add an air gap.
3. The plumbing under the sink had several signs of past leakage and the supply lines were corroded and subject to failure. No leakage was observed at time of inspection.

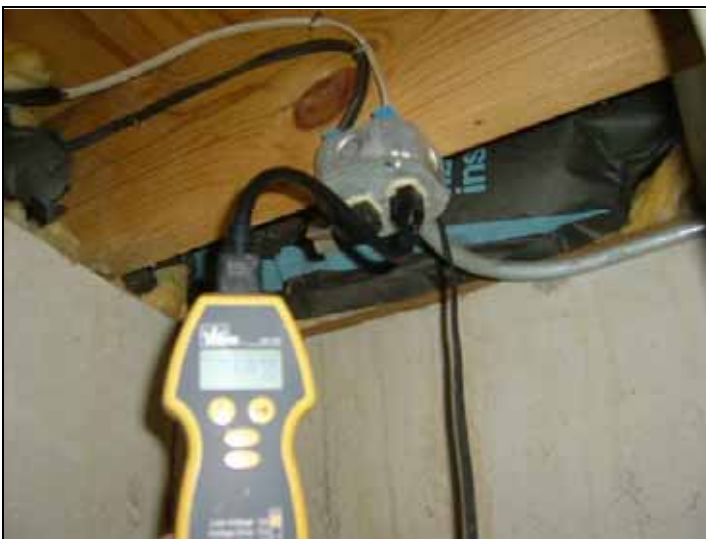
3. Testing a sample amount of outlets revealed an inconsistent voltage drop under load. When a 15-amp load was applied to the circuit the line voltage dropped 8-14.5% any voltage drops over 5% are considered out of acceptable range per manufactures standards. The most common causes for this are excessive length of the wire in the circuit or poor connections. The connections most often responsible are push-in type receptacles. This wiring method (also called speed wiring) is acceptable by NEC code, but often results in poor connections. The solution to this is using the screw type terminals for a better connection. This condition needs to be further evaluated by a qualified electrician to determine the quality of connections.

Sump pump and well pump had voltage drops of 14% other outlets had similar drops.

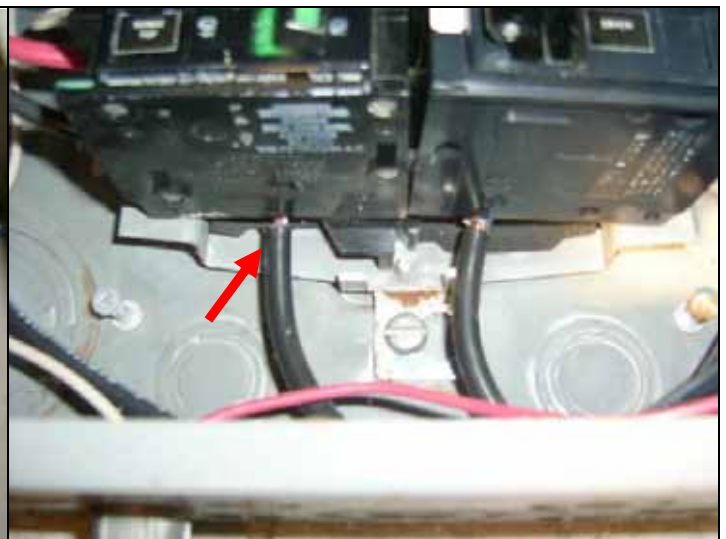
1. The panel and sub panel had several problems noted. The sub panel had numerous concerns and was wired improperly. The main panel was overcrowded and several space saver breakers were used that may exceed the capacity of the panel. The GFCI breaker failed to operate. Because of the numerous concerns noted and the panel being overcrowded and the sub panel improperly wired I recommend having the panels replaced with one new panel of adequate capacity as recommended by an electrician.
2. The grounding and bonding of the electrical system utilized the water pipes. A water softener was installed that appears to have broken the grounding connections. Several

Sub panel wires improper connections and size.

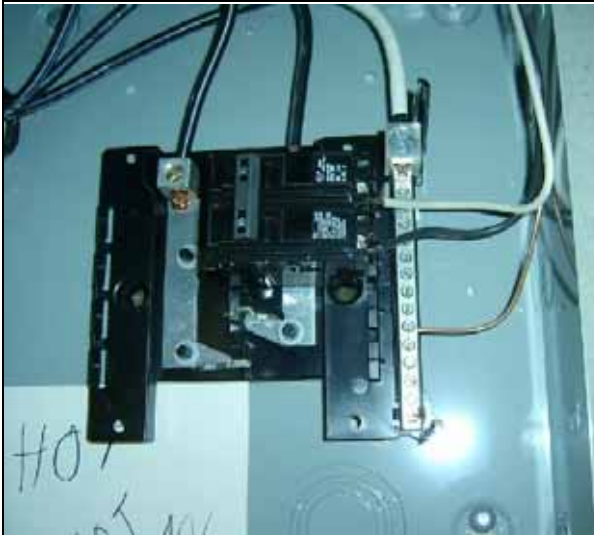
Improperly wired sub panel

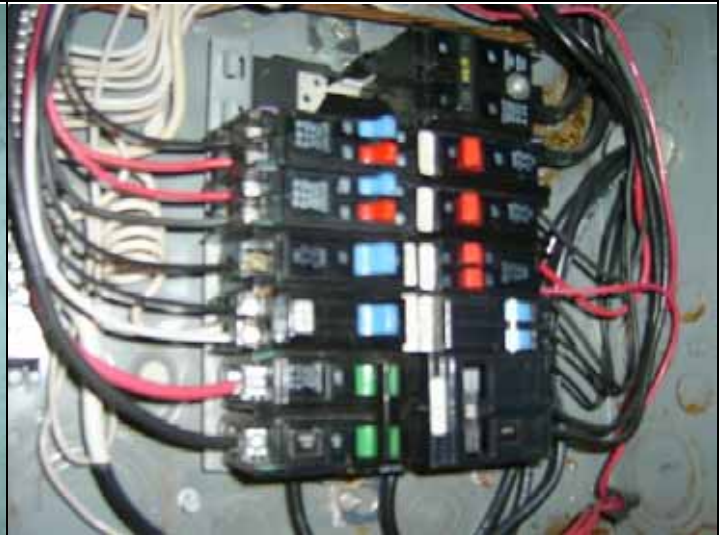
Crowded, overcapacity panel

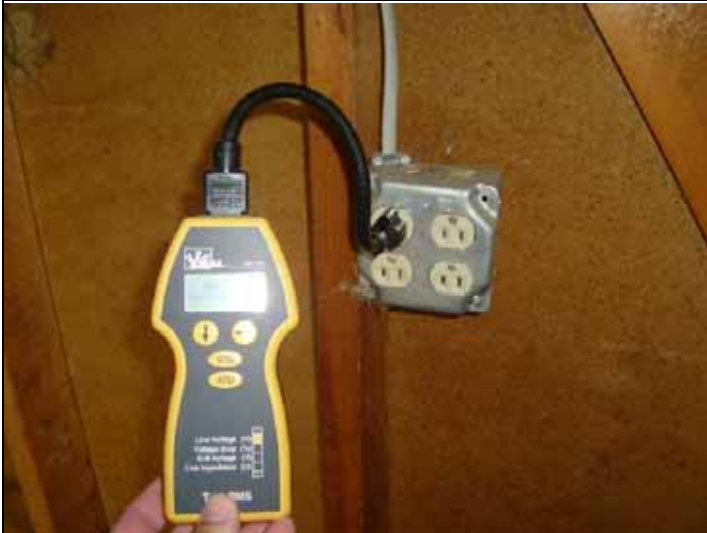
4. The garage had several wiring concerns noted. Two open junction boxes were noted. Several outlets were loose and lacked GFCI protection and even lacked grounds. The wiring appears to have been done improperly and will need to be repaired by an electrician.

No grounds, loose, no GFCI

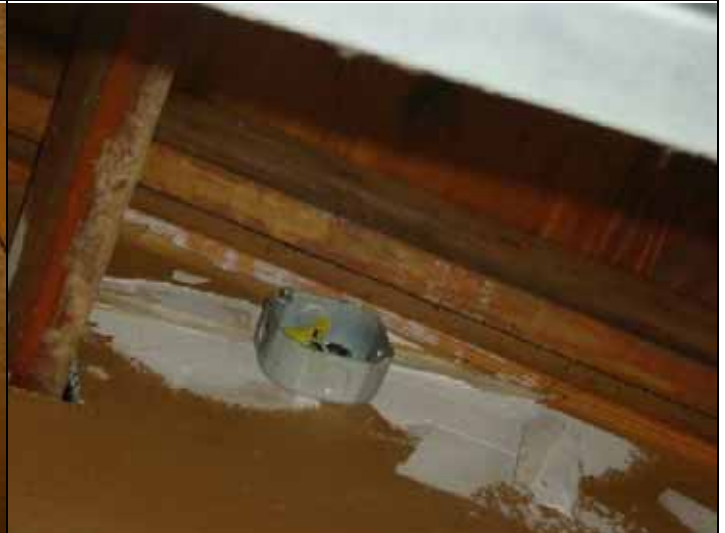
Open junctions

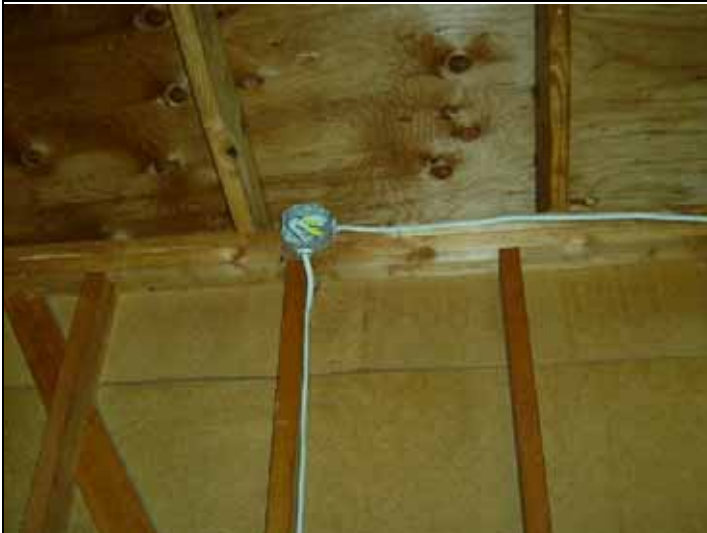
Open junction

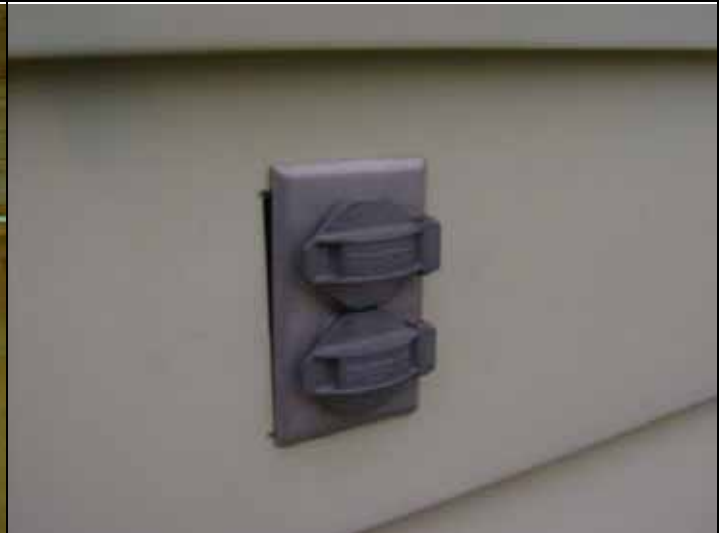
Loose outlet, needs GFCI protection

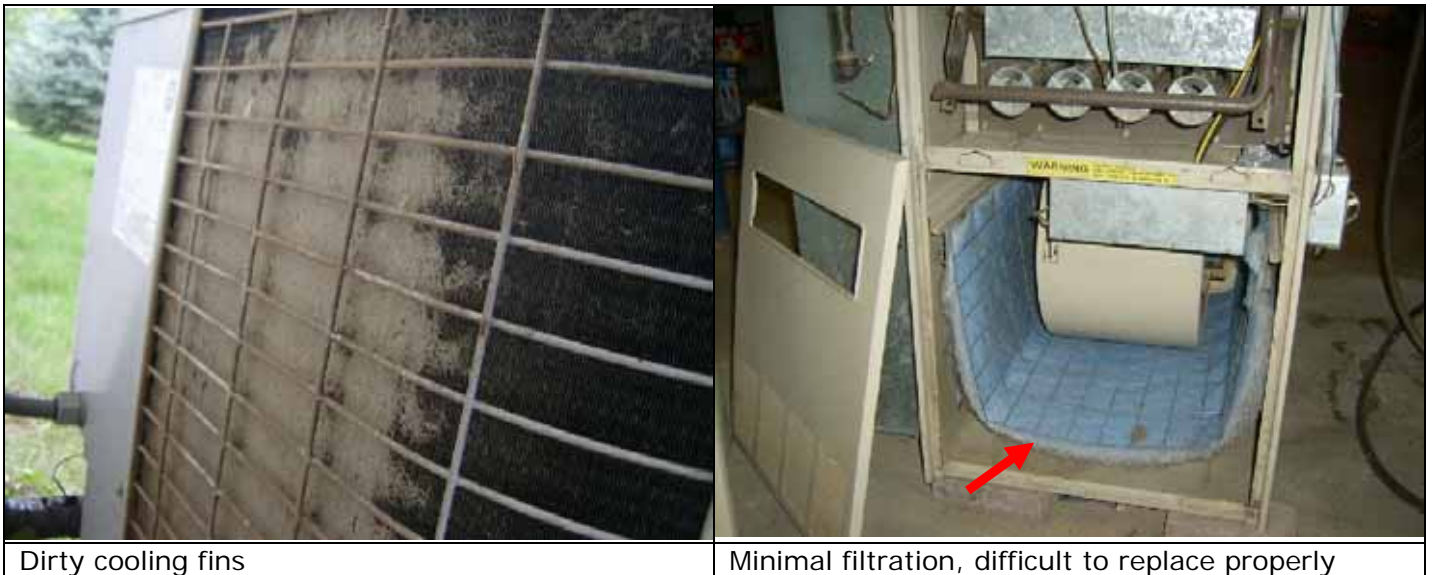
1. The air-conditioning operated as normal but I always recommend having the system fully inspected by a qualified HVAC technician prior to close of escrow. They can test refrigerant levels and inspect component only visible when disassembled using specialized tools and equipment. The equipment should also be cleaned and serviced at this time and then on a regular basis to keep it operating efficiently.
2. The air conditioner will need to be cleaned and leveled.

Dirty cooling fins

Minimal filtration, difficult to replace properly

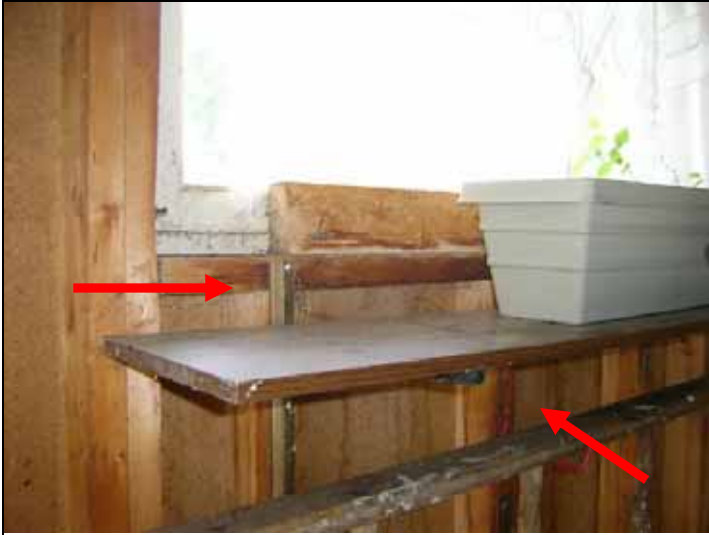
Signs of leakage around window

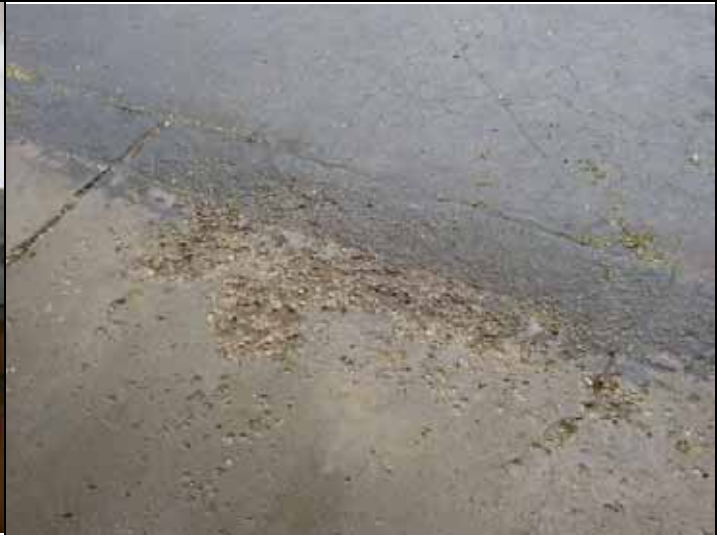
Pitted concrete

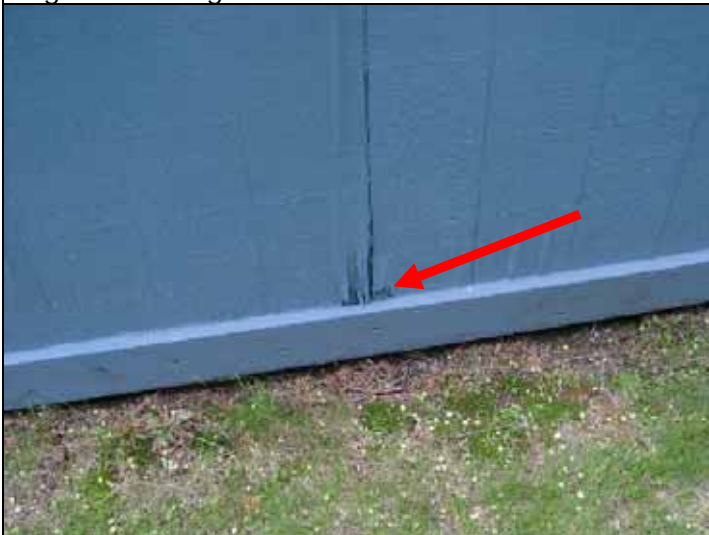
Delaminating plywood

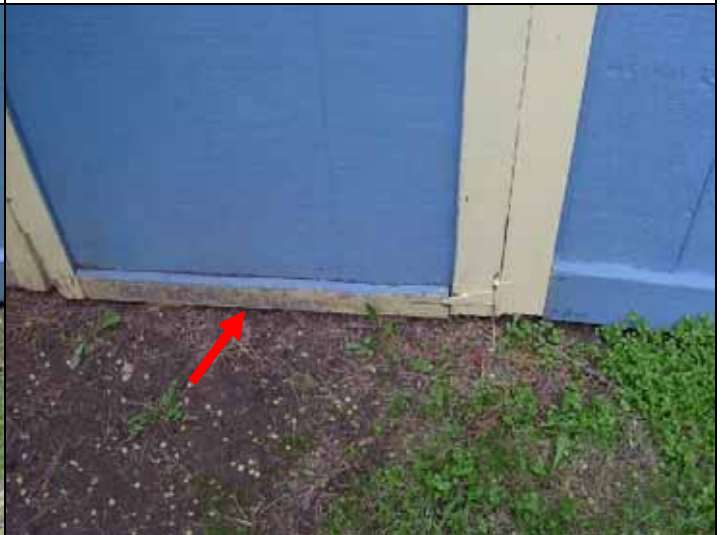
Wood rot on doors
