Dedicated Home Services LLC

This is an actual inspection report

Aaron Pfaff, Dedicated Home Services LLC

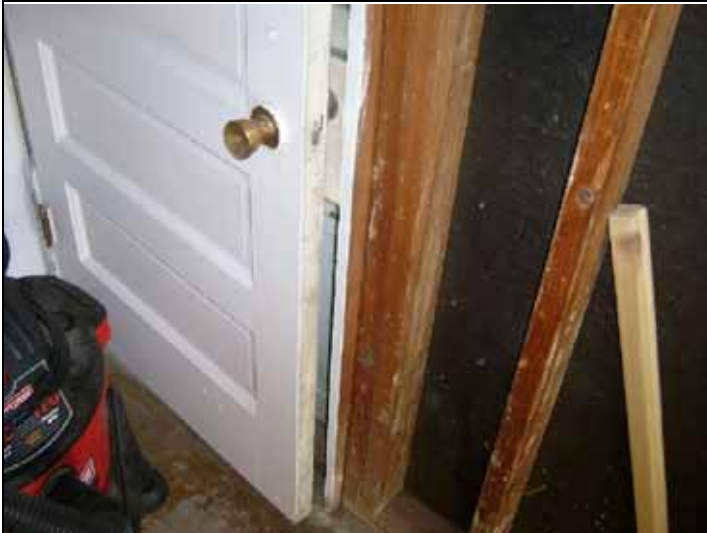
Door not aligned well needs adjustment
