Dedicated Home Services LLC

This is an actual inspection of a newly constructed home

***** See roofing section*** Even new homes can have significant defects in workmanship that are often overlooked by builders and municipal code**

Aaron Pfaff, Dedicated Home Services LLC

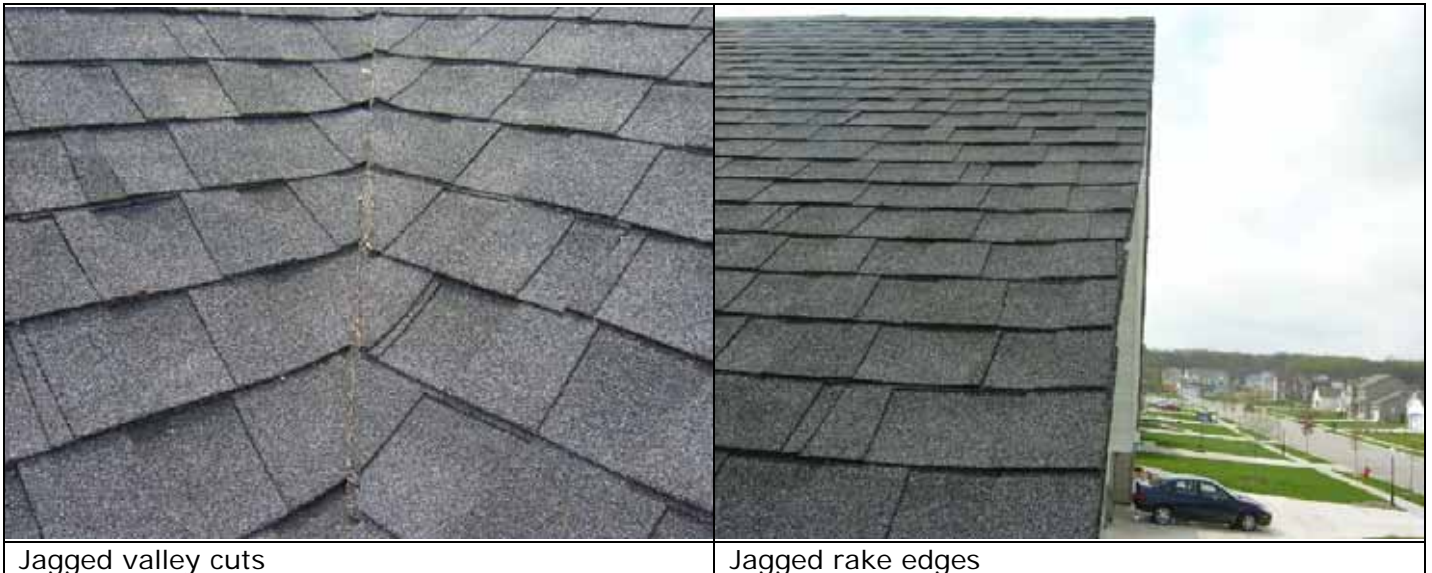
1. The roof exhibited several signs of sloppy workmanship. The edges and valley cuts were jagged and there was nails and debris on the roof and in the gutters. There was one complete shingle missing and several others that were not laying flat. There were some staples exposed and others that were not driven to proper depth or have backed out. The roof had no underlayment installed. Typically tar paper is used and acts as a second line of defense for leakage and acts as a release to prevent shingles from adhering to plywood deck. The wood and shingles expand and contract at different rates and if there is no release underlayment it can shorten the life of the roof covering. Many shingle manufacturers void the warranty if no underlayment is used. The roof was stapled rather than using roofing nails. This method of attachment is not the preferred method by most manufacturer standards and may void warranties of some manufacturers. Have the shingle replaced immediately and have a roofer examine the roof and repair any popped staples. Check the manufacturer's specifications for installation and warranty. Because of lack of underlayment the roof covering will likely need to be removed and replaced.

Several shingles not sealed, staples popped
