# Dedicated Home Services LLC

**This is an actual report for a typical ranch home**

Aaron Pfaff, Dedicated Home Services LLC

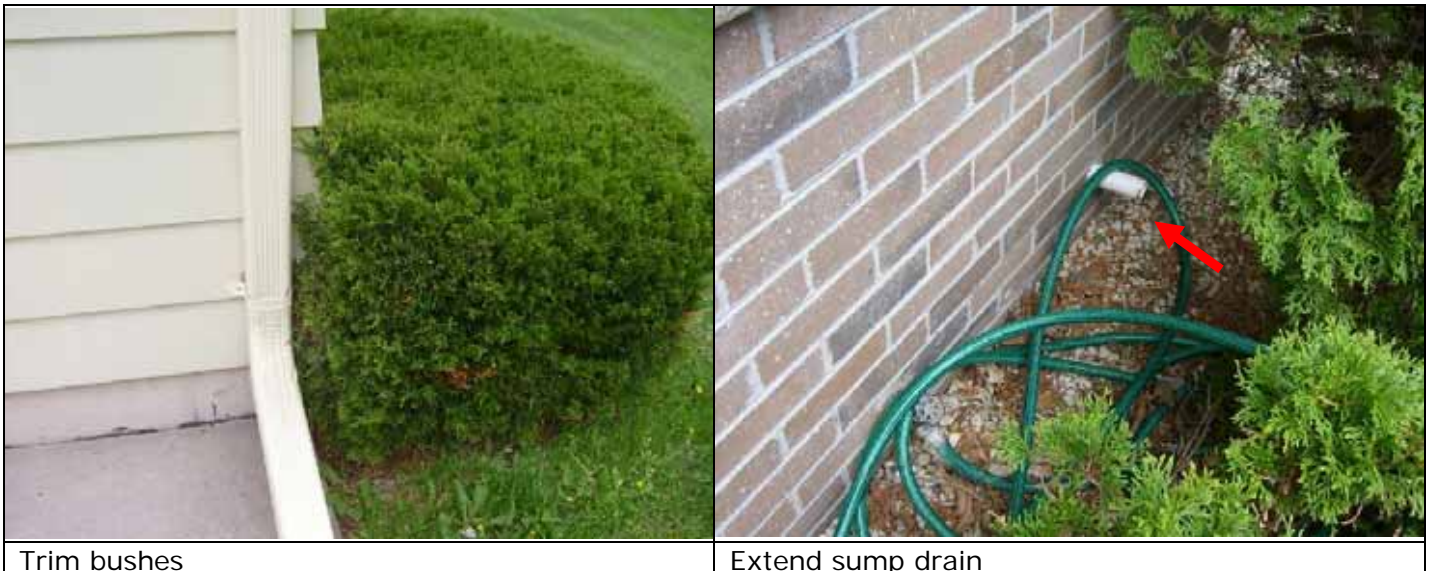
Trim trees

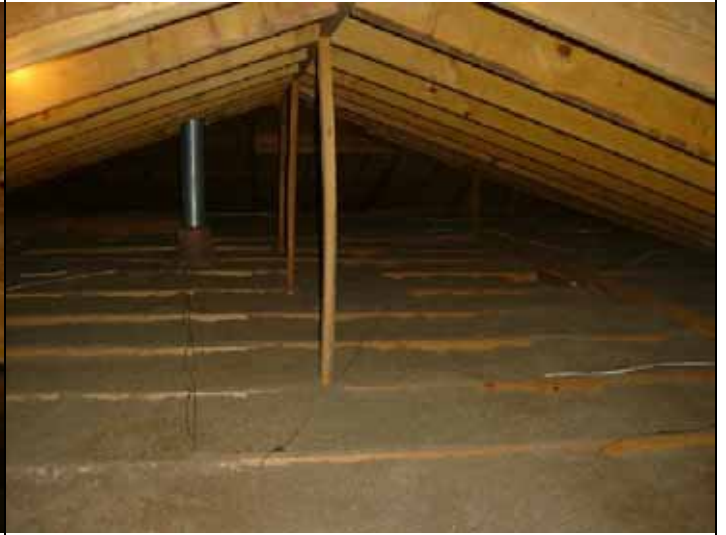
4. The roof had a few areas near the garage portion on the front that had a waviness observed. The framing in the garage revealed a need for additional framing to most likely as collar ties to prevent the spread of the outer walls. Similar observations were made in the attic. The ridge board from the garage and intersecting valley and roof section above entry had some framing that was very lightly constructed. It appears that some movement has occurred and I recommend consulting a qualified carpenter or structural engineer to evaluate the framing and recommend a method of adding additional support.

View of main gable in attic

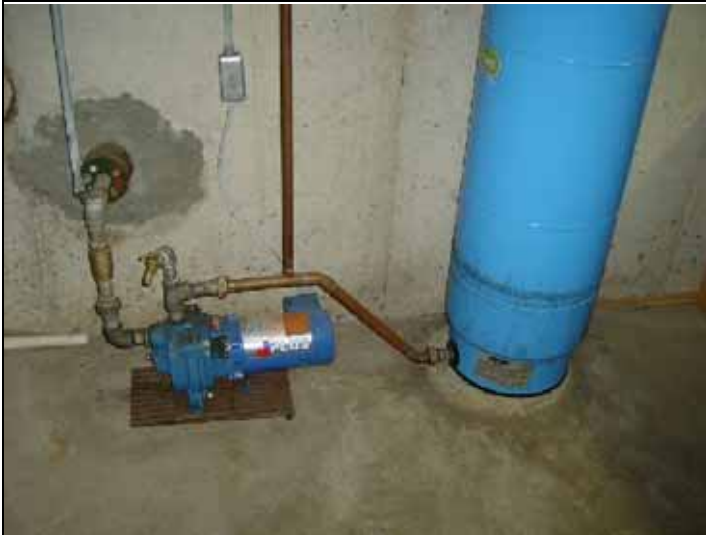
Shallow well pump and pressure tank
